Dendrochronologic Evidence for the Frequency and Magnitude of Paleofloods

Thomas M. Yanosky
United States Geological Survey, Reston, Virginia USA

Robert D. Jarrett
United States Geological Survey, Lakewood, Colorado USA

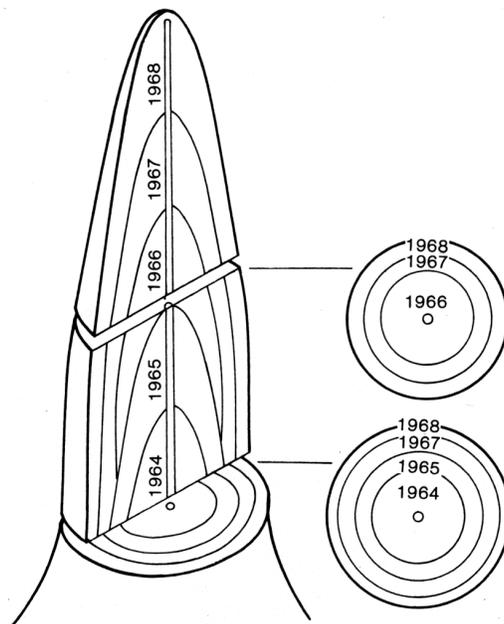
Figure 2. Stylized diagram of tree rings in transverse and longitudinal sections. From Phipps [1985].

Trees grow in height only from the division and elongation of cells at stem tips. Thus, a scar on a trunk or branch will remain at its original height as the tree grows taller. Growth in diameter results from the division of a thin layer of living cells (the cambium) just inside the bark, each year producing a new layer of wood, or ring. Phipps [1985] describes the three-dimensional nature of rings as concentric circles in transverse section and as parabolas when viewed longitudinally (Figure 2). The age of the tree can be approximated by counting the number of rings in the lower trunk, but a precise year can be assigned to each ring only by crossdating; that is, by matching ring-width patterns of a tree with those of nearby trees [Fritts, 1976]. Rings are composed of specialized tissues that conduct sap, provide support, and store organic materials. The relative size, amount, and arrangement of these components confer the typical appearance and physical properties of the various woods [see Phipps, 1985]. The structure of wood sometimes is modified by environmental factors and events that occur during the growth season, thus preserving anatomical evidence of past growing conditions.

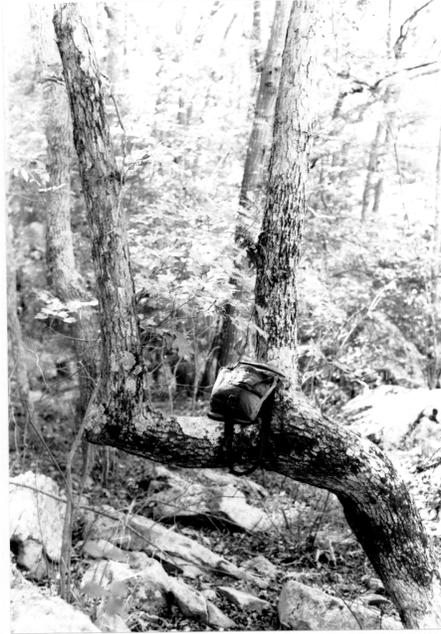
Figure 3. Growth habit (“Sigafos tree”) of a white oak (*Quercus alba* L.) on a flood-plain terrace along the Potomac River near Washington, D.C. USA. The vertical sprout at right started to grow from the tilted trunk in 1937. The flood of record occurred in March 1936, followed by the 4th highest flood of the century in April 1937. Photo by T.M. Yanosky.

Flood-plain trees along high-gradient streams commonly are small and shrubby, particularly when flooded frequently. Partial uprooting results in the formation of vertical sprouts along a leaning trunk, imparting a characteristic growth habit sometimes referred to as a "Sigafos tree" (Figure 3.). Trunk tilting or crown damage during dormancy results in the production of sprouts during the next growing season. Thus, the age of the sprout can be used to determine when the flood occurred [*Sigafos*, 1964]. Some trees in high-damage zones bear sprouts that document numerous floods, the oldest typically forming along lowest parts of the trunk. For example, *Sigafos* [1964] described one tree that formed sprouts documenting floods of the Potomac River that occurred in 1942, 1948, and 1955. If the crown and most of the bole are destroyed, two or more sprouts growing from the very base eventually impart a "split trunk" appearance similar to the multiple-stemmed trees growing from logged stumps.

Trunk tilting alters the widths of rings formed in subsequent years. Ring widths may be reasonably uniform along the circumference of vertical stems, whereas new growth becomes eccentric after a stem is tilted. That is, the width of a single ring may differ strikingly along the axis of lean. In hardwoods, rings are wider on the upper side than lower side of leaning trunks; rings in conifers are wider on the lower side. The number of eccentric rings can be used to determine how long the trunk has been tilted, and thus when the flood occurred.

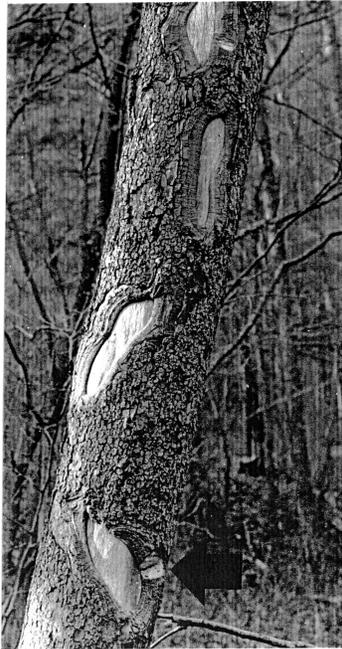
Figure 4. Impact scars on the trunk of a sycamore tree (*Platanus occidentalis* L.) growing along a stream in northwestern Virginia, USA. Scars document the occurrence of four floods and provide estimates of crest elevations. The uppermost scar is ~2.5 m above ground surface. The small wedge cut (arrow) along the margin of the bottom scar permits the counting of rings that formed since the cambium was damaged by flooding. Photo by C.R. Hupp.

Ice, logs, sediments, and other flood-borne debris sometimes abrade the bark and destroy part of the underlying cambium, resulting in the formation of scar tissue (callus) rather than new wood and bark. Callus is undifferentiated, often discolored tissue that forms a permanent record of localized cambial destruction. Eventually, new cambium grows over the scar and restores the production of wood and bark. Until this occurs, however, the scar is visible from the outside of the tree, sometimes for many years. Because trees grow in height only from shoot tips, the height of a scar above the low-water channel represents a minimum flood elevation (Figure 4), although the stage will be underestimated if the tree partly uproots after the scar forms. *Harrison and Reid* [1967] noted that the intensity of scarring does not necessarily reflect flood magnitude, but rather is a function of the amount of debris. Scarred trees most probably are found along stream reaches where bed gradients are high or flows are constricted, and are less frequent along streams with low gradients, wide flood plains, and small basin areas [*McCord*, 1996].

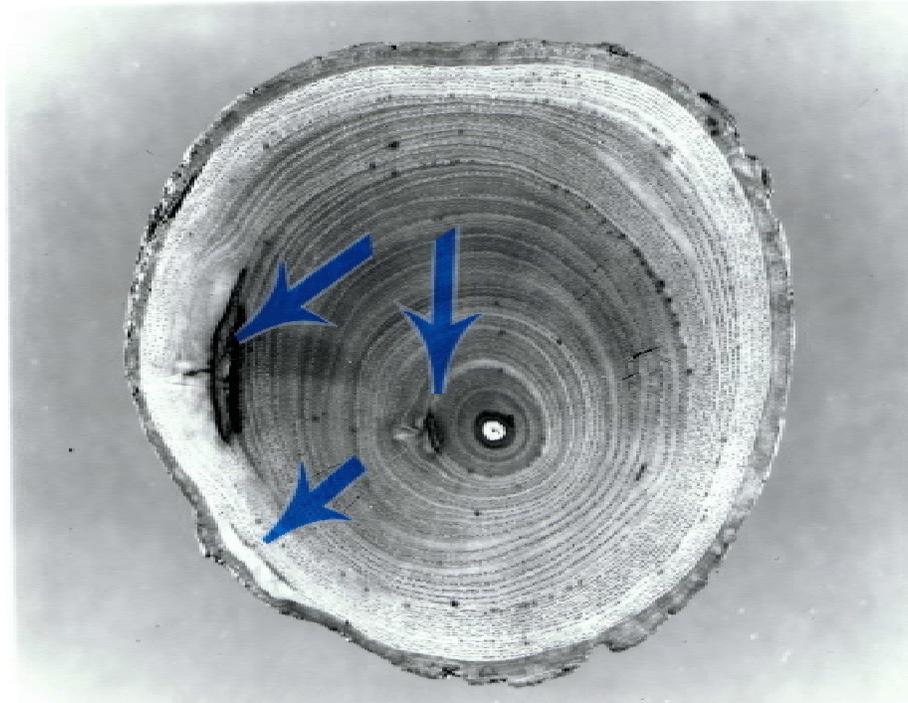
Figure 5. Impact scars healed by new growth. Three scars (arrows) formed along the upstream-facing radius. Life size. Photo by D. Usher.

If abrasion destroys the bark and cambium but no underlying rings, an increment core [*Phipps*, 1985] can be taken directly into the scar face and through the entire trunk diameter. The flood year can be calculated by subtracting the number of rings along the scar-containing radius from that of the intact radius. However, the removal of a small wedge-shaped sample along the scar margin (Figure 4) is preferable when tissues beneath the cambium have been damaged or abraded away. Healed scars within the tree most likely are discovered when cross sections are examined (Figure 5), although this method is undesirable because it requires the sacrifice of the tree. Flood years are estimated by counting the number of rings between the healed

scar and the outside ring. Subtle changes in bark morphology sometimes suggest the presence of a healed scar close beneath the surface, but deeper scars are detected only by hit-or-miss increment corings taken along the trunk. A series of corings at selected intervals (~30 cm) along the upstream- or channel-facing trunk increases the likelihood of detecting healed scars [Waythomas and Jarrett, 1994; McCord, 1996].

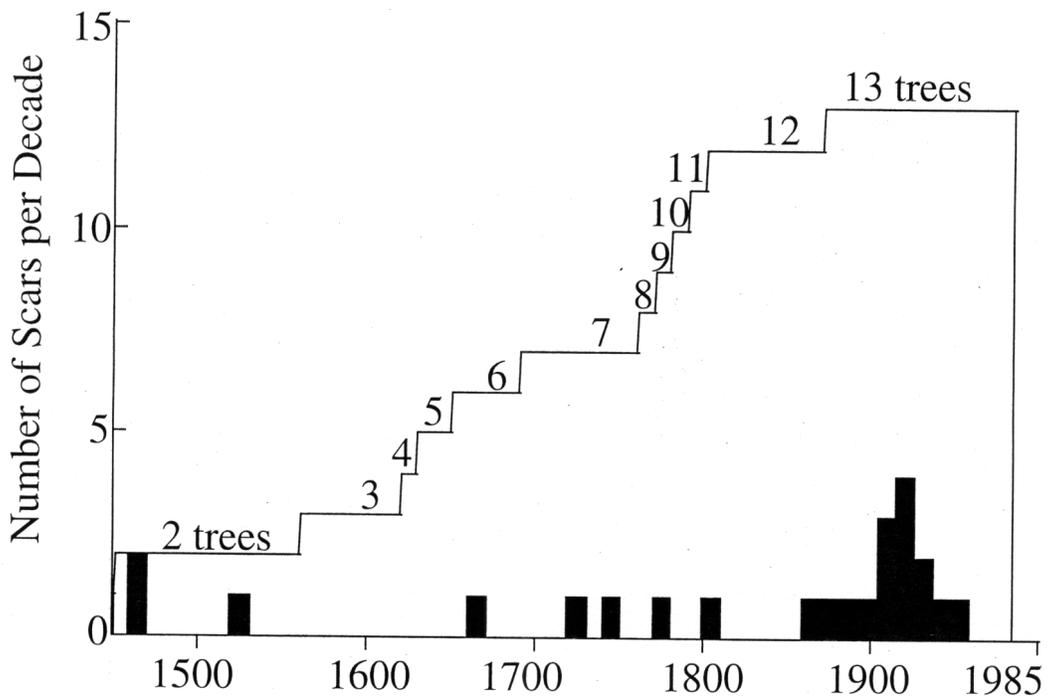
Figure 6. Flood-scar chronology by decade for Kanab Creek, Utah, USA. Note the clustering of floods during the 90-year interval beginning in the 1860s and the abrupt decrease in the number of study trees prior to the late 18th century. Modified from *McCord* [1996].

The most extensive use of scars to extend flood records has been that by McCord [1990; 1996]. He used increment corings and wedge cuts from coniferous trees to extend flood histories at eight sites in Arizona, New Mexico, and Utah, USA. The longest reconstruction was for Kanab Creek in southern Utah (Figure 6), where evidence was recovered for floods that occurred in 1471, 1521, 1660, 1726, 1742, 1773, 1809, 1866, 1872, 1883, 1890, 1902, 1909, 1910, 1916, 1925, 1936, and 1949. Furthermore, McCord showed that floods were not random but rather clustered in the period 1866-1949. Climate change or land-use practices may account for the increased frequency of floods, which, in turn, probably initiated the formation of arroyos on Kanab Creek [Webb *et al.*, 1991].

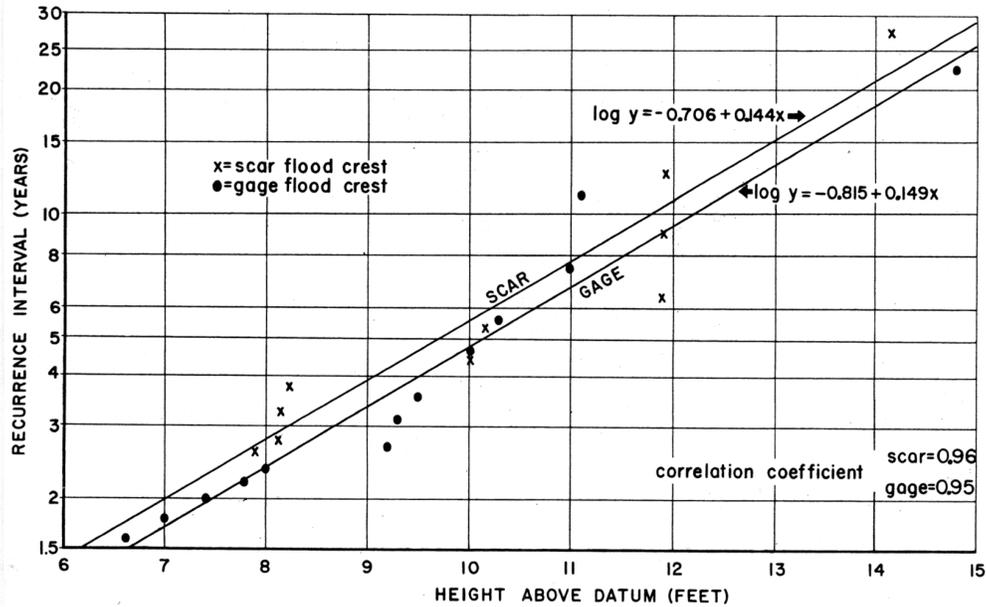
Figure 7. Flood-frequency graph for the Turtle River, North Dakota, constructed from instrumented records and from maximum scar heights. To convert stage heights to meters, divide by 3.281. From *Harrison and Reid* [1967].

Harrison and Reid [1967] compared a flood-frequency graph constructed from an analysis of ice-scarred trees to instrumented records for the Turtle River in eastern North Dakota, USA (Figure 7). Scars were recovered for 10 of the 12 floods during the 21-year period of record, despite that only three trees were studied. Evidence also was found for three floods that occurred before the period of record. More importantly, stage estimates from scar data generally were within 0.3-0.6 m of actual crest elevations recorded 32 km downstream. Thus, in addition to being the first to compare scar data to documented flows, Harrison and Reid [1967] showed that maximum scar heights corresponded to ice-laden flood crests along a low-gradient stream.

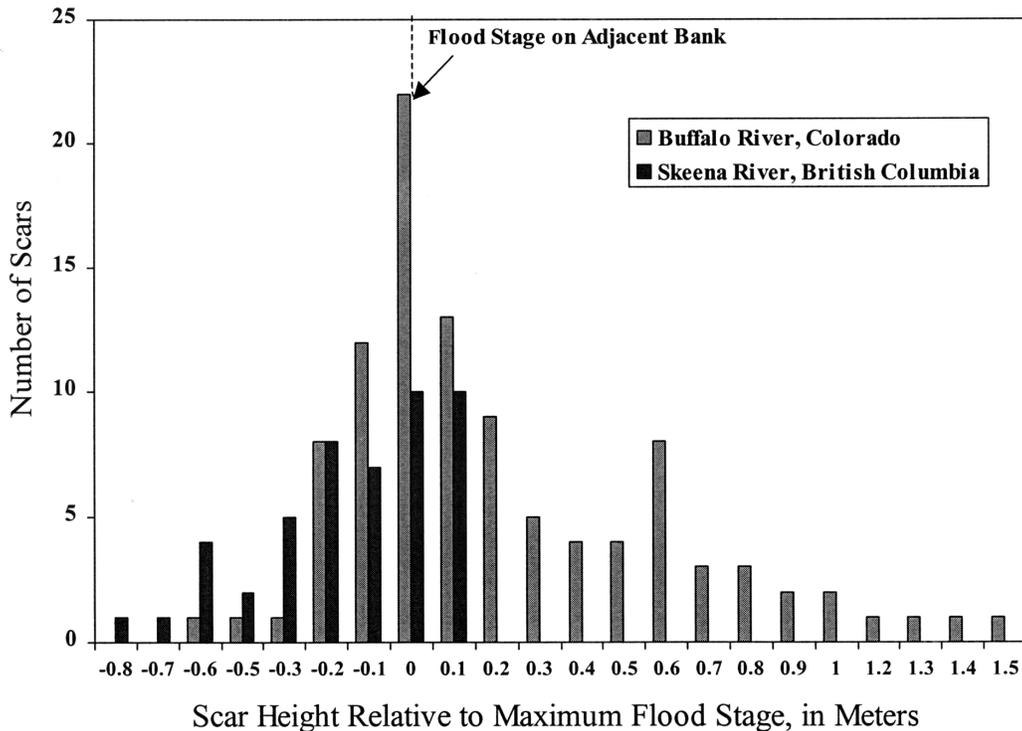
Figure 8. Maximum heights of scars on riparian trees relative to peak flood crests on the Skeena River, British Columbia (N=48 trees) [*Gottesfeld*, 1996] and on Buffalo Creek, Colorado (N=102 trees). Despite differences in gradient, flood magnitude, and the length of study reaches, the respective scar heights were reliable indicators of actual flood crests along both streams.

Scar data were collected from 102 riparian trees along an 8-km reach of Buffalo Creek. The elevation of each high-water mark along the streambank was extended to the top of the highest scar on each tree with a string line and bubble level. No older flood scars were observed, a finding consistent with the observations of local residents. The heights of all scars ranged from -60 to +150 cm relative to high-water marks (mean +21 cm); 64 scars (63%) were within 20 cm (Figure 8). Scar heights relative to high-water marks were slightly greater along lower than upper parts of the study reach, possibly owing to increased flow depths, velocities, turbulence, and durations. Increased debris transport along lower reaches may increase the likelihood of scarring

Scar data from the flood on Buffalo Creek also were analyzed according to the position of damaged trees within channel cross sections. Scar data were compared between streamside trees exposed to maximum flood-flow velocities ("main-channel" trees) and those more distant from the channel ("overbank" trees). The mean height of scars on 67 trees comprising the main-channel group was +23 cm relative to high-water marks, compared to +17 cm in 35 overbank trees. The lack of a significant difference between the two groups of scar heights probably reflects the extraordinary magnitude of the flood and the open-spaced nature of riparian forests in the semi-arid foothills of the Colorado Rocky Mountains. Additionally, some riparian areas along Buffalo Creek were burned severely, thus reducing even further the flow resistance typically provided by vegetation.

The mean height of scars relative to measured crest elevations along Buffalo Creek was ~40 cm greater than that determined along the lower-gradient Skeena River [Gottesfeld, 1996], and the range of scar heights also was greater (210 versus 90 cm). It is possible that extraordinary floods on low-gradient streams might possess sufficient energy to produce a tree-scar distribution similar to that of Buffalo Creek. Although additional tree-scar data are needed from a wider range of hydrologic and botanical conditions, the few studies conducted to date suggest that maximum scar heights provide acceptable estimates of paleoflood stages along low- and high-gradient streams, regardless of the kind of transported debris.

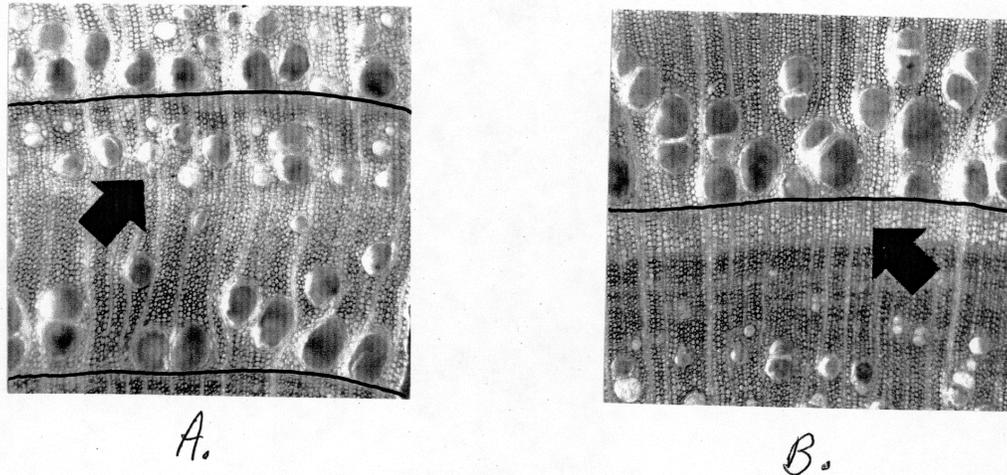
Figure 9. Ring anatomy of ash trees flooded during the growing season [Yanosky, 1983; 1984]. Direction of growth is from bottom to top, and ring boundaries are delineated by inked lines. Magnification X 60. (a) Large vessels (“flood ring”) (arrow) within the outer part of this ring formed when the tree produced a new leaf crop following the stripping of leaves by a flood in late-May, 1942. Typically, large vessels form only within the first part (earlywood) of a ring and not within the remainder (latewood). (b) A zone of atypically large and thin-walled fibers (“white ring”) (arrow) formed within the terminal latewood of this ring in response to late-summer root flooding (mid-August, 1942) that otherwise did not damage the leaf crop. Fibers produced before (below) the white ring are small and possess thick walls, thus imparting the dark hue typical of latewood. Photos by T.M. Yanosky.

Anomalous growth caused by flooding has been studied most intensely in ring-porous trees. Typically, ring-porous trees form one or several radial rows of large vessels (earlywood) during the expansion of leaves and elongation of twigs, and smaller vessels (latewood) thereafter for the remainder of the growth year. This striking difference in size between the two groups of vessels results in prominent ring boundaries. Yanosky [1983] found that ash trees (*Fraxinus pennsylvanica* Marsh.) growing along the Potomac River near Washington, D.C., sometimes formed rows of atypically large vessels ("flood rings") within the latewood (Figure 9a), and that anomalous vessels formed only during years when flooding occurred in late spring or summer. He observed that much or all of the leaf crop was stripped by flood currents, and that trees re-foliated soon after flooding subsided. As a new crop of leaves developed, another set of spring-like vessels developed. The position of anomalous vessels relative to the total width of the ring could be used to estimate when the flood occurred, usually to within about two weeks. Floods that occurred during the interval of earlywood formation also resulted in anomalous growth, most commonly as jumbled or additional ranks of earlywood vessels. Yanosky (1983) found evidence for 12 floods that preceded the 1930 period of record, including three prior to 1895 (the inception of record keeping at the Point of Rocks gaging station).

Yanosky [1983] also noted that earlywood vessels were abnormally small and sparse in many trees subjected to catastrophic ice jamming in 1948 and 1968. Because vessel enlargement is controlled in part by hormones produced by expanding leaves, *Yanosky* concluded that ice damage to shoots and buds during dormancy resulted in a later deficiency of hormones during budbreak, and thus to a reduction in vessel diameters. Flood-ring vessels also are smaller than typical earlywood vessels, most likely because post-flooding refoliation also produces smaller amounts of growth hormones.

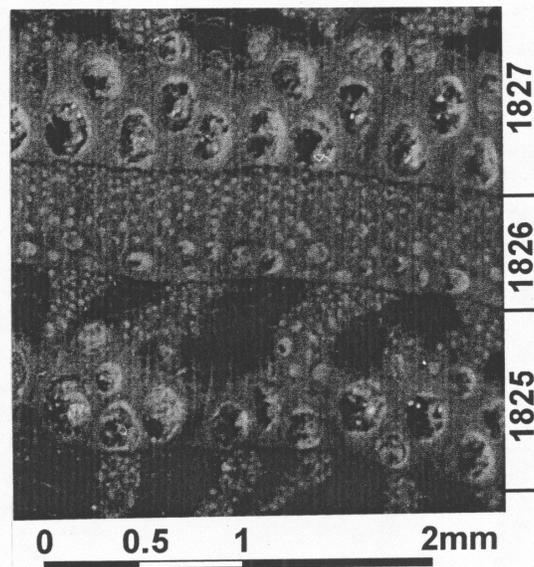
Figure 10. Ring anatomy of a bur oak (*Quercus macrocarpa* (Michx.)) inundated during the great flood of May 1826 flood on the Red River, Manitoba, Canada [St. George and Nielson, 2000]. Direction of growth is from bottom to top. Note the reduced width of the 1826 ring, the small, diffuse earlywood vessels, and the dearth of thick-walled fibers (the darkest tissues in adjoining rings). Photo by S. St. George.

The effects of flooding upon ring growth of bur oak (*Quercus macrocarpa* (Michx.)) were studied by *St. George and Nielson* [2000] in the basin of the Red River, Manitoba, Canada. They constructed a 536-year oak chronology from living trees, buried logs, and architectural beams. Prolonged root inundation during May 1826 and 1852, the largest 19th century floods, resulted in the formation of rings with single ranks of diffuse, uniformly small earlywood vessels. Latewood vessels are scattered evenly throughout the remainder of rings, rather than in typical flame-like patterns, and the walls of fibers are atypically thin (Figure 10). As along the Saone River in France, it seems unlikely that trees in the Red River basin were damaged mechanically by floodwaters. *St. George and Nielson* also discussed the possibility of estimating the peak elevation of the 1826 flood, the century’s largest, but most of their samples were from architectural structures for which tree-growing locations could not be determined.
