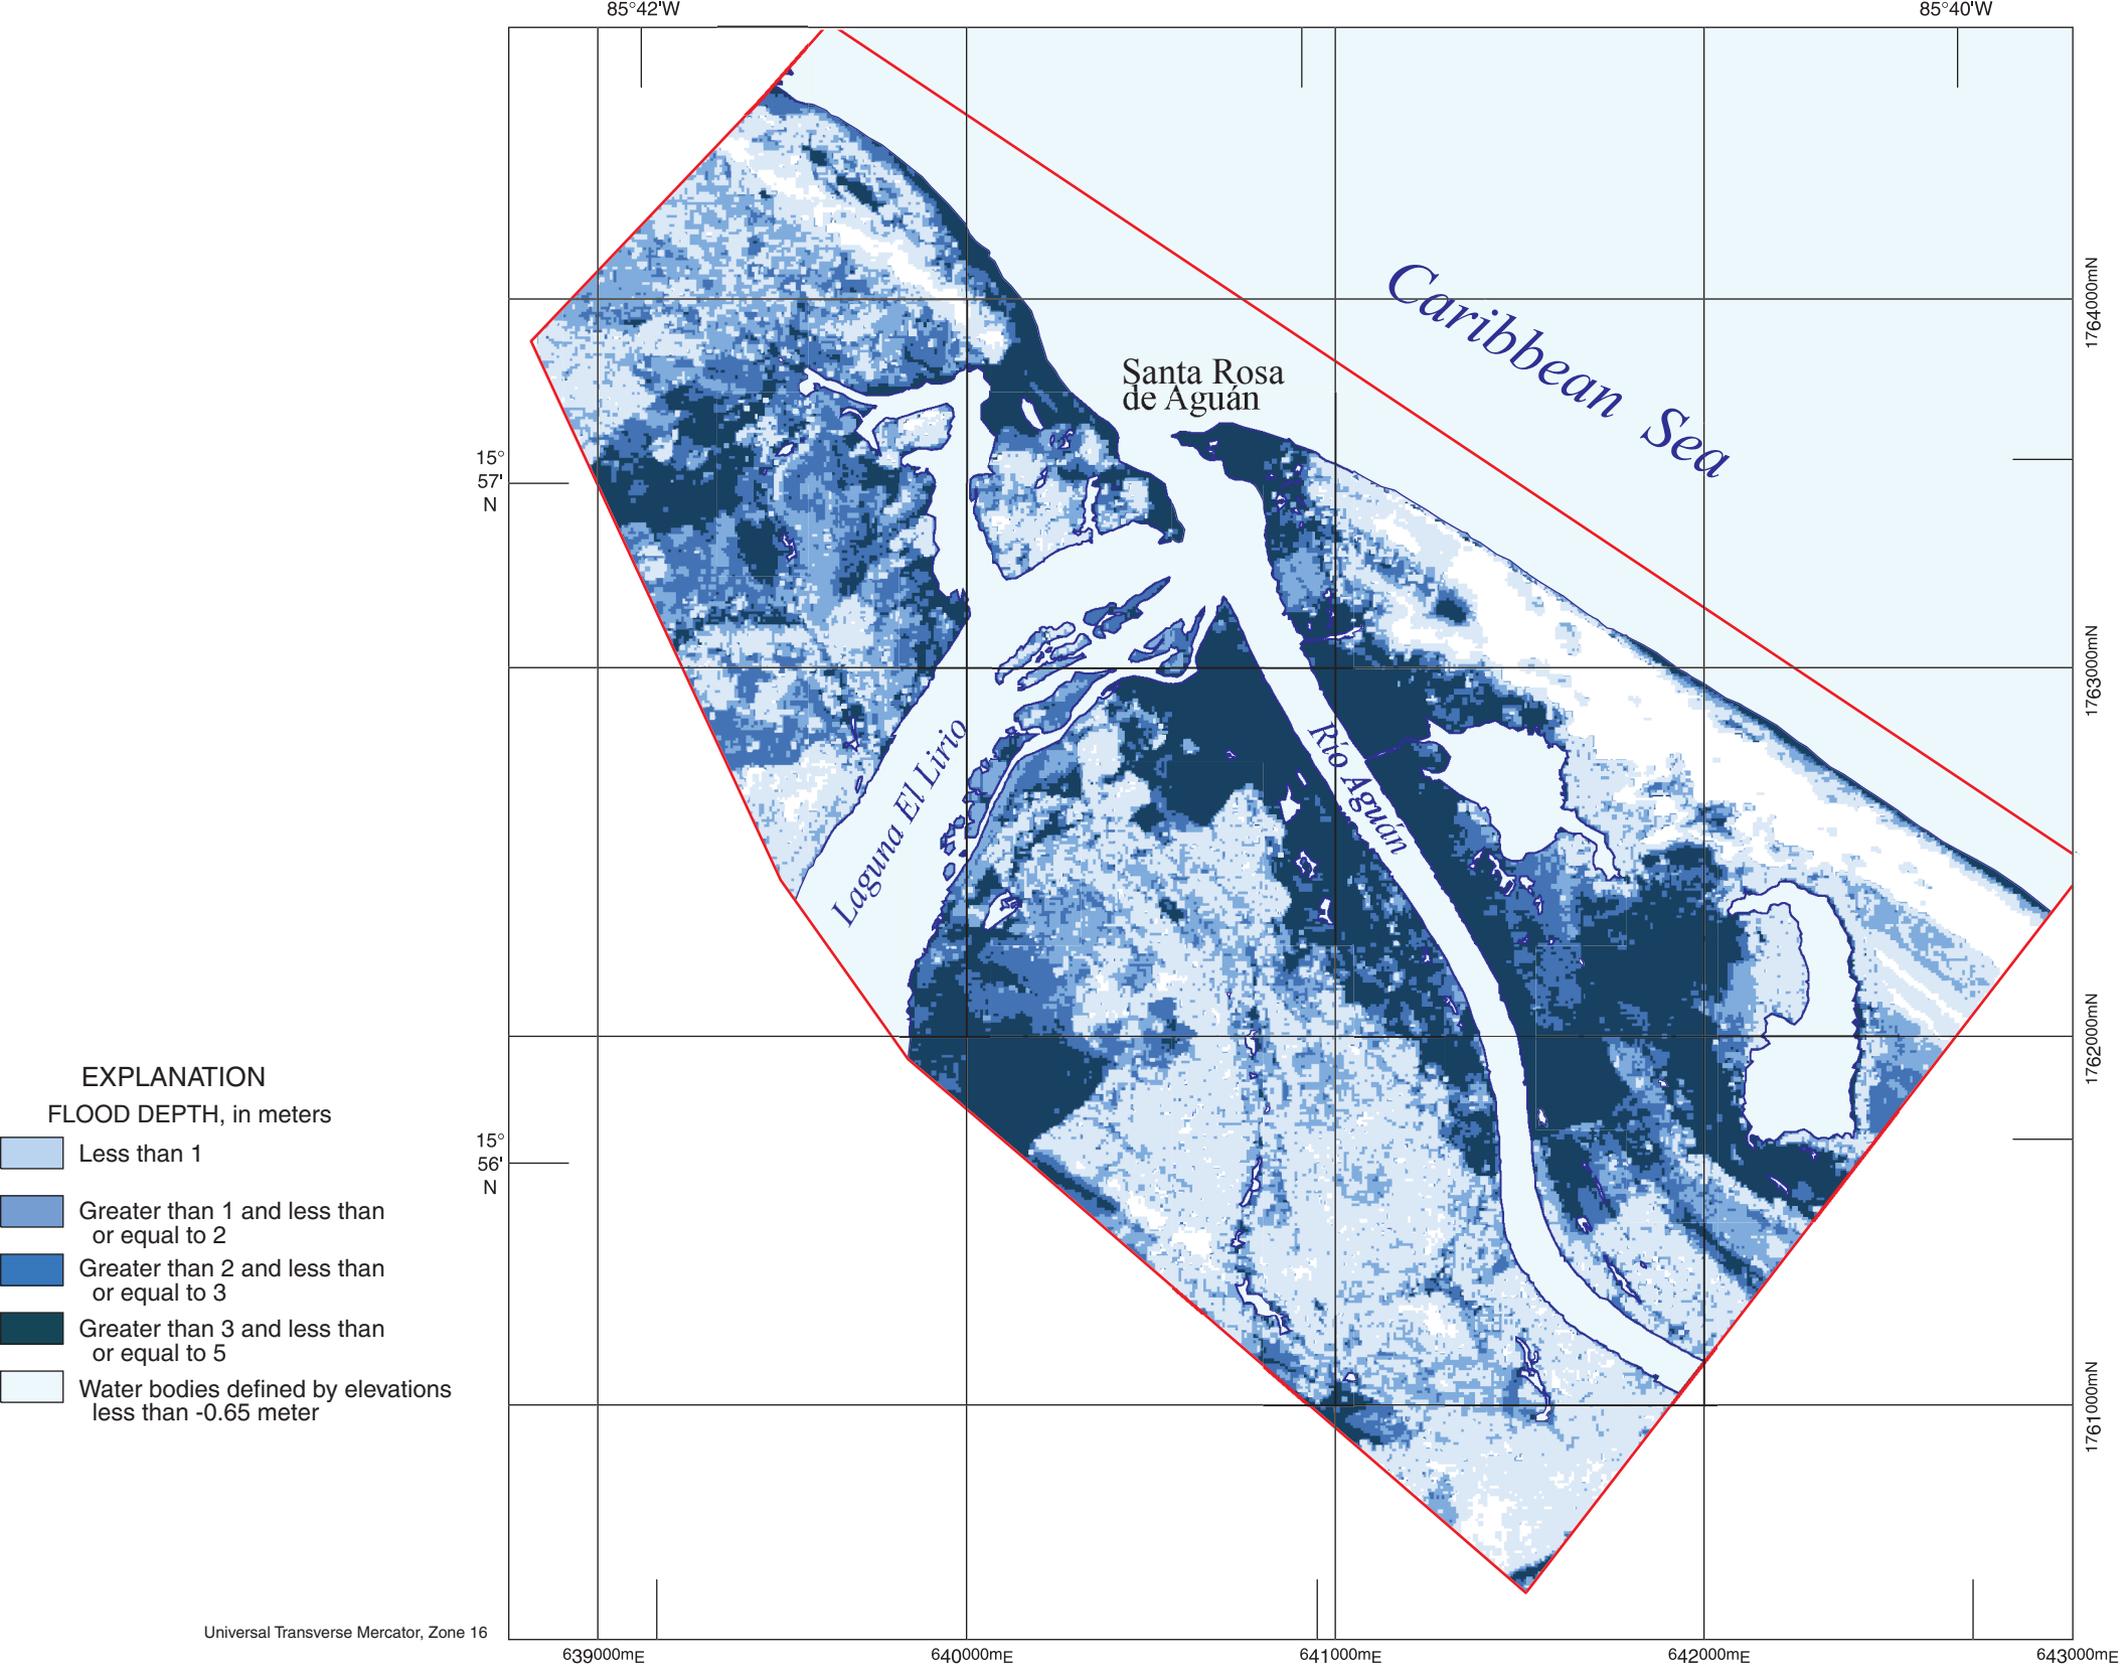
Figure 4. Depth of inundation for the 50-year storm tide at Santa Rosa de Aguán, Honduras.
