Report for 2005NY66B: GIS-based riparian buffer management optimization for phosphorous and sediment loading

**GIS-BASED BUFFER MANAGEMENT OPTOMIZATION FOR PHOSPHOROUS:
A Field Test of Whether a Topographically-Based
Phosphorous Model Can be Used to Locate Best Management Practices**

by
Paul L. Richards and Mark Noll*
Department of Earth Sciences
SUNY College at Brockport
350 New Campus Drive
Brockport, NY 14420-2914
**prichard@brockport.edu*
(585) 395-5715

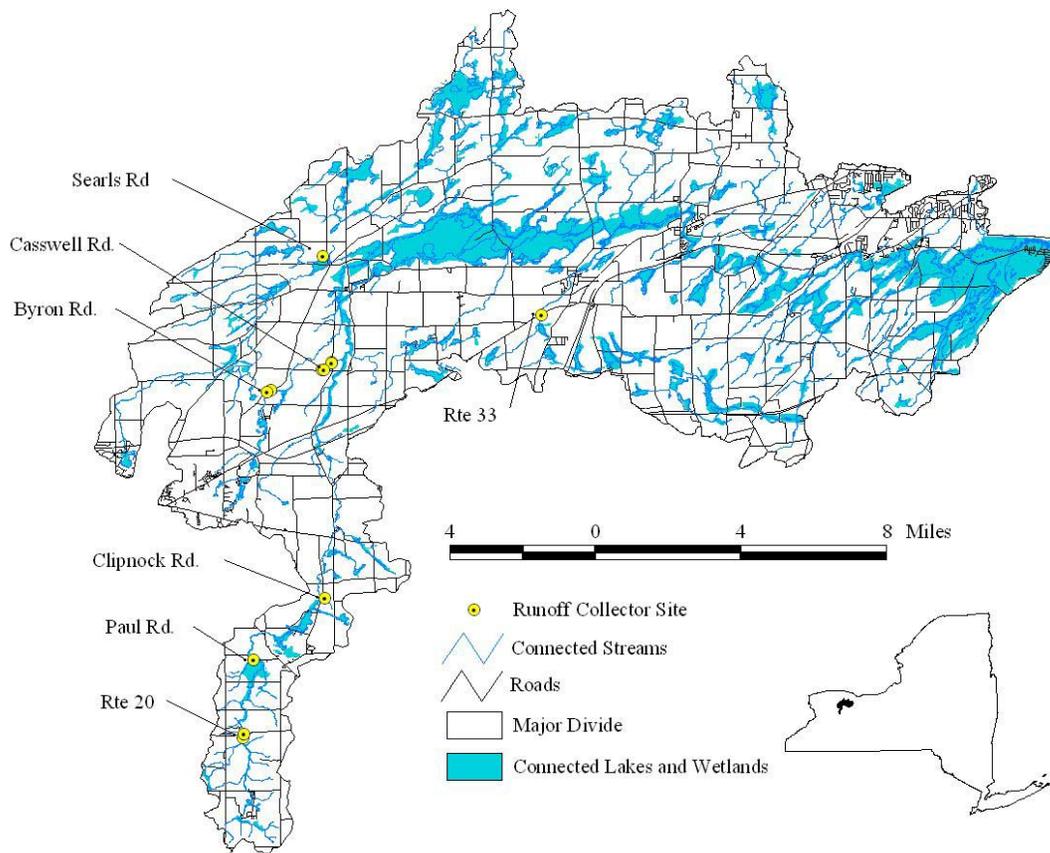
Figure 1 The study area, Black Creek Watershed, is located in western NY. A topographically-based phosphorous loading model was run over the entire watershed to identify sites on streams where, by virtue of slope and aspect, receive greater than normal phosphorous loads. The idea was to target stream reaches at these sites with wider buffers or other appropriate best management practices. Field measurements of overland flow and phosphorous fluxes were conducted on 12 of these sites to determine the validity of the model.

To guide our selection of sites, a field survey and GIS assessment of 25 sites took place throughout the Black Creek Watershed. Sites were photographed, located by GPS and then evaluated by overlaying the phosphorous model on 2002 aerial photographs. Local crop cover was noted from field observations and the type of topography (straight hill slop, convex, concave) was identified. Using this information, 12 sites were selected for the field analysis. These sites were chosen because they have a broad range of different model phosphorous transport rates, and are representative of the topographic and landcover characteristics of rural stream segments in the Black Creek Watershed. Sites are located in the heavily farmed southwestern portion of the watershed (Figure 1).

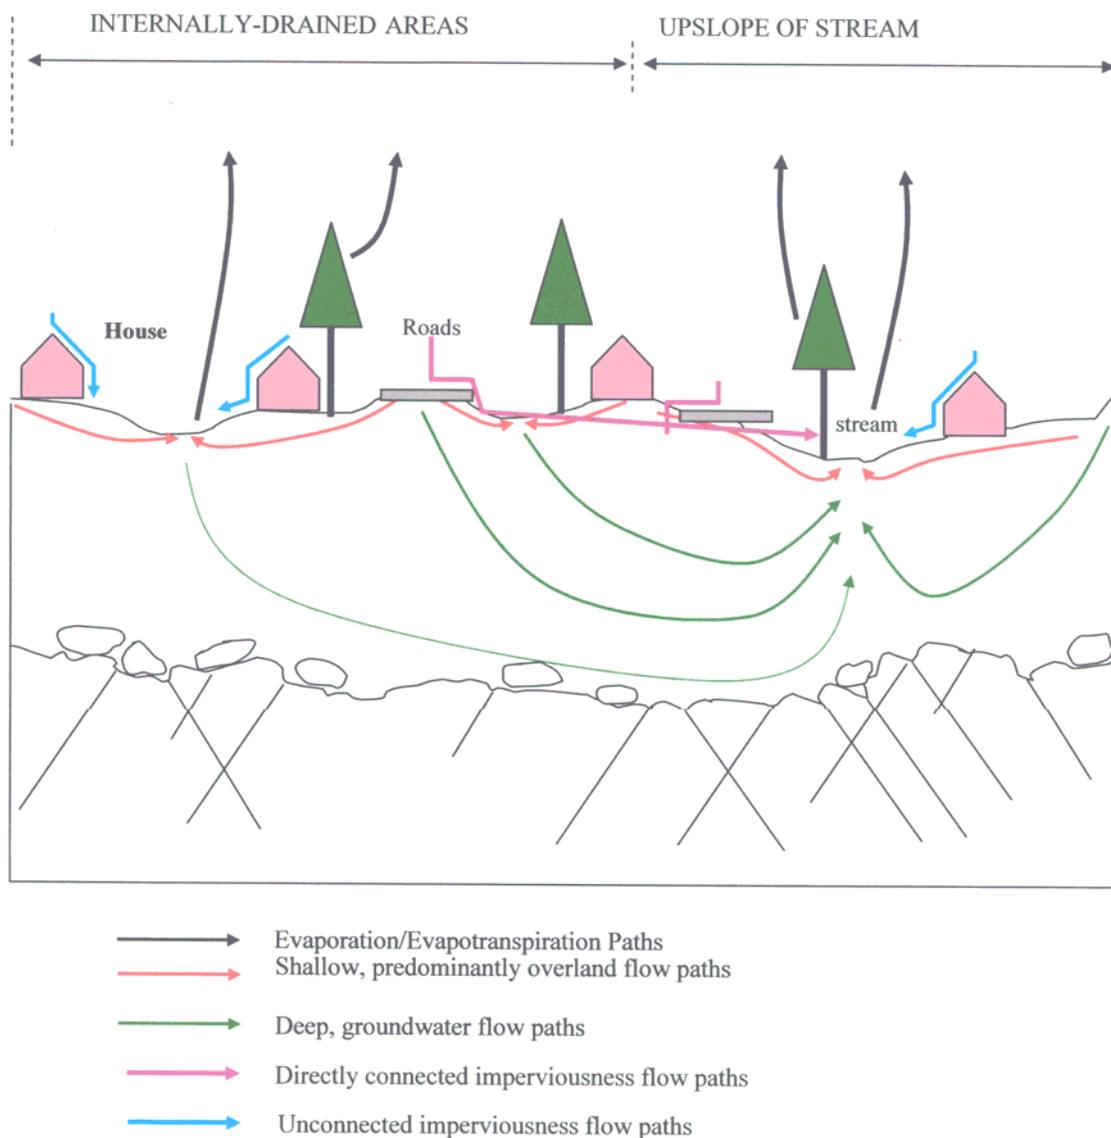
Figure 2 Schematic of watershed profile showing flowpaths associated with Internally-drained and directly-connected areas. These areas were mapped in the watershed using the PCSA algorithm (Richards and Brenner, 2004) to identify topographically connected areas where sediment and particulate phosphorous fluxes can possibly reach the stream network. Internally-drained areas are also important because they can be areas of enhanced groundwater recharge.

The loading model was supplemented with a topographic analysis to determine the extent of internally drained areas. The PCSA algorithm (Richards and Brenner, 2004) was used to map the extent of large-scale internally drained depressions in the watershed (Figure 2). Areas outside of these depressions are directly connected and are capable of delivering sediment and phosphorous to the stream network. Although not explicitly used in the assessment of the phosphorous model, the results of this analysis will be useful for prioritizing BMP strategies in the Black Creek Watershed.

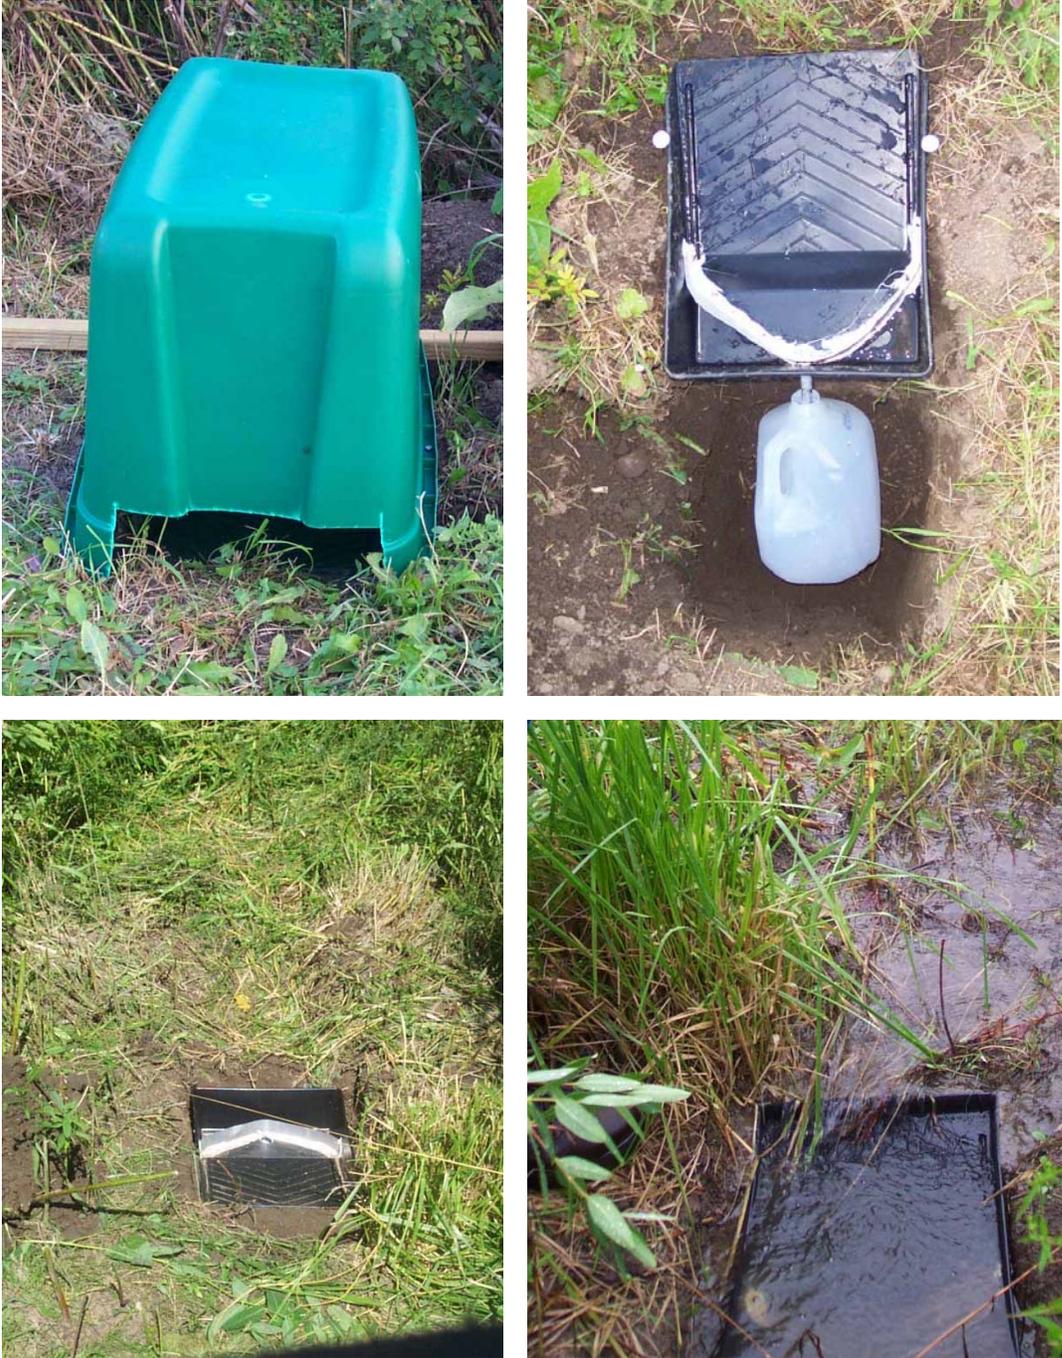
Figure 3

Runoff collectors designed for this study that were used to estimate overland runoff volumes. Overland runoff enters the hole at the front of the rain shield, flows through a collection tray and then into a 1 gallon water jug which is located in a 12 by 12 by 14 inch hole underneath. These collectors are accurate for small < 4.3 liter overland flow events. Higher volumes overflow into the hole. The design of the collector facilitates accurate measurements of active overland flow by allowing the user to measure discharge with a beaker and stopwatch.

Sites were instrumented with runoff collectors (Figure 3) to measure the volume of active overland flow. Runoff collectors were located in a topographic lows showing signs of drainage in the vicinity of where the phosphorous model determined a high phosphorous transport path exist. The small size of the runoff collector containers caused them to overflow on occasion, requiring visits to the site shortly after rainfall events to measure flow rates by hand. These measurements were made by measuring the flow rate through the runoff collector tube and over the back edge of the runoff collector using a graduated beaker and stop watch. Sites were visited and measured daily after the event until active runoff stopped. The duration of ponding in front of the runoff collector was also observed. Typically the first flow measurement was made within 18 hours of the event. To estimate total flow during the event we assumed this measurement was made at the peak flow and that overland flow did not occur before the event. A simple triangle was used to integrate the runoff during the active runoff period which is assumed to be 24 hours. This approach is crude and underpredicts the true volume of overland flow, however since the timing of observations was frequent and regular we could rank sites relative to each other qualitatively by counting the number of times the runoff collector was active. Small rainfall events did occur where some of the runoff collector did not overflow. From this information we could further rank sites in their propensity for generating overland flow. Site A whose runoff collector did not overflow obviously received more runoff than site B whose runoff collector overflowed in the same storm.

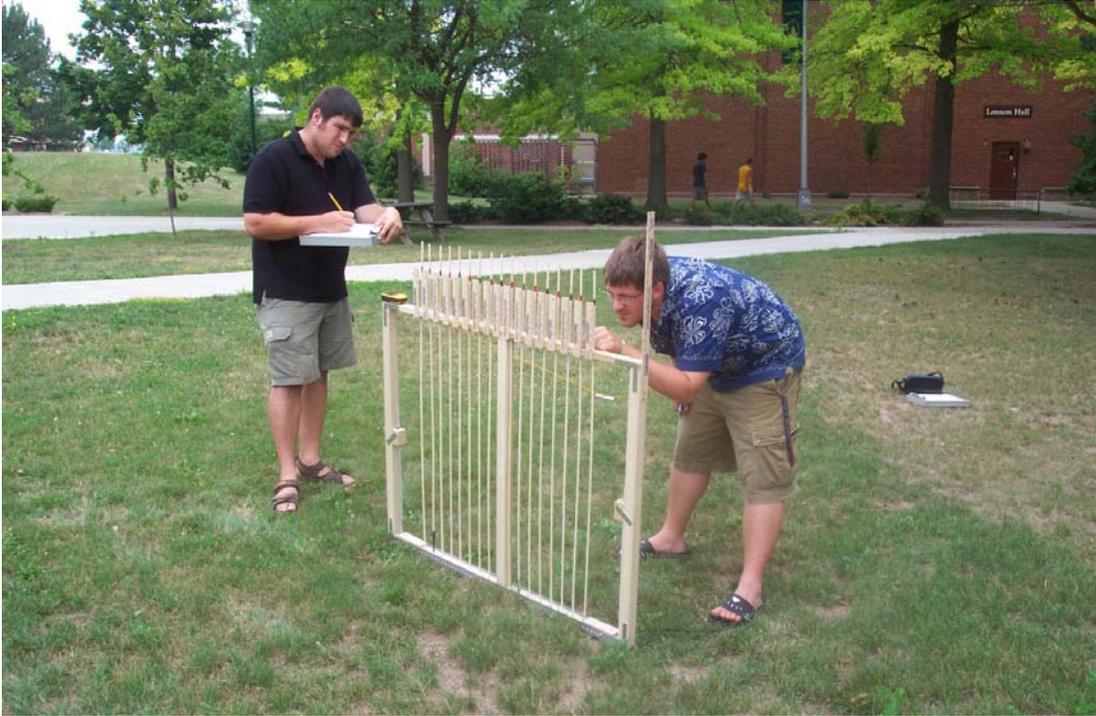
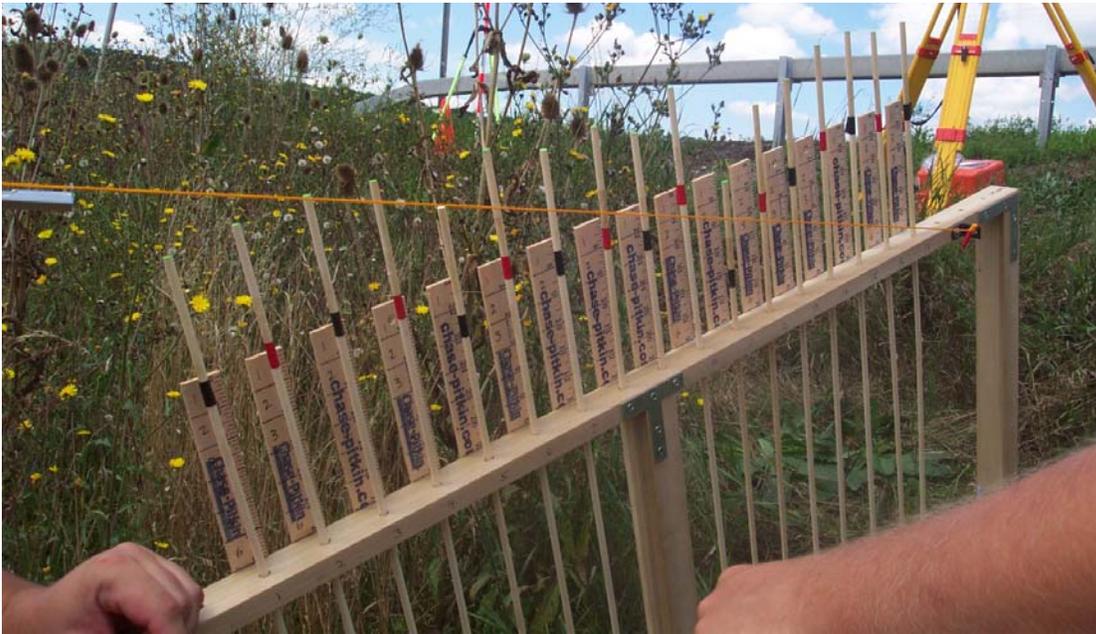
Figure 4

Device (roughness clinometer) designed for this study that was used to measure depression storage and slope at runoff collector sites. The device is placed into the ground along the direction of maximum slope and dowels are lowered to touch the ground. Measurements of dowel displacement are then processed with software (rough4.exe, available at <http://vortex.esc.brockport.edu/pauljr>) to calculate depression storage, slope and surface roughness. Prior to using the instrument, the site is cleared of sticks and dead vegetation. Details of the device can be found in Richards and Grimm (2005) as well as on the above web site.

Depression storage was estimated from surface microtopography digitized with a roughness clinometer (Figure 4). Depression storage was measured 6 times at 10 foot intervals along the main flowpath upslope of the runoff collector. Storage was evaluated for each topographic high using an algorithm that determines the equation of a line that extends horizontally from the topographic high to a point where the line intersects with the ground surface. The area between this line segment and the ground surface is estimated numerically using the trapezoidal approximation. Storage associated with all topographic highs were summed and divided by the length of the roughness clinometer to obtain depression storage volume, per unit width, per unit length of flowpath. The dimension of this parameter is a simple length unit that is comparable to mm of rainfall. Thus, a depression storage of 5.6 means that the equivalent of 5.6 mm of rainfall can be stored in the surface without any runoff happening.

Funding from the grant was also used to design the hardware and software of the Roughness Clinometer, a device used to measure depression storage, roughness and slope in the field. Details of the device can be found in:

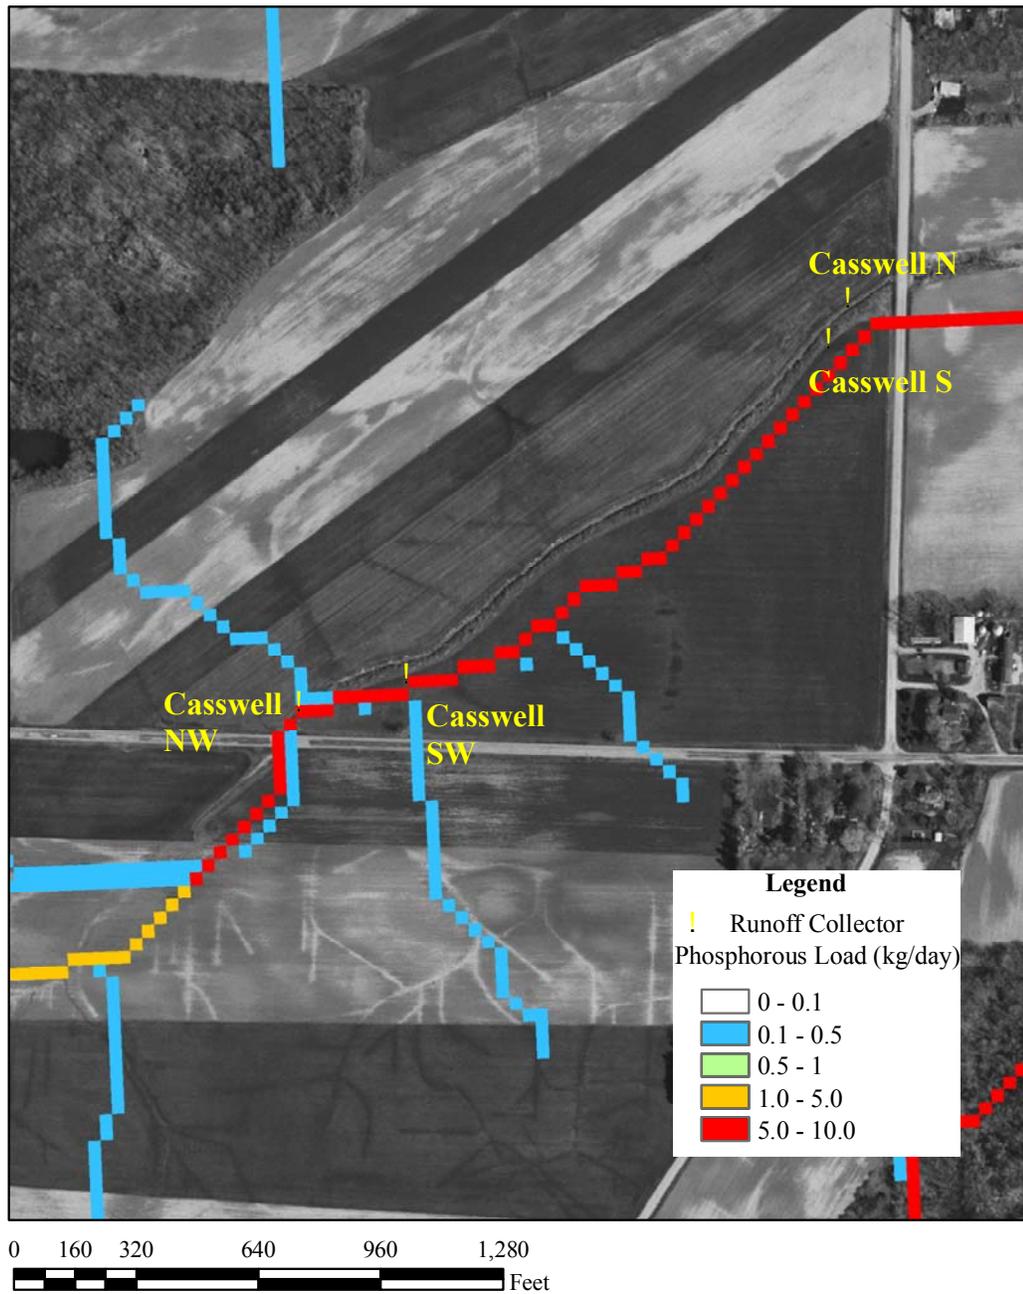
Figure 6 Modeled phosphorous flow paths superimposed on a 2002 aerial photograph of the Casswell Rd sites. Runoff collectors for Casswell N, Casswell NW, Casswell, S and Casswell SW are indicated. Note the offset of the model below the stream.

The sites at Caswell Rd show mixed results. Casswell NW was ranked by the model as the most important contributor of phosphorous. In the observed data it was also ranked high (3rd largest contributor). The other sites were miss-ranked significantly. The rankings within the Casswell sites themselves were also misranked except for Casswell NW. At the Casswell site all soils are soil hydrologic group D, thus the result of the model was controlled primarily by the area of flow accumulation. The performance of the model was interpreted to be caused by poor DEM registration and functional limitations (the model does not account for depression storage or slope, which vary significantly between the sites). Average depression storage was about 0.48 inches for Casswell SW compared to 0.16 inches for Casswell NW. These minor differences may have an impact on the response of these sites to small precipitation events. There was another odd aspect of the DEM at Casswell Rd, the slope computed from it was much lower than the slopes measured in the field. The poor quality of the DEM in the vicinity of Caswell rd has clearly limited the usefulness of the model for predicting precisely where the phosphorous flowpaths intersect the stream network.

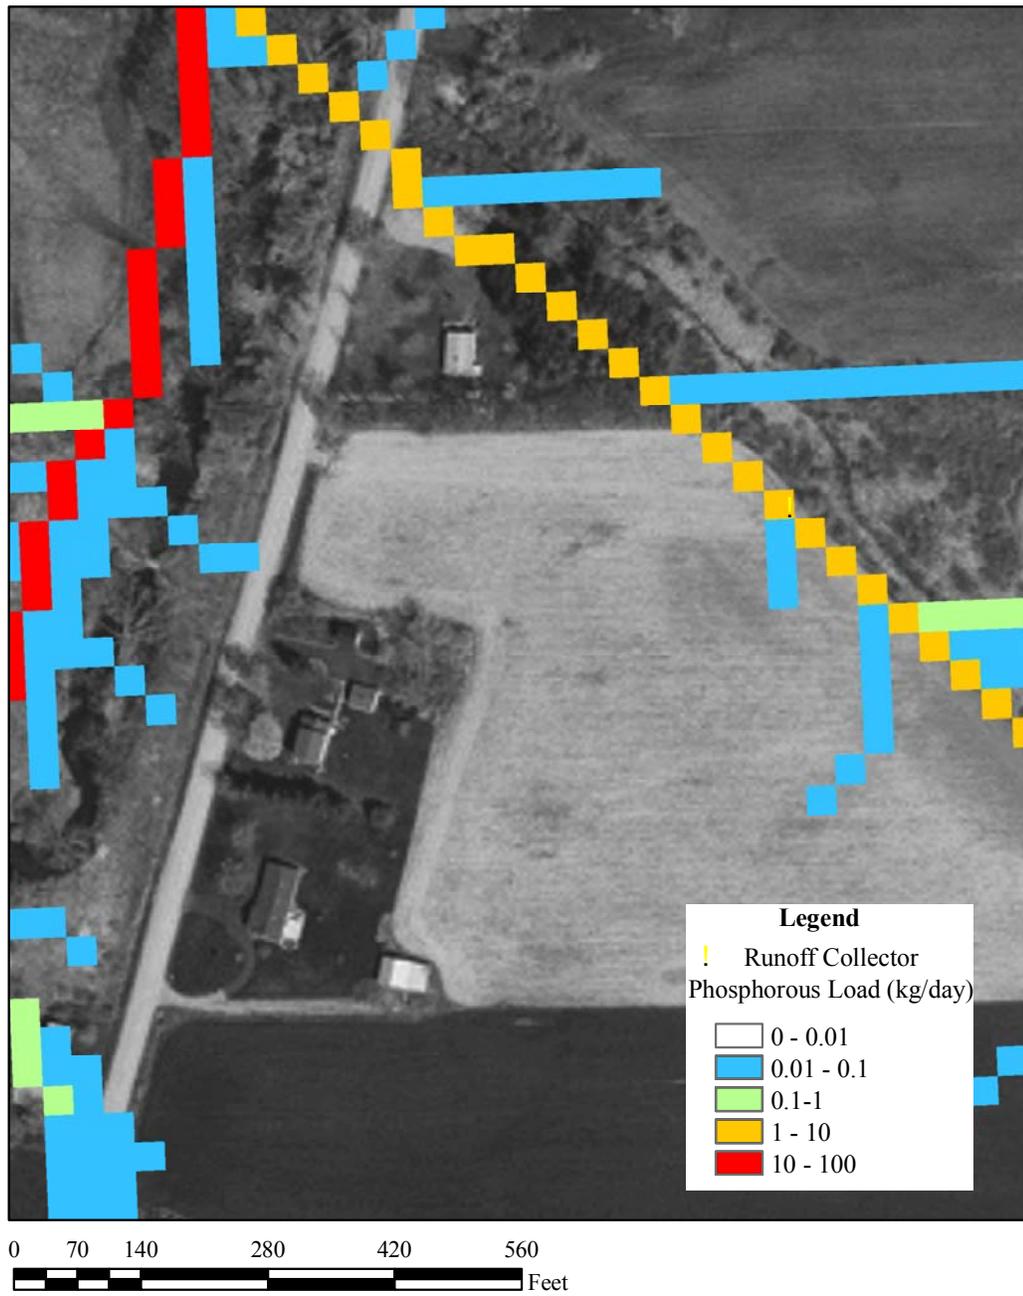
Figure 7 Modeled phosphorous flow paths superimposed on a 2002 aerial photograph of the Clipnock Rd site. The runoff collector for Clipnock Rd is indicated.
