Indirect Measurement Summary

Brier Creek near Langley, Arkansas

Flood of June 11, 2010

Type of measurement: Slope Area

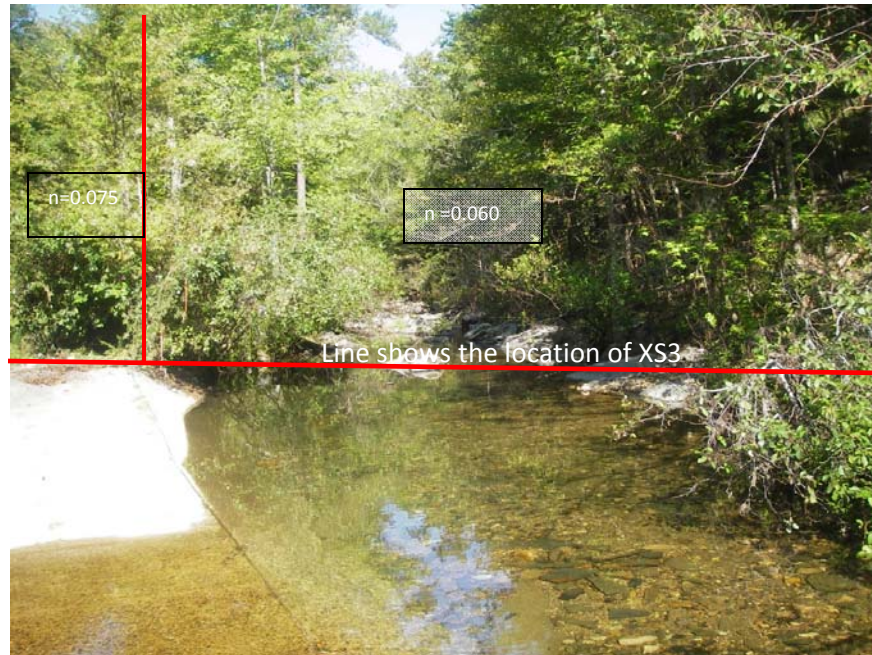
The right overbank contains open timber, thick sprouts/brush, and some grass and concrete road slab. The composite n value for the right overbank was estimated to be 0.075 based on engineering judgment.

The main channel/left bluff has gravel and fairly open with no protrusions of trees in the main channel and the left bluff has considerable sprouts/brush very near the bank and open timber at the valley wall. The n value was estimated to be 0.060 based on engineering judgment.

Looking upstream from upstream low-water bridge toward XS 3. Note: bridge crosses stream immediately below XS3 and then the concrete slab is part of XS3.

P6170042.mov—video just below XS3 (most upstream) looking upstream at the XS3.

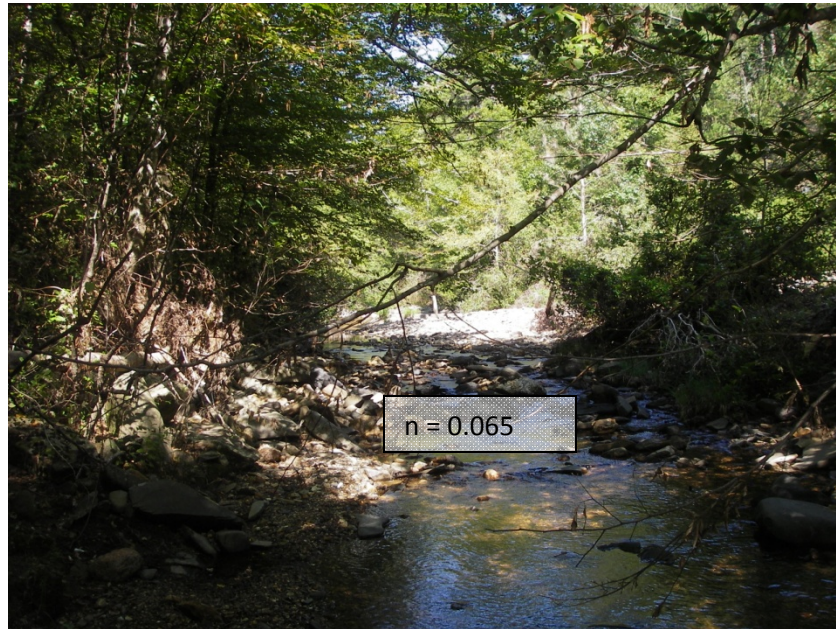
The main channel/right bluff consists of trees, dense sprouts, and sparse trees and boulders. The n value was estimated to be 0.065 based on engineering judgment.

XS 2 looking upstream

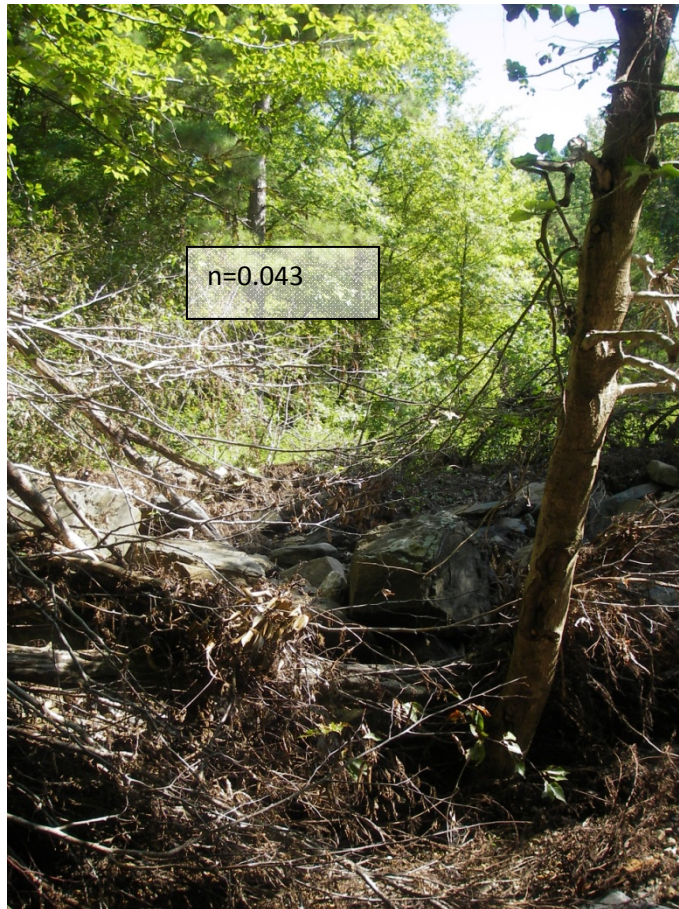
The left overbank contains open timber and weeds/grasses. The n value was estimated to be 0.043 based on engineering judgment.

XS 2 looking at left bank from middle of cross section. Note the openness of the left overbank is not as apparent in this photograph as in the video for this cross section. See video "P6170040.mov"

P6170040.mov—video at X2 (middle cross section). Standing on left bank in grass and looking around. Then walking to main channel. Note there is quite a bit of sprouts, trees growing up in the channel.

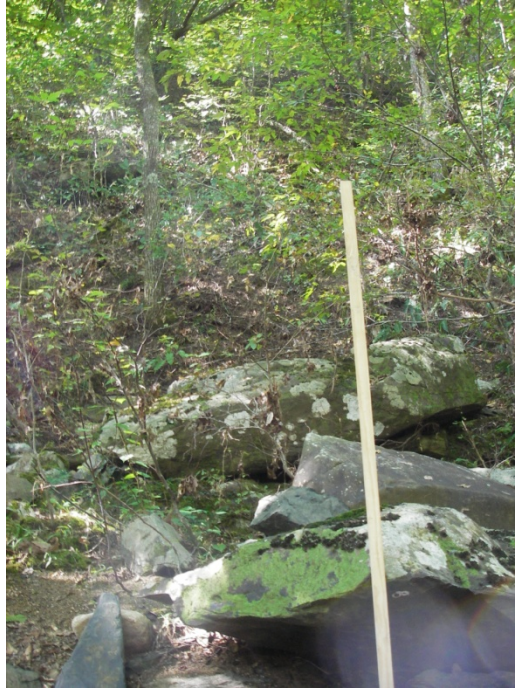
XS2 looking at right bank from middle of cross section

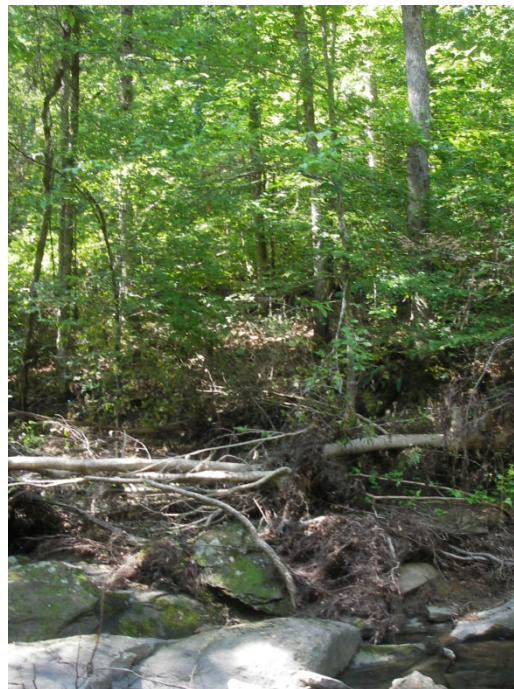
XS1 looking at right bank from middle of cross section

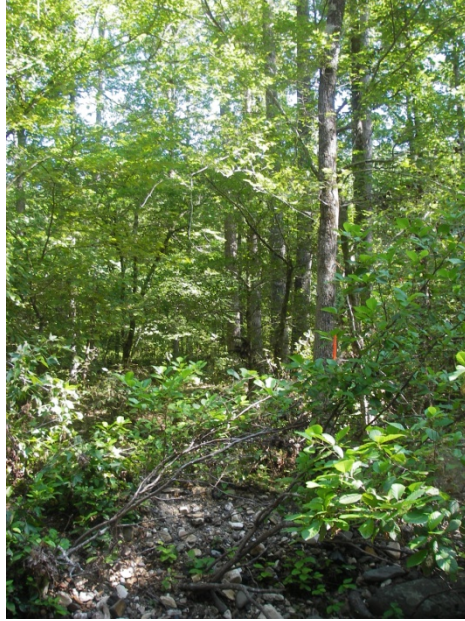
The left overbank was comprised of weeds and thin brush. An n value of 0.040 was estimated based on engineering judgment.

XS1 looking at left bank from middle of cross section

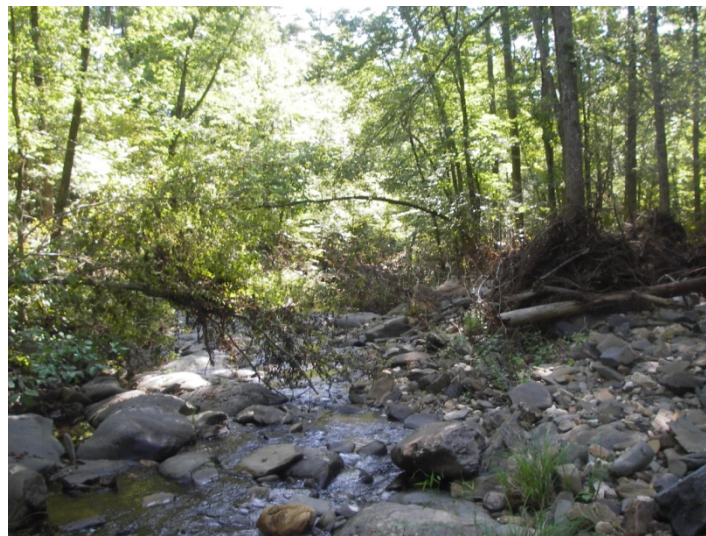
XS1 looking downstream from middle of cross section

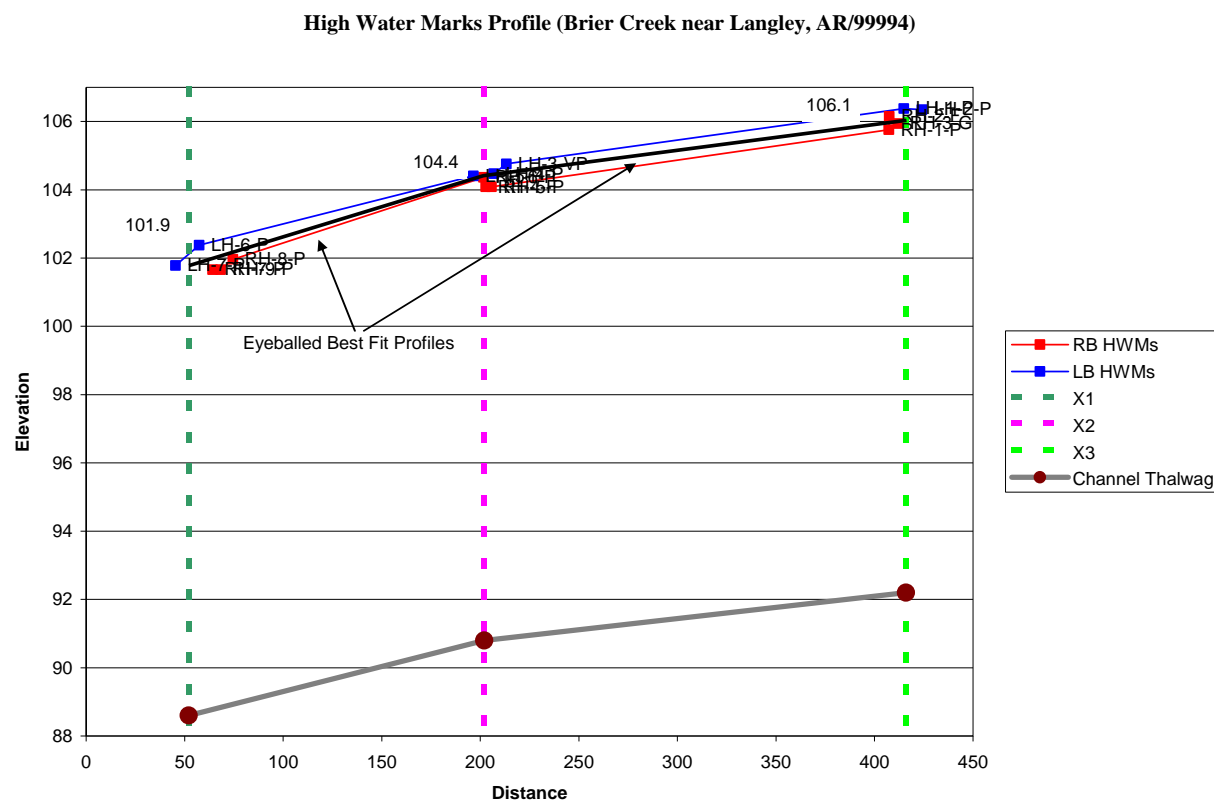
Below I have plotted the channel thalweg profile which shows an increase in channel slope downstream of XS2 as opposed to upstream. This increase in slope is reflected in the water surface profile

The velocity at XS1 would be higher than XS2 because of the increased water surface slope. See response to comment 1 regarding roughness.
