Indirect Measurement Summary

Little Missouri River at Albert Pike, Arkansas

Flood of June 11, 2010

Type of measurement: Slope Area

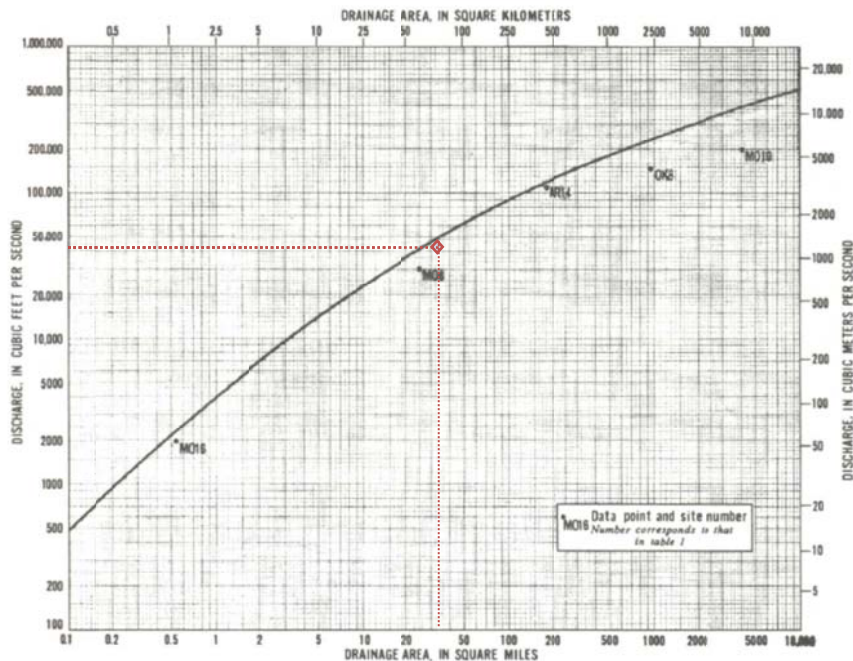
FIGURE 10.—Peak discharge versus drainage area, and envelope curve for region 8.

Unit Discharge: 1,180 cfs/mi². Crippen and Bue (1977) envelope curve for this region (Region 8) is below, with this flood approximately plotted. You will note that this flood plots on the envelope.

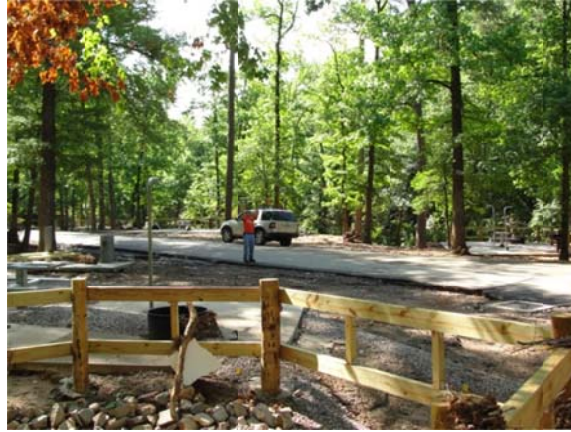
Looking from upstream diagonally to the XS2. Note location of high water marks as shown by hydrographer holding rod horizontally.

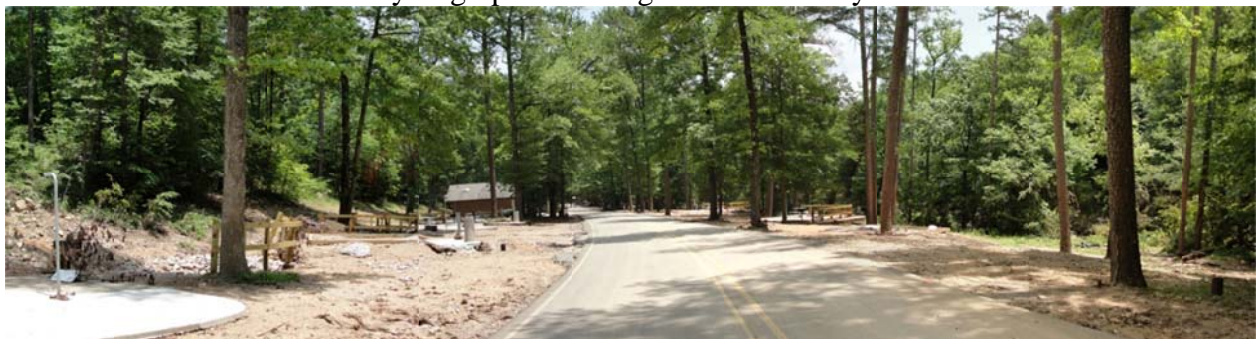
Looking from XS1 downstream through Left overbank area

The left overbank is loop C of the campground which was empty of campers the night of the flood. There are scattered trees in the overbank area along with a road that runs parallel to the stream channel. There are constructed picnic areas through this left overbank area with some treated lumber fencing that does not span wide distances. See 2 video clips:

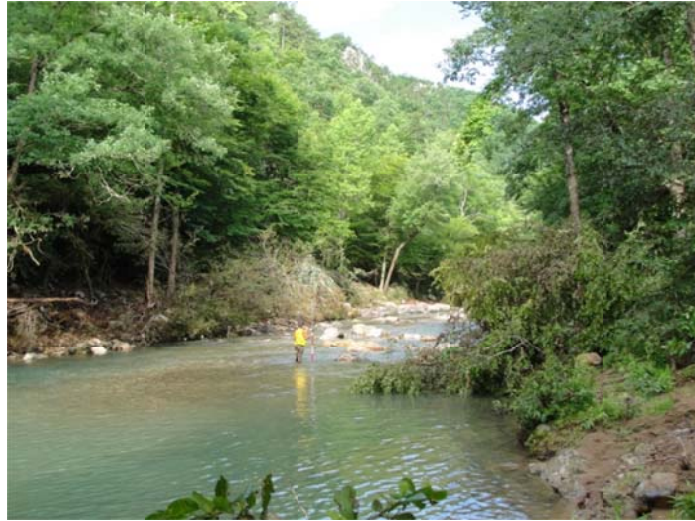
Looking from left bank upstream to XS1 where rodman is in middle of main channel. Note the boulders that are visible are not present in the main channel in the indirect reach

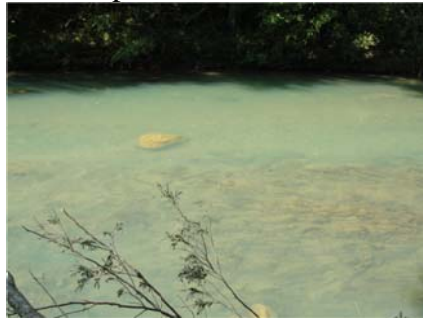
Looking at channel bottom at XS3 from left bank looking to right bank

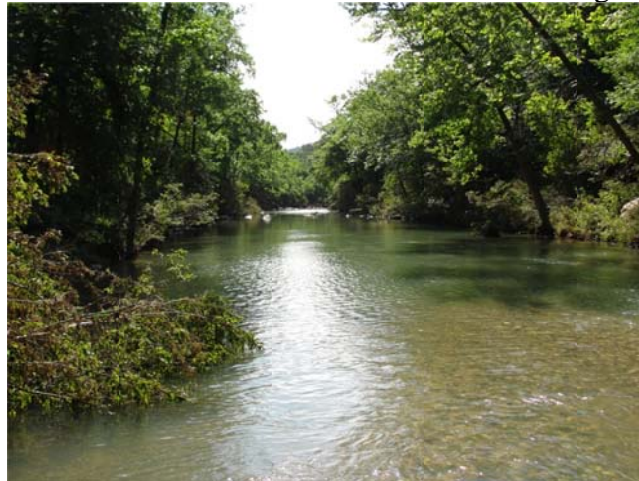
From XS1 looking downstream, note some gravel on the bed of this xsect

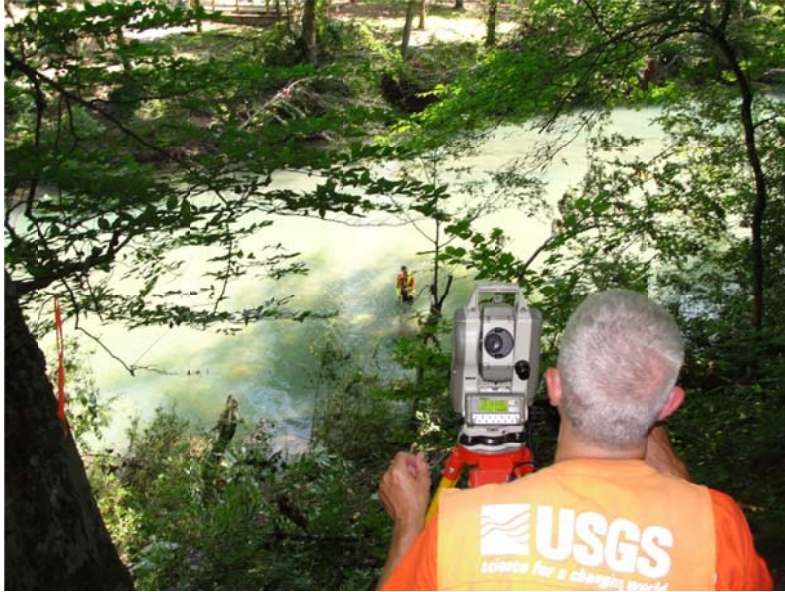
From trail on right bank valley wall at XS1 looking to leftbank and main channel.
