07360200 Little Missouri River near Langley, Arkansas

Flood Event of June 11, 2010

Type of Measurement: Slope Area using USGS slope-area program Version 97-01

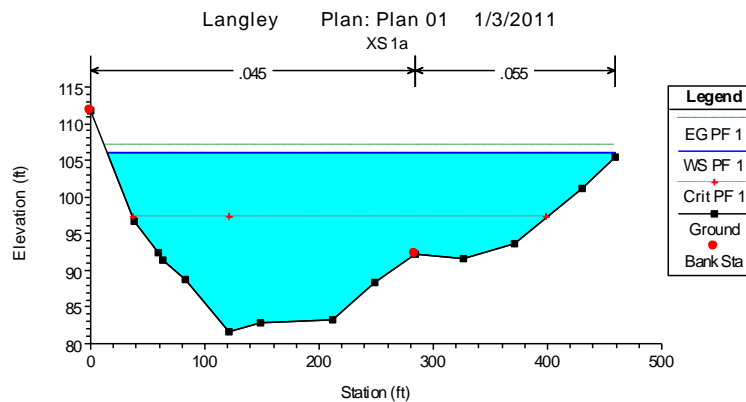
Figure 2. Graphic to illustrate cross section 1(a).

Cross Section 1(a): Cross section 1(a) (fig 2) consisted of a wooded left bank with large oaks (8 – 12" diameter) and a steep slope (2:1 slope); a channel with no debris or obstructions but a few large boulders and a bedrock bottom, and a shallow sloping right bank (1:5 slope). The left bank and main channel were assigned a Manning's value of 0.045 by J.E. Funkhouser. The main channel consisted of a bedrock bottom with large boulders present (1' – 3' diameter). The main channel appeared to have approximately 25 feet of water flowing over it during the June 11 event. A Manning's value of 0.055 was assigned to the right bank by J.E. Funkhouser. The right bank consisted of densely vegetated debris and a field opening on the far right. Approximately 12 feet of water was flowing over the right bank during the June 11 event. Surveyed HWM found the water surface elevation (WSE) on the left to be near 103.08 ft and 103.73 ft on the right. The WSE elevation that was chosen to use for the indirect measurement was 103.40 ft (average of both).

The original cross section 1 was later found to be an expanding reach when the flow computations were being made. To try to handle this, XS1a was surveyed in November 2010 upstream of XS1 because of expansion problems. This new cross section was labeled XS1a and was used for the indirect.

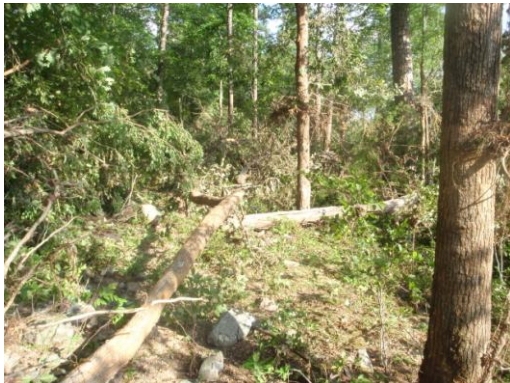
XS1. Left bank. Looking downstream. N=0.045

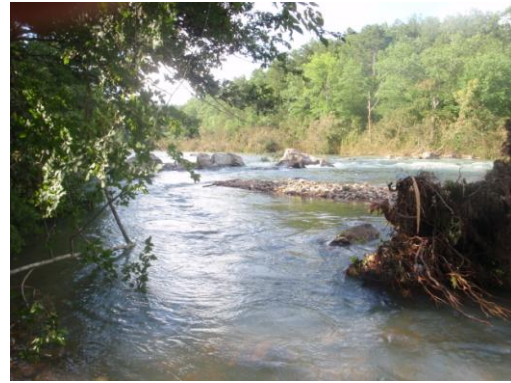
XS1. Main channel. Looking upstream. N=0.045

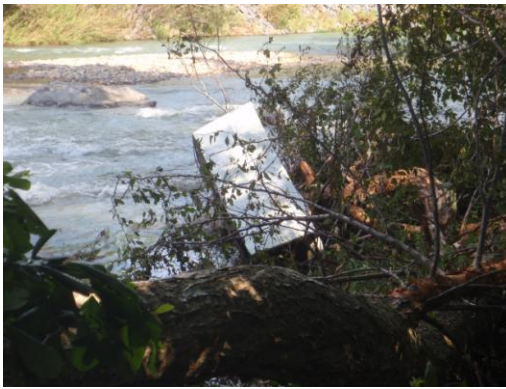
XS1. Main channel. Looking downstream. N=0.045

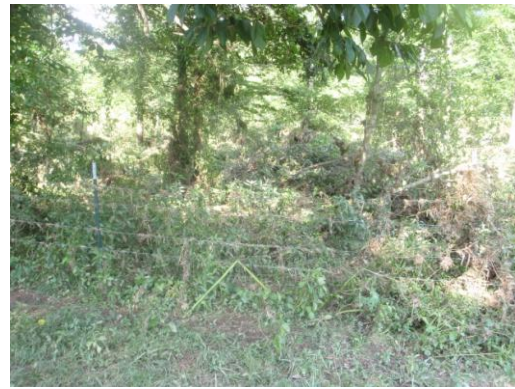
XS1. Right bank. Looking streamward. N=0.055

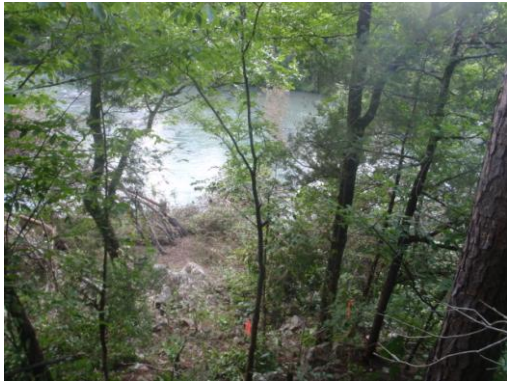
XS2. Left bank. Looking streamward. N=0.045

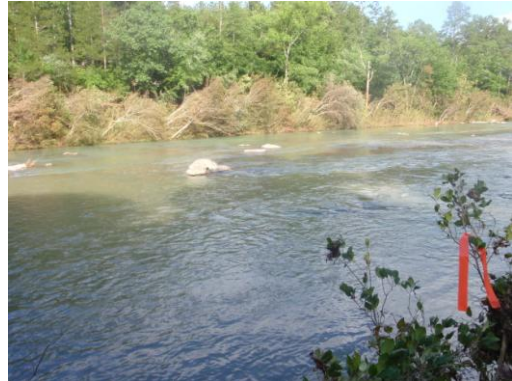
XS2. Main channel. Looking downstream. N=0.045

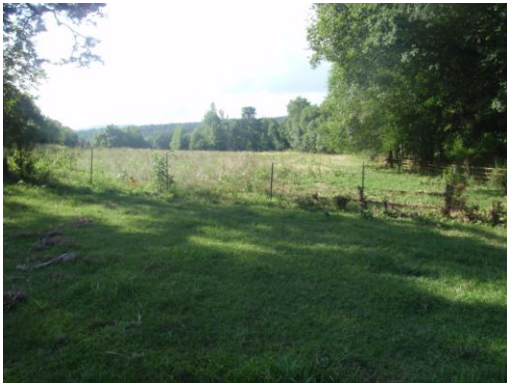
XS2. Right bank. Looking upstream. N=0.053

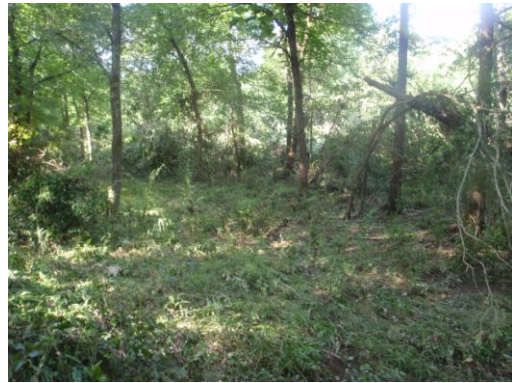
XS2. Right bank. Looking bankward. N=0.053

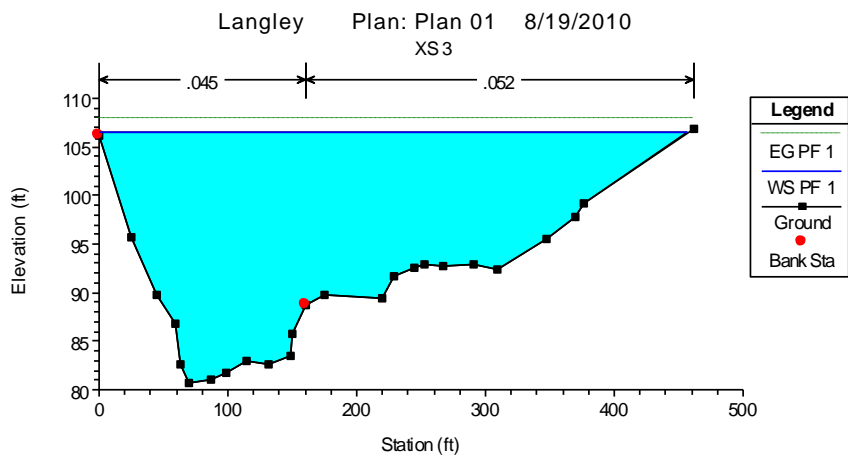
Figure 4. Graphic to illustrate cross section 3.

Cross Section 3: Cross section 3 (fig 4) consisted of a wooded left bank with large oaks (8 – 12" diameter) and a steep slope (2:1 slope); a channel with no debris or obstructions but a few large boulders and a bedrock bottom, and a very shallow sloping right bank (1:20 slope). The left bank and main channel were assigned a Manning's value of 0.045 by J.E. Funkhouser. The main channel consisted of a bedrock bottom with large boulders present (1' – 3' diameter). The main channel appeared to have approximately 25 feet of water flowing over it during the June 11 event. A Manning's value of 0.052 was assigned to the right bank by J.E. Funkhouser. The right bank consisted of densely vegetated debris and a large field opening on the far right. Approximately 18 feet of water was flowing over the right bank during the June 11 event. Surveyed HWM found the water surface elevation (WSE) on the left to be near 105.88 ft and 105.97 ft on the right. The WSE elevation that was chosen to use for the indirect measurement was 105.93 ft (average of both).

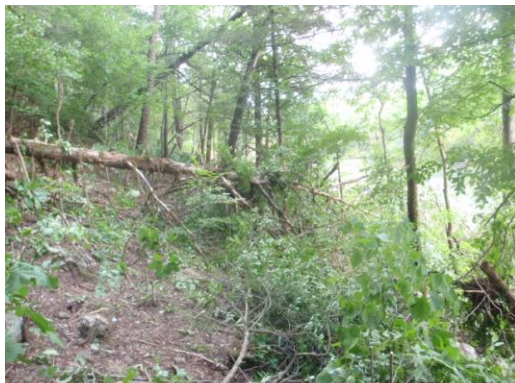
XS3. Left bank. Looking downstream. N=0.045

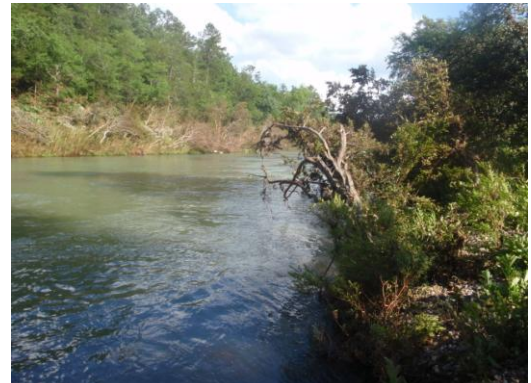
XS3. Main channel. Looking downstream. N=0.045

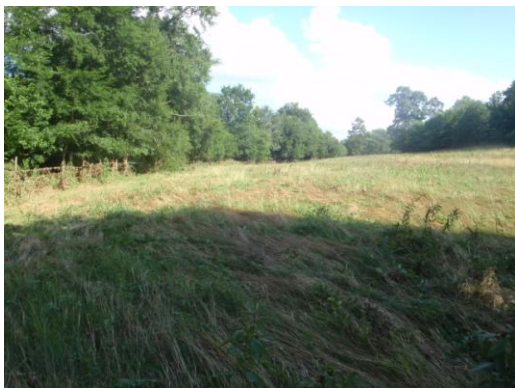
XS3. Right bank. Looking downstream. N=0.052

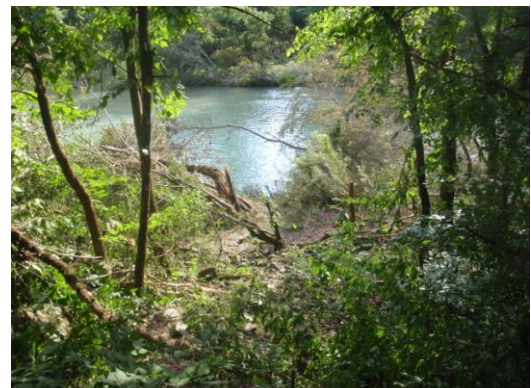
XS3. Right bank. Looking streamward. N=0.052

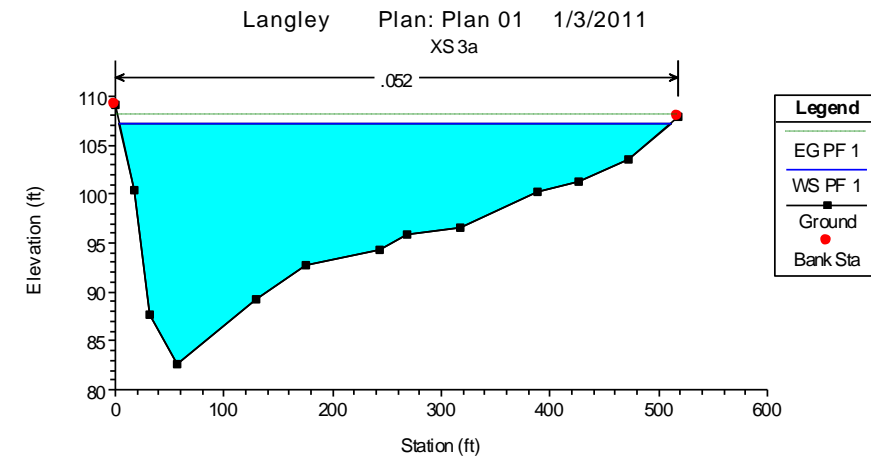
Figure 5. Graphic to illustrate cross section 3a.

Cross Section 3a: Cross section 3a (fig 5) consisted of a wooded left bank with large oaks (8 – 12" diameter) and a steep slope (2:1 slope); a channel with no debris or obstructions but a few large boulders and a bedrock bottom, and a very shallow sloping right bank (1:20 slope). The left bank, main channel and right bank were assigned a Manning's value of 0.052 by J.E. Funkhouser. The main channel consisted of a bedrock bottom with large boulders present (1' – 3' diameter). The main channel appeared to have approximately 25 feet of water flowing over it during the June 11 event. The right bank consisted of densely vegetated debris and a large field opening on the far right. Approximately 18 feet of water was flowing over the right bank during the June 11 event. Surveyed HWM found the water surface elevation (WSE) on the left to be near

108.16 ft and 106.20 ft on the right. The WSE elevation that was chosen to use for the indirect measurement was 107.18 ft (average of both).

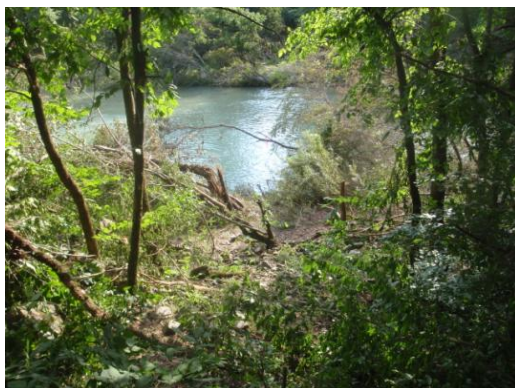
XS3a. Left bank. Looking streamward. N=0.048

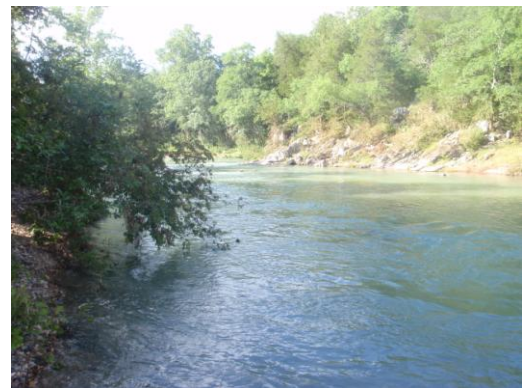
XS3a. Main channel. Looking upstream. N=0.048

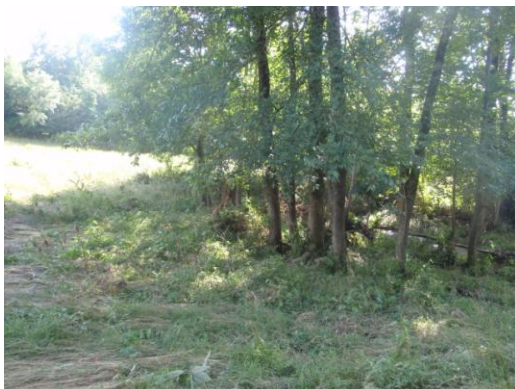
XS3a. Right bank. Looking bankward. N=0.048

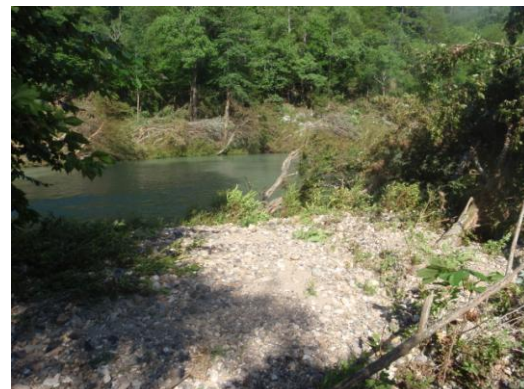
XS3a. Right bank. Looking streamward. N=0.048
