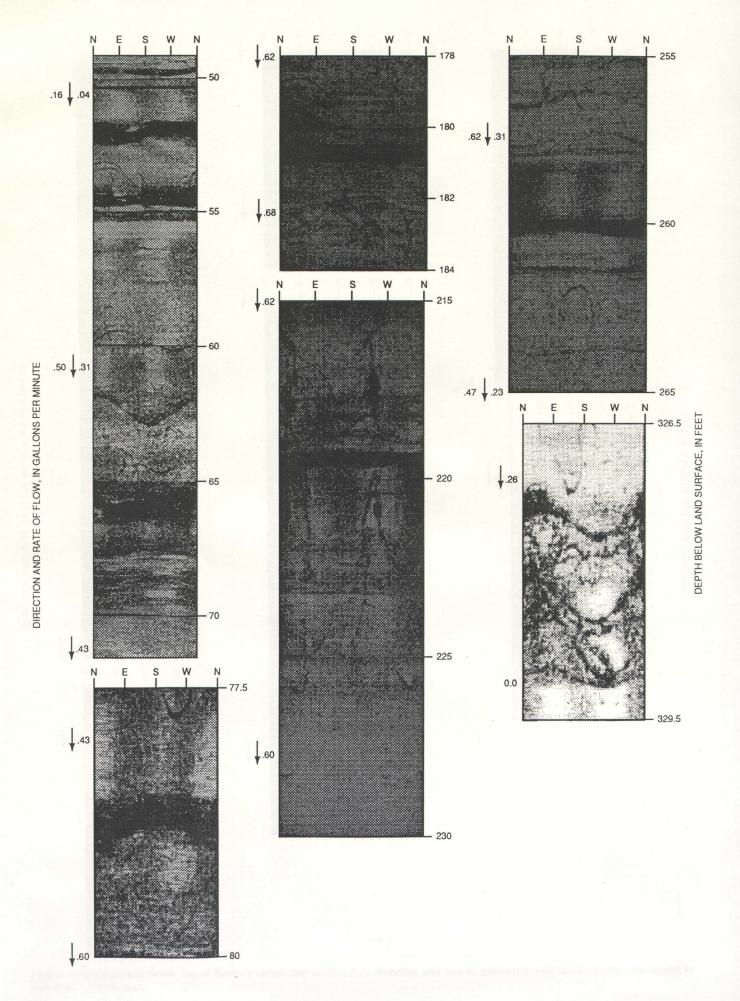
Figure 7. Acoustic-televiewer log of fracture zones and vertical-flow direction and rate as measured with the heat-pulse flowmeter in well P899 at Mahopac.
