**Puerto Rico Water Resources Research Institute
Annual Technical Report
FY 2008**

Monitoring Nutrients Content in the San Juan Bay Estuary using Hyperspectral Remote Sensing

Title: Monitoring Nutrients Content in the San Juan Bay Estuary using Hyperspectral Remote Sensing

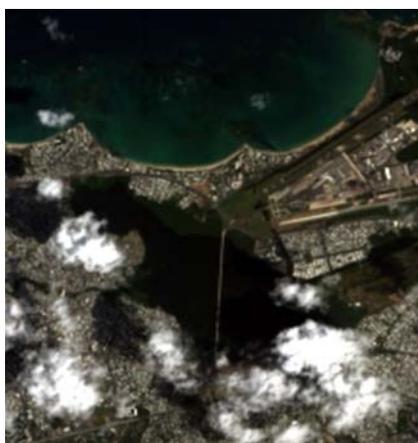
FIGURE 1
FEBRUARY 24, 2006

Three (3) individual images (See Figures 1, 2 and 3) were produced from the San Jose Lagoon by the HIS on different occasions: February 24, May 12 and August 14, 2006. Raw images were radiometrically calibrated and geometrically corrected using different United States Geological Survey's (USGS) Level 1R algorithms.

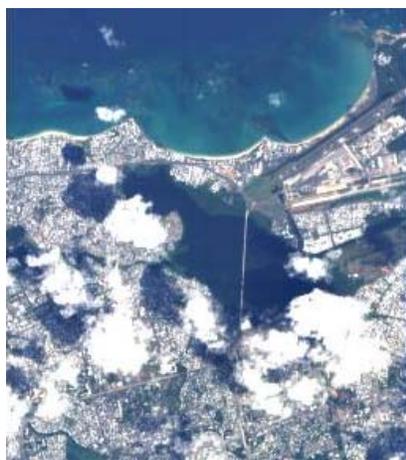
FIGURE 4
FEBRUARY 24, 2006

Atmospheric corrections were performed to the above radiance images with the ENVI-Fast Line-of-Sight Atmospheric Analysis of Hyperspectral cubes (FLAASH) atmospheric correction module. The FLAASH software was used to remove the spectral atmospheric transmission and scattered path radiance using the MODTRAN4 radiative transfer algorithm estimating the radiance received by the sensor. The atmospheric corrections were completed following the FLAASH Atmospheric Correction Guide (Morillo, 2005). Figures 4, 5 and 6 show the reflectance images after atmospherically corrected.

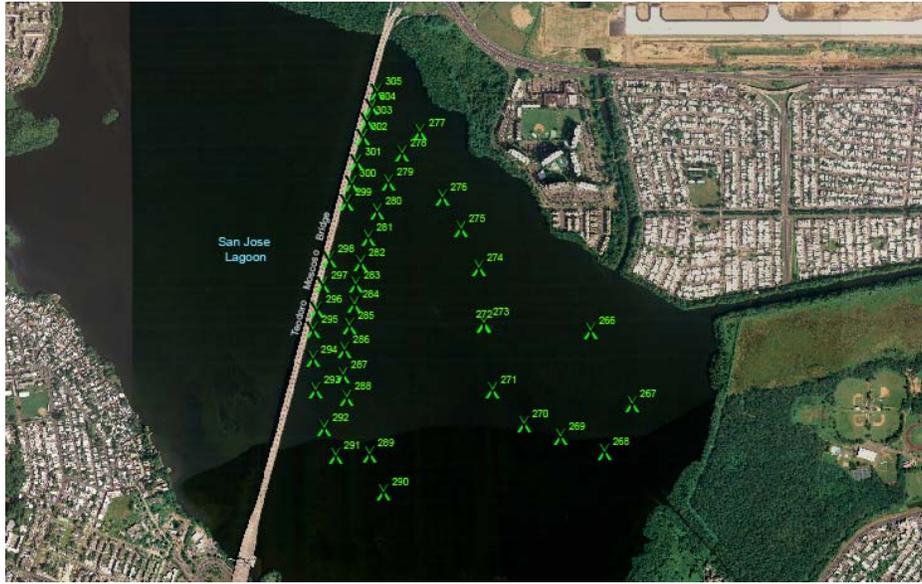
An *in-situ* sampling survey was conducted at approximately 40 (forty) sampling stations defined by a location map (Figure 7) during the months of February, May, and August, 2006 for the presence of nitrates and total phosphorus for each sampling station. Analyses and results of samples collected in the field were conducted by a private environmental laboratory in accordance with 40 CFR Part 136 (Methods for Chemical Analysis for Water and Wastes, EPA, 1974).

FIGURE 7
FIELD SAMPLING STATIONS

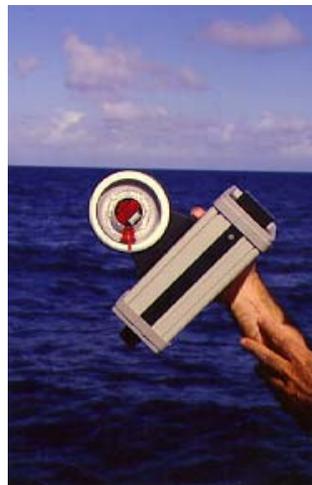
FIGURE 8
GER 1500 SPECTRORADIOMETER

Radiance values were obtained with the use of a GER 1500 spectroradiometer (Figure 8) at each sampling stations per sampling survey. Field remote sensing reflectance was calculated from average radiance values at each sampling station per sampling survey.

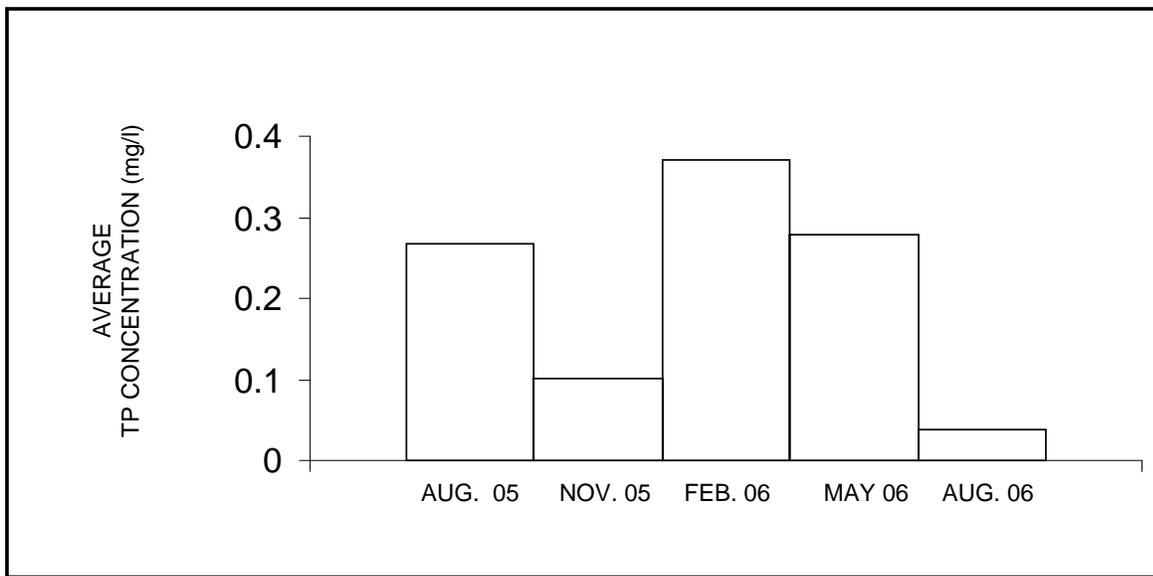
Both field sampling and imaging data were collected in several stations within the SJL sampling locations. Total phosphorus concentration was measured for August 8 and November 7, 2005, and for February 24, May 12, and August 14, 2006. The results are shown in Figure 9.

FIGURE 9: MEAN CONCENTRATION OF TOTAL PHOSPHORUS.

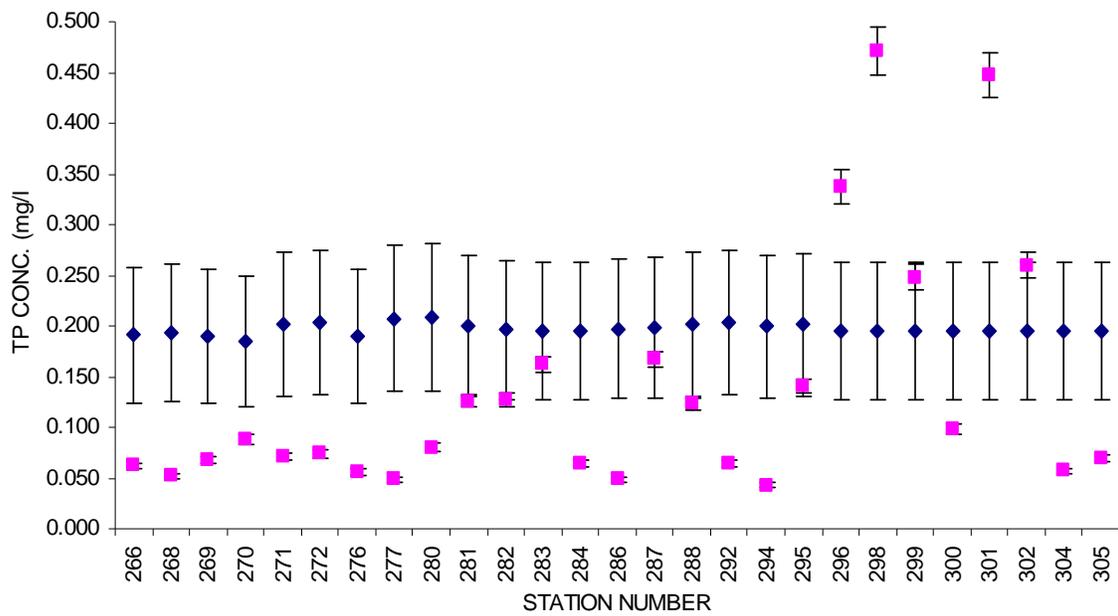
**FIGURE 13: HYPERION REFLECTANCE VS. TP (FEBRUARY 24, 2006) (LINEAR)
 ALGORITHM VALIDATION WITH 5 -12 2006 *IN-SITU* SAMPLES**

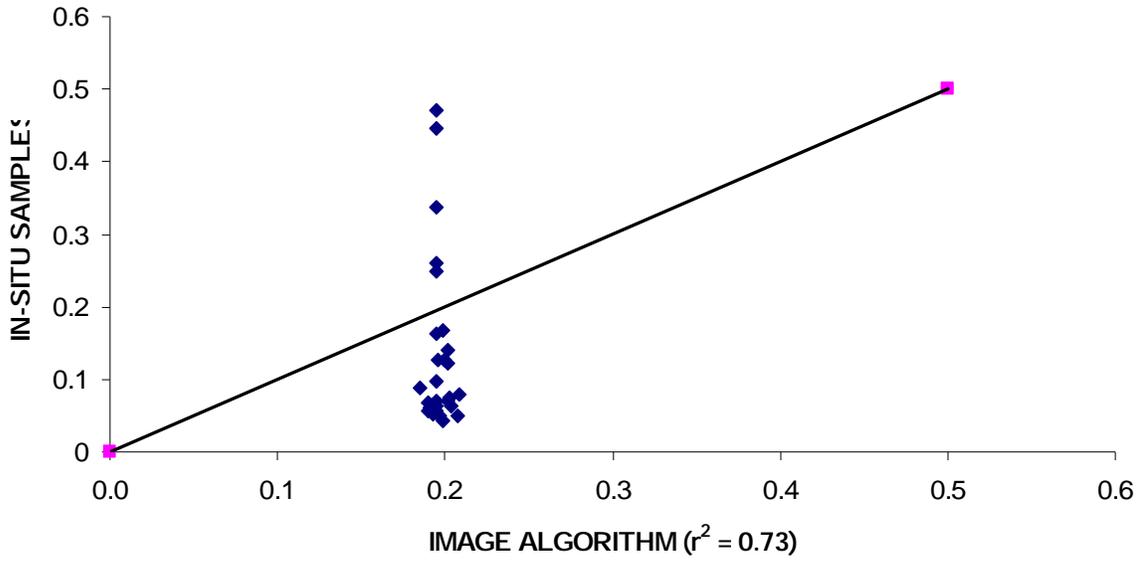
FIGURE 14: SCATTER PLOT FOR TP CONCENTRATION IMAGE ALGORITHM (2-24-2006) (LINEAR) VS. IN SITU SAMPLES (5-12-2006) (log Band 569/log Band 579)

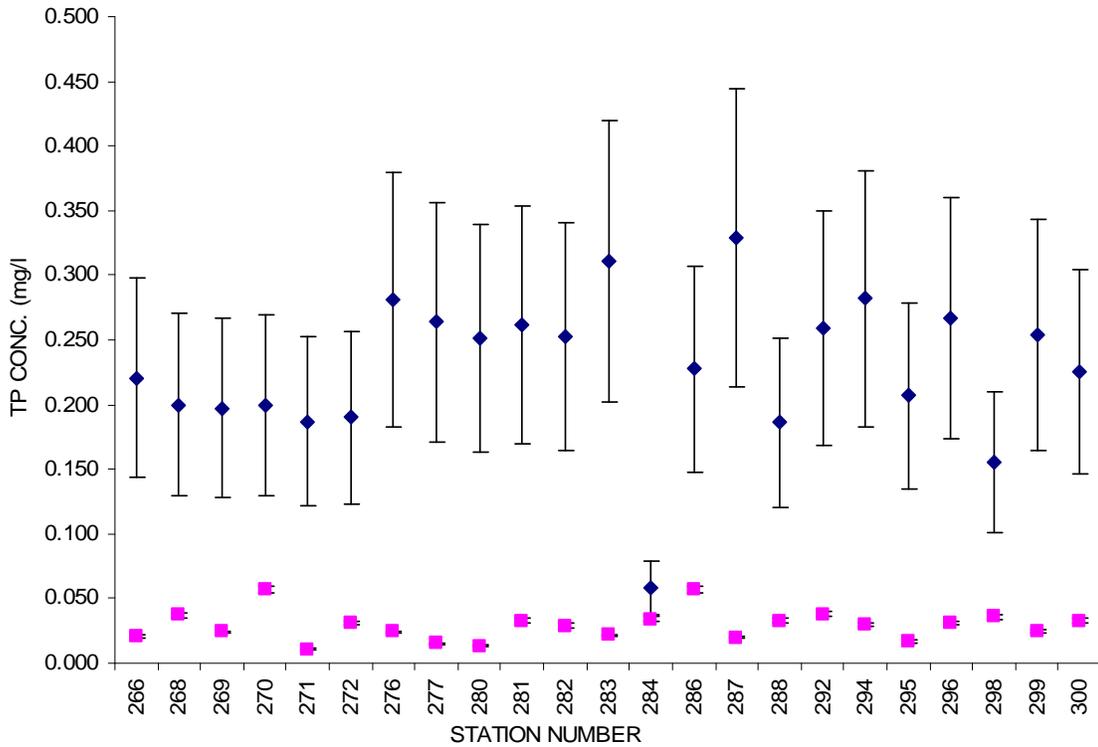
FIGURE 15: HYPERION REFLECTANCE VS. TP (FEBRUARY 24, 2006) (LINEAR) ALGORITHM VALIDATION WITH 8-14-2006 IN-SITU SAMPLES

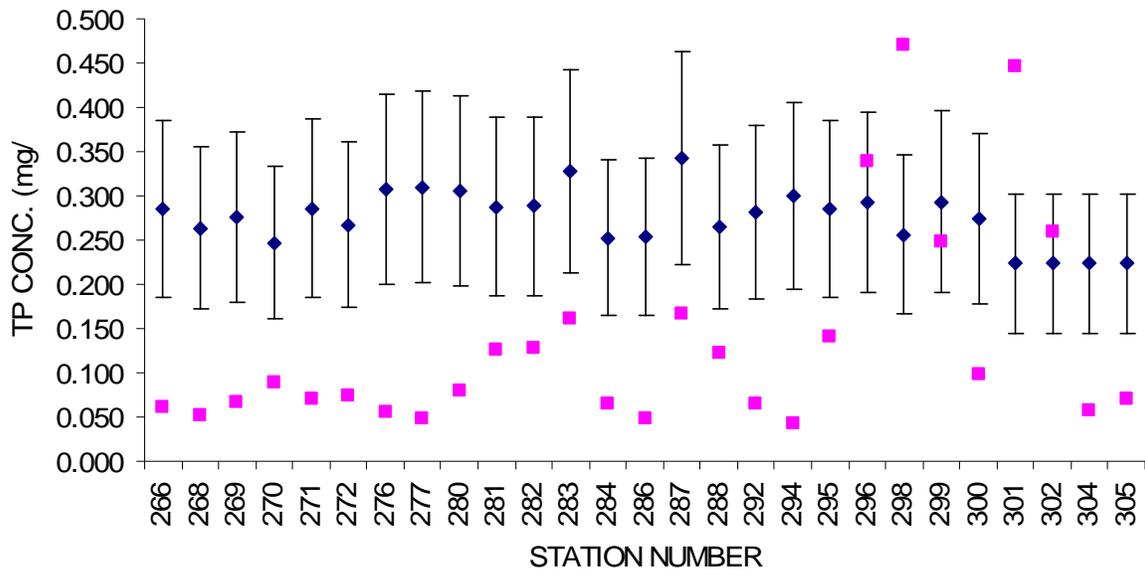
FIGURE 18: HYPERION REFLECTANCE VS. TP (FEBRUARY 24, 2006) (POLYNOMIAL) ALGORITHM VALIDATION WITH 5-12-2006 *IN-SITU* SAMPLES

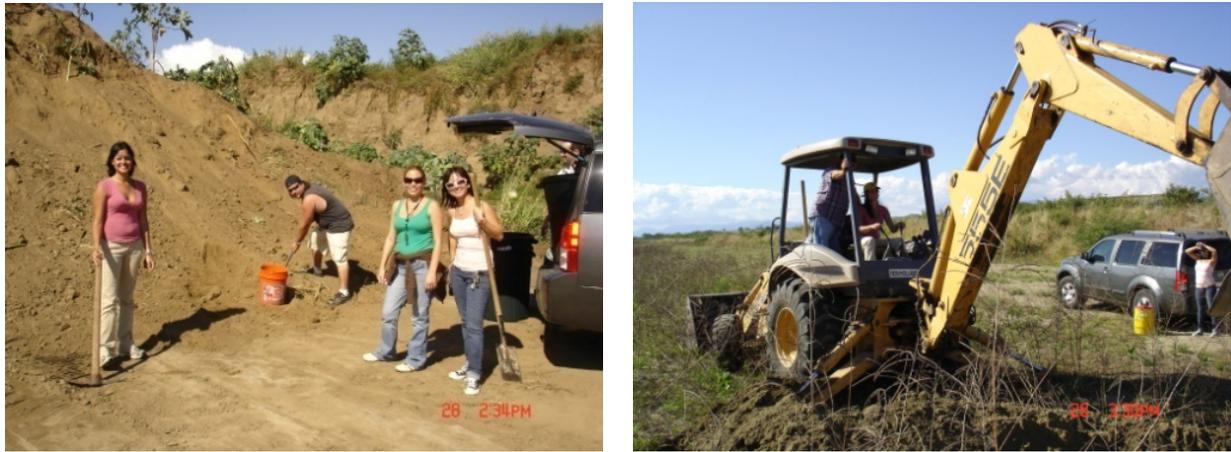
soil from the Coamo Lake will be used as a top soil at a depth of 1 m. In these regards, two soils were sampled on site as shown in **Photo 1**. After being transported, the soil samples passed a sieve size 3/8" were collected for the experiment.

Photo 1. Soil Sampling on site.

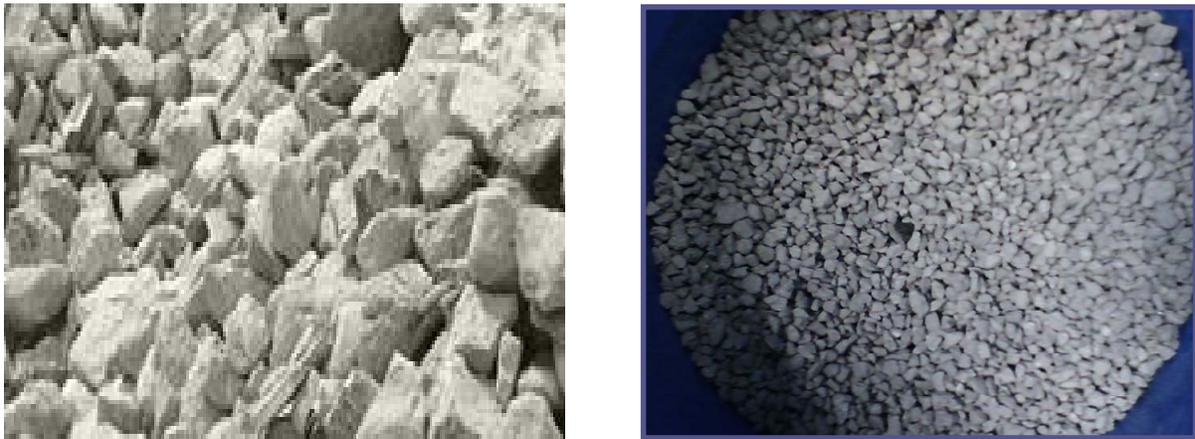
Coal ash aggregates were obtained from a local coal burning power plant in Guayama, PR. It is a solidified mixture of fly and bottom ashes with water. Main chemical components, by weight, are: 51% of ($\text{SiO}_2 + \text{Al}_2\text{O}_3 + \text{Fe}_2\text{O}_3$), 30% Lime (CaO), and 15% SO_3 (Pando and Hwang, 2006). The CAAs were first oven dried at 105°C overnight, crushed with a mechanical mixer, and sieved to collect the CAA sizes of 2.36 ~ 9.53 mm (**Photo 2**).

Photo 2. Coal ash aggregates before (left) and after (right) preparation for the experiment,

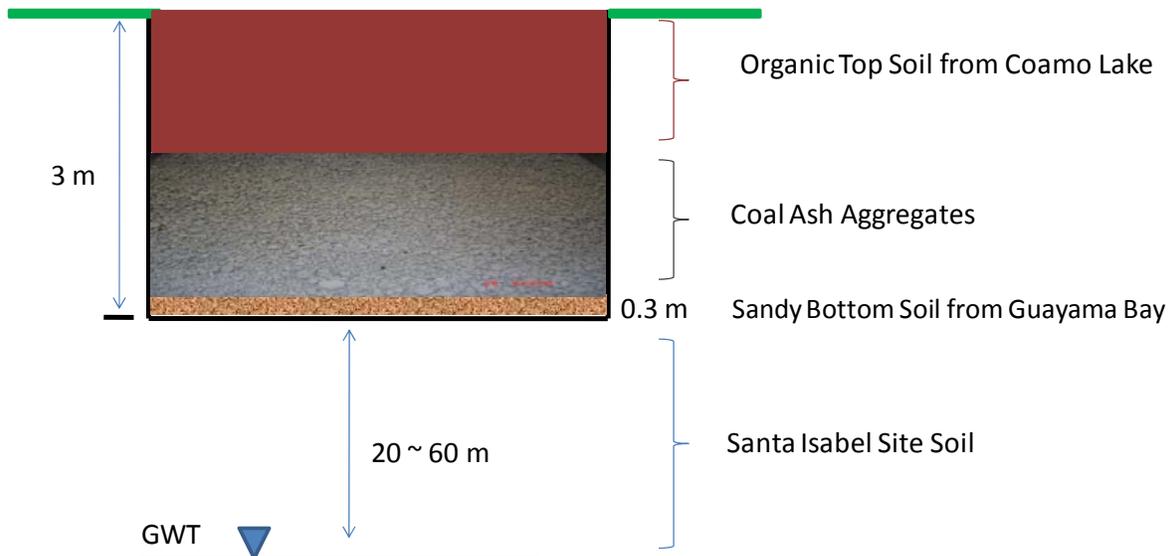
The volumetric ratio of the CAAs to the organic top soil is a treatment factor with two levels of 8:4 and 4:8, which was the ratio of the depth of the top soil to the CAAs. Simulated precipitation was made three times a week by spraying tap water on the top of the reactors. Precipitation rates are another treatment factor with two different levels: high rainfall 60 mL each application, low rainfall 30 mL each application. Two rainfall amounts were calculated according to the actual maximum and minimum average precipitation in Santa Isabel. Half of the reactors were assigned to the smaller particle sizes (2.36 ~ 4.75 mm) of CAAs and the remainder to the greater particle sizes (4.75 ~ 9.53 mm). Thus, the particle size of the CAAs is another treatment factor containing two levels.

Figure 2. Schematic of backfilling of the site.

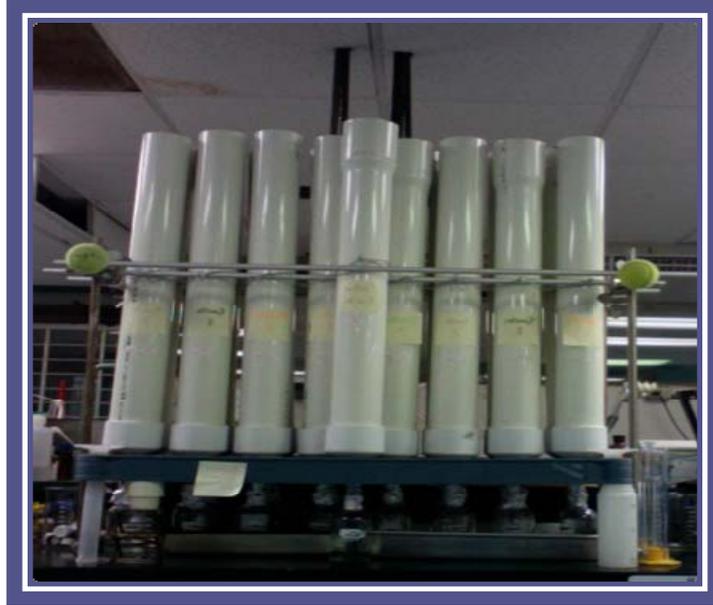
Photo 3. Column Reactors setup for water quality assessment in a statistical design and analysis.

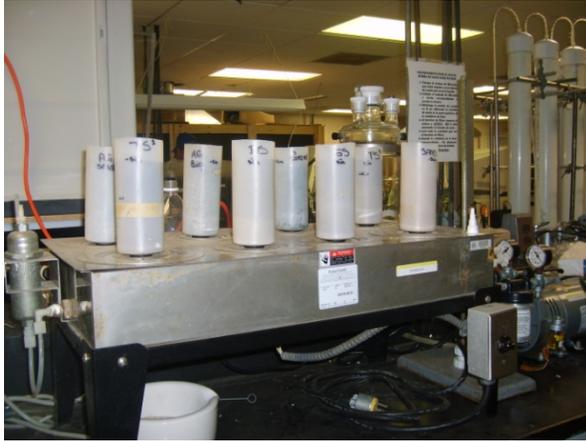
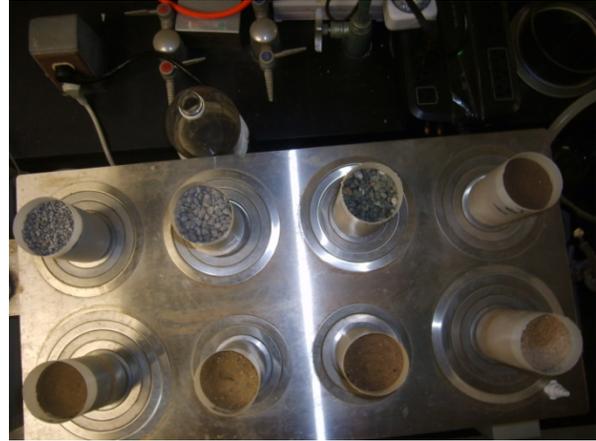
Total 8 plastic reactors (2.5-in D x 6-in L) were constructed to test leaching characteristics of each solid material being used in the project as shown in Photo 4. Each component was packed at a depth of 5 inches. Table 2 shows the design matrix of leaching test. Tap water was sprayed on the top of the reactors on every Mondays, Wednesdays, and Fridays. During the first 2 watering events, 40 mL was sprayed, but the amount of water added was increased to 100 mL to collect enough amount of infiltrated water with which water quality parameters were analyzed. This experiment was done over 4 weeks.

Photo 4. Views of leaching tests of each solid material used in the project.

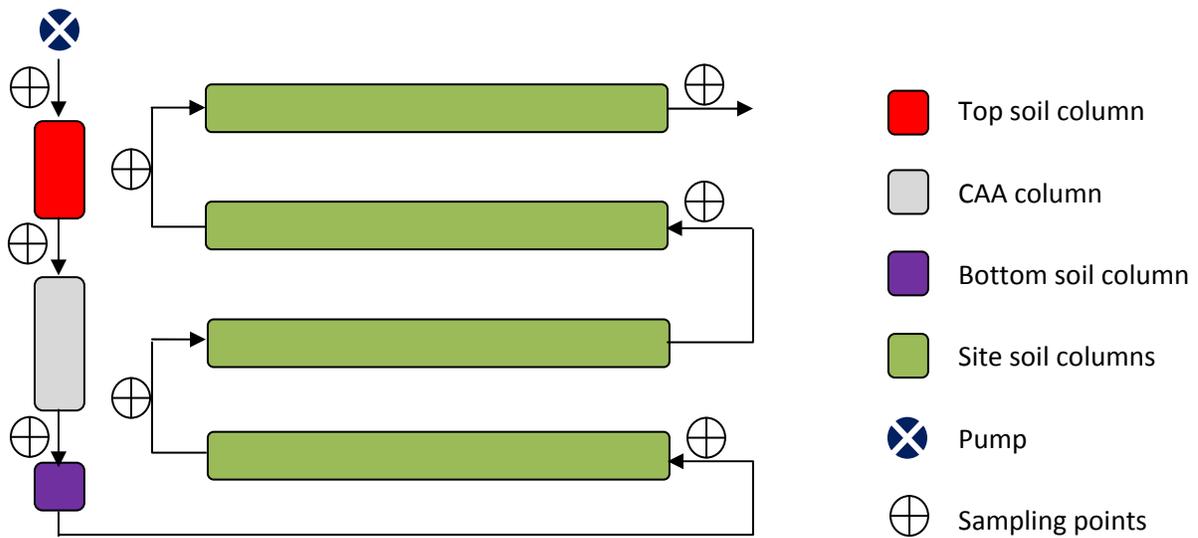
One (System 1) was operated at 10 °C and the other (System 2) was at room temperature. A lower temperature set-up was to test water quality parameters in a condition similar to a field soil and groundwater environment with respect to temperature. Distribution of soils and aggregate was shown in Table 3 and schematics of column set-up are shown in Figure 3.

Figure 3. Schematics of column set-up for Long-Term Water Quality Monitoring.

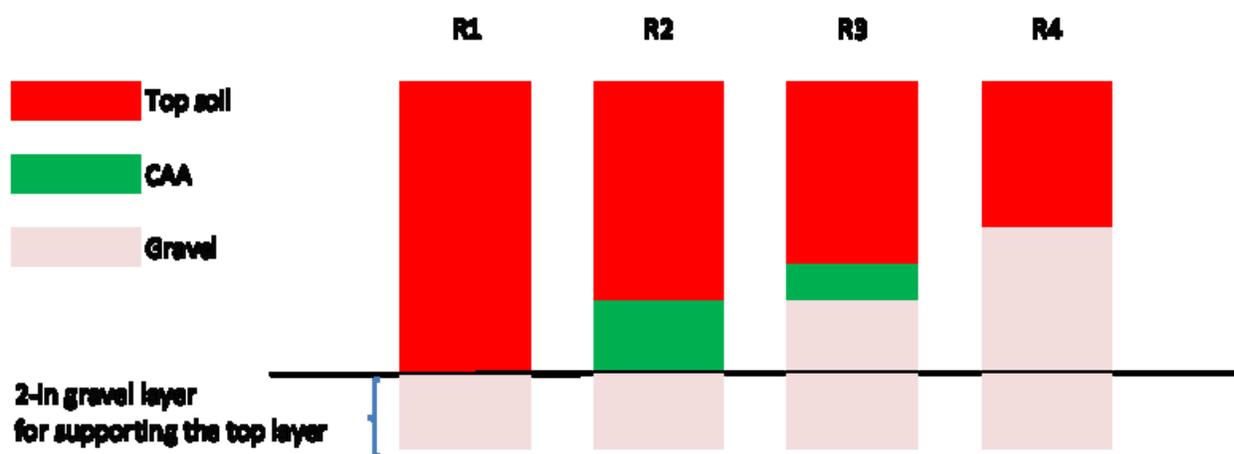
Layers		Reactor 1	Reactor 2	Reactor 3	Reactor 4
Top soil layer	Depth (in)	8	6	5	4
	Bulk density (g/cm ³)	1.51	1.56	1.23	1.56
Hindrancelayer	CAA, depth (in)	-	2	1	-
	Bulk density (g/cm ³)	-	0.80	0.91	-
	Gravel, depth (in)	-	-	2	6
	Bulk density (g/cm ³)			1.77	1.40

Figure 4. Schematics of the reactors run for testing physical hindrance of the CAA against germination and growth.

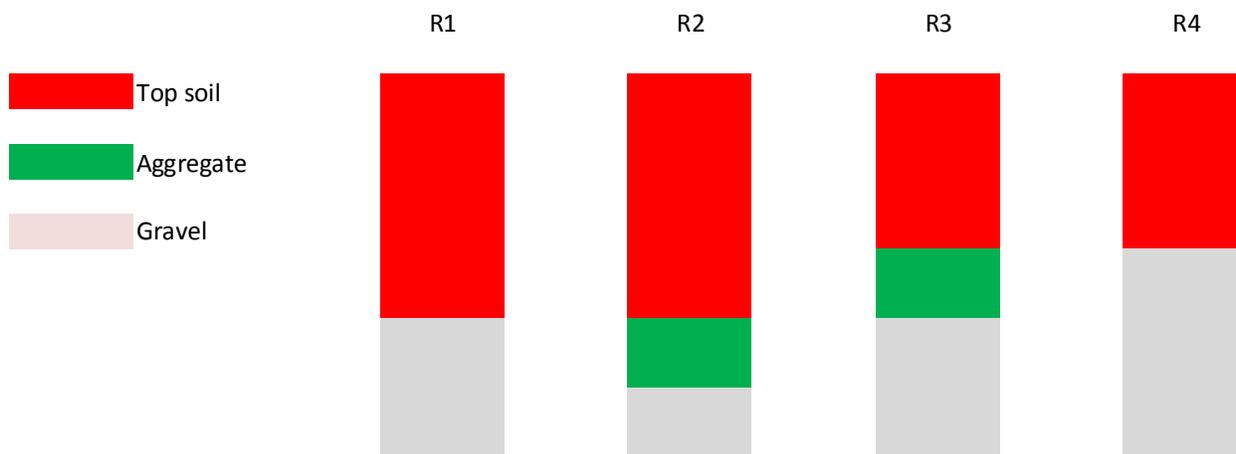
After completing Physical Hindrance experiment, all beans were removed from the reactors and the configurations of the reactors were slightly modified as shown Figure 5. This experiment was to assess potential contribution of the CAAs as nutrient source for the plants. Four different plants were tested: botellas, beans, papayas, and pumpkins. Baby botellas and papayas were obtained from a nursery farm at the site and planted in the reactors #1 and #2, and #3 and #4, respectively. Beans were seeded directly to the reactors #3 and #4. Pumpkins were later seeded to the reactors #3 and #4 after the beans were completed with the experiment and removed from the reactors. Due to deeper and bigger roots, the reactors #1 and #2 had deeper top soils by 40% than the reactor #3 and #4. Like the Physical Hindrance experiment, 840 mL of tap water was evenly sprayed on the top of the reactors every other day during the experiment. Germination and growth monitoring was done every Mondays and Fridays.

Figure 5. Assessment of CAAs as a nutrient source for the various plants: botellas, papayas, beans and pumpkins.

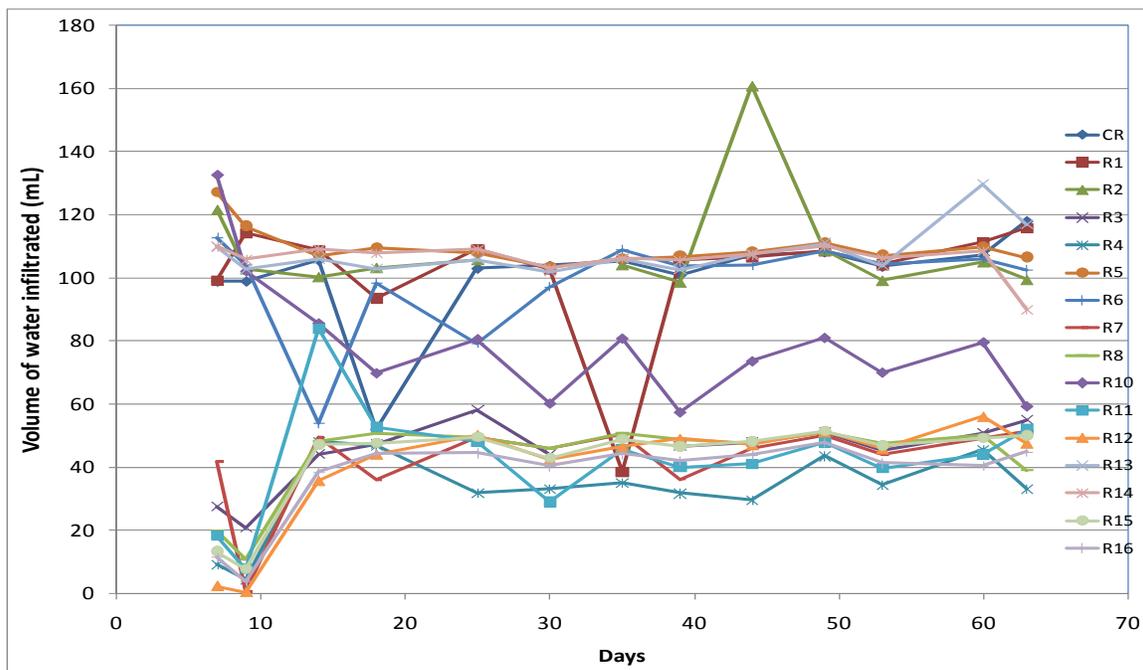
The water volume infiltrated in each reactor weekly is shown in Figure 6. Apparently, it seems the rainfall intensity influenced greatly on the infiltrated water volume.

Figure 6. Volume of water infiltrated weekly in each reactor.

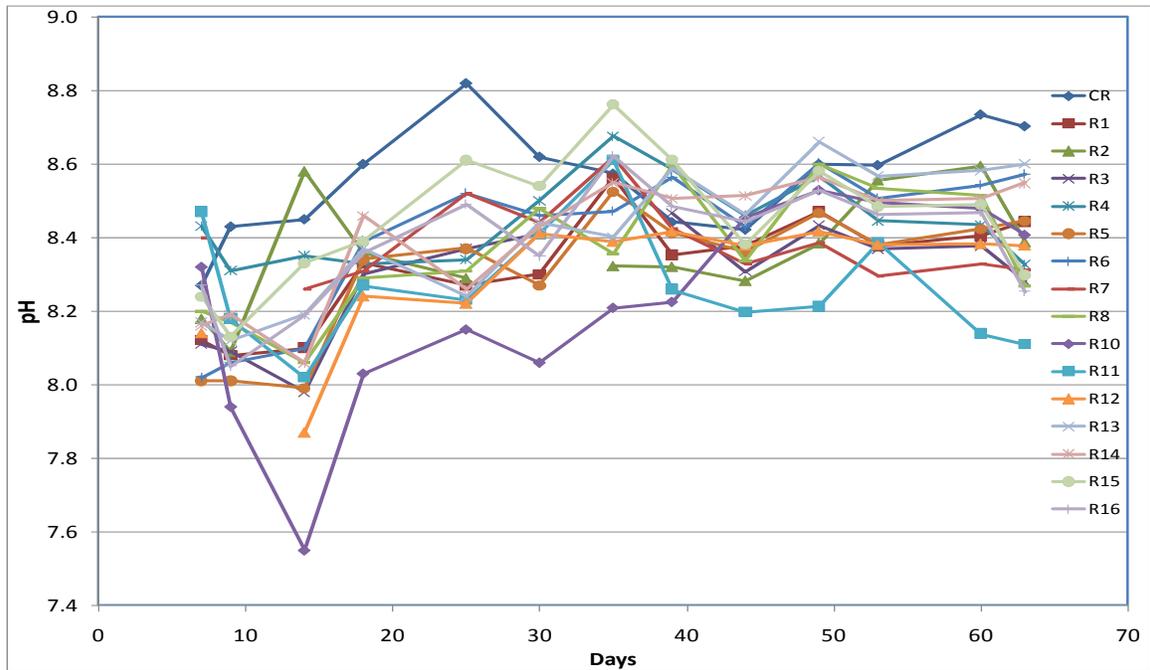
The infiltrated water from each reactor containing the CAAs had a slightly basic pH (~8.5) throughout the experiment, as shown in Figure 7. A higher pH of the control reactors was attributed to the characteristics of the sand used for the system.

Figure 7. Value of pH in the water infiltrated weekly in each reactor.

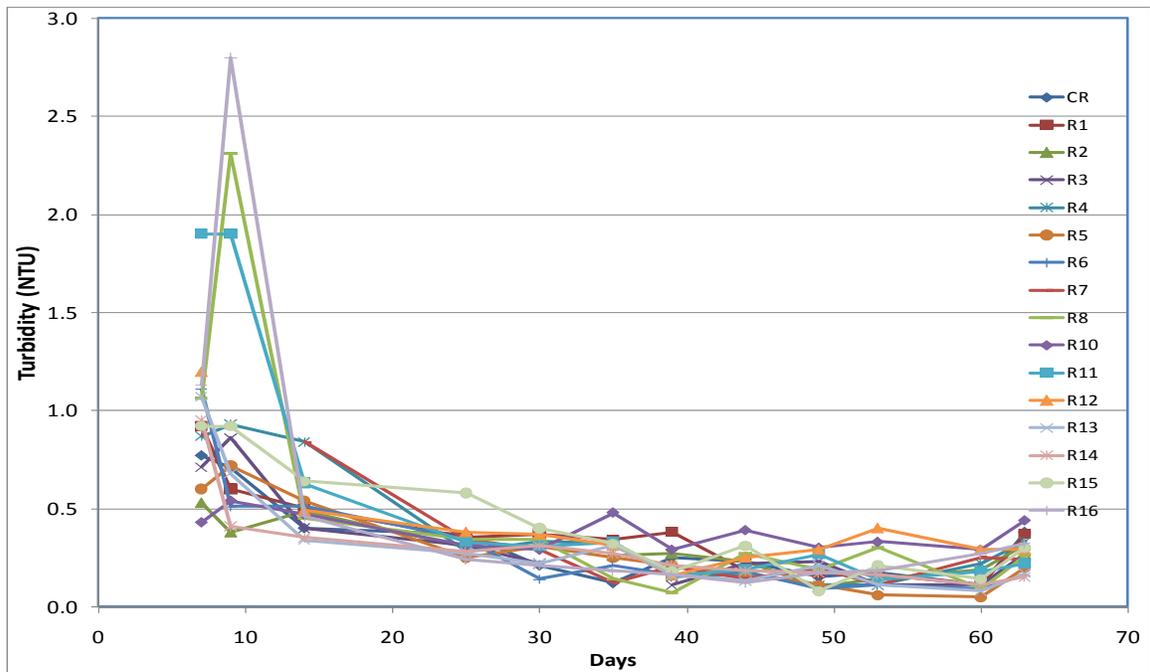
Turbidity was monitored in the range between 0.5 and 1 NTU, except for a couple of outliers, in the beginning of the experiment. However, it reduced to a value less than 0.5 NTU as shown in Figure 8.

Figure 8. Turbidity in the water infiltrated weekly from each reactor.

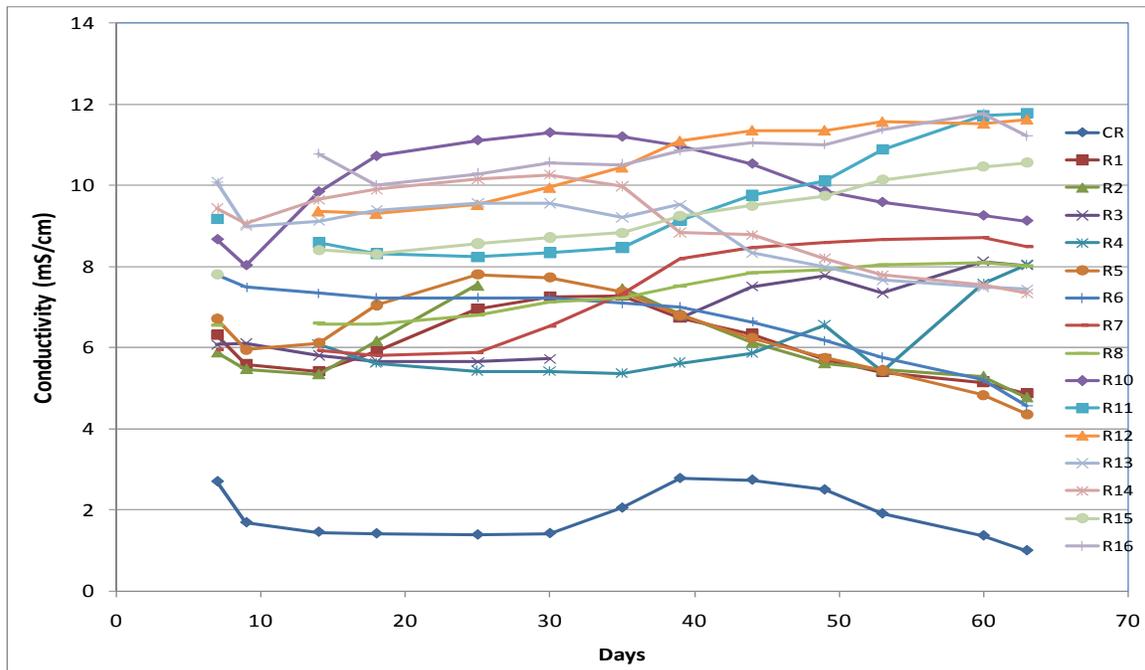
Specific conductivity showed higher strengths in all treatment columns compared to that in the control reactor as shown **Figure 9**. A similar trend was observed for the hardness concentrations.

Figure 9. Specific conductivity in the water infiltrated weekly from each reactor.

As shown in Figure 9 previously, the factors produced different effects on the monitored parameters throughout the experiment (i.e., temporal effects). In this regard, those factors which produced statistically significant difference in the monitored parameters were selected and plotted in order to compare temporal effects of the factors. Figures 11 and 12 show temporally significant factors which produced a statistical difference in pH values (top) and turbidity (bottom,) and hardness, respectively.

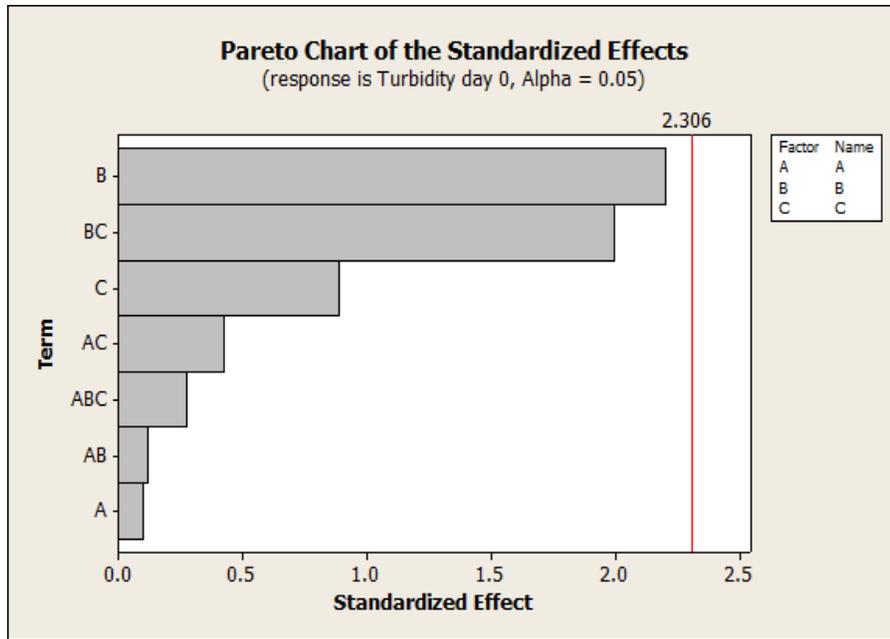
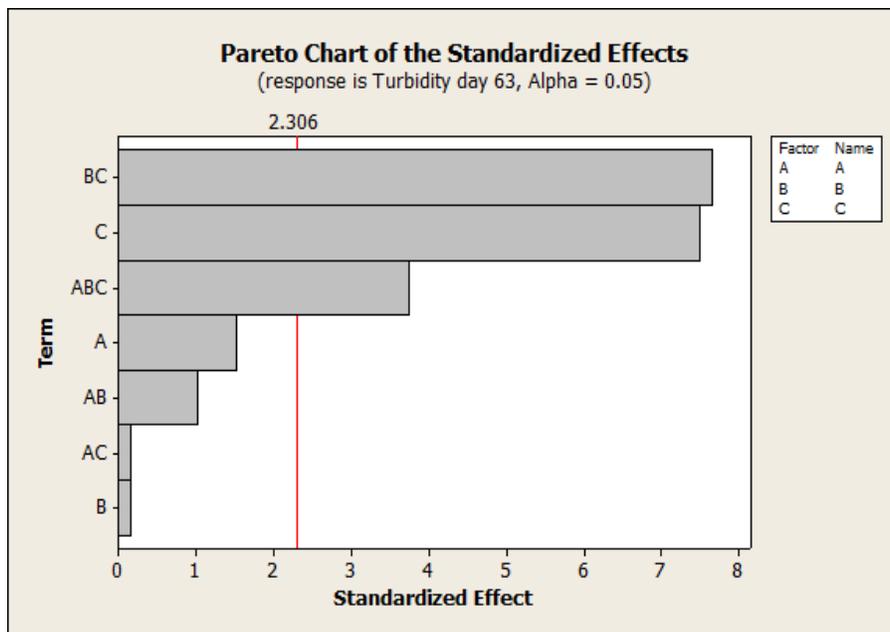
To evaluate the causes and effects produced by the factors aforementioned in the Method section, 3-factor, 2-level statistical analysis was conducted based on the corresponding the statistical design. For this purpose, the latest version of the Minitab software was used. Example plots are shown in **Figure 10**.

Figure 10. Examples of the statistical analysis using the Minitab software.

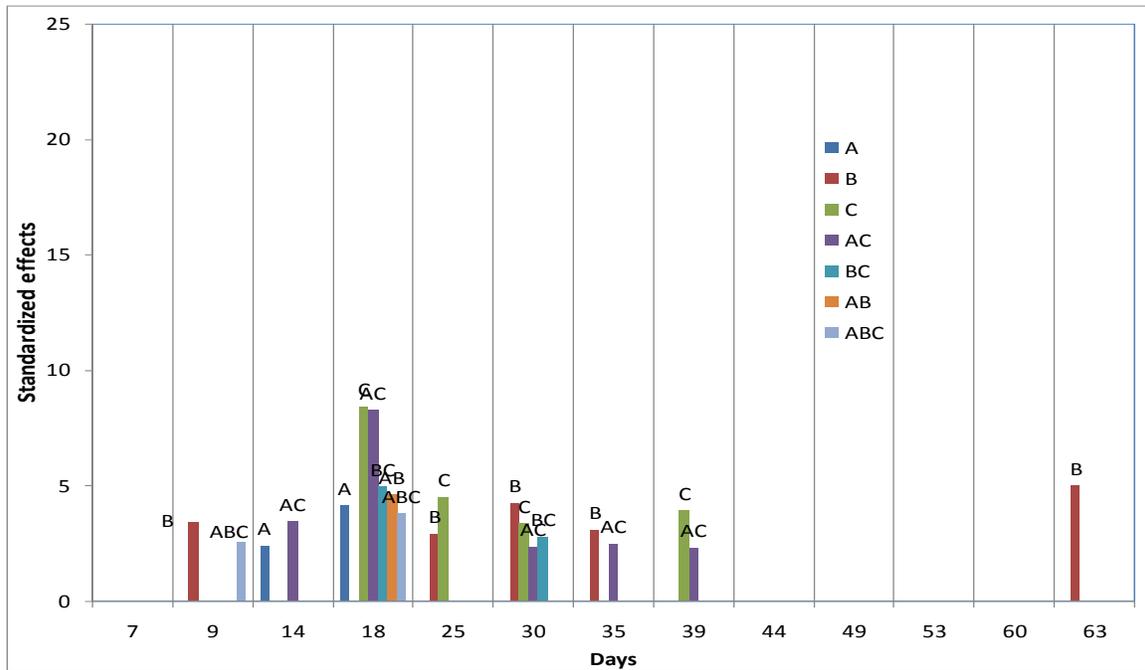
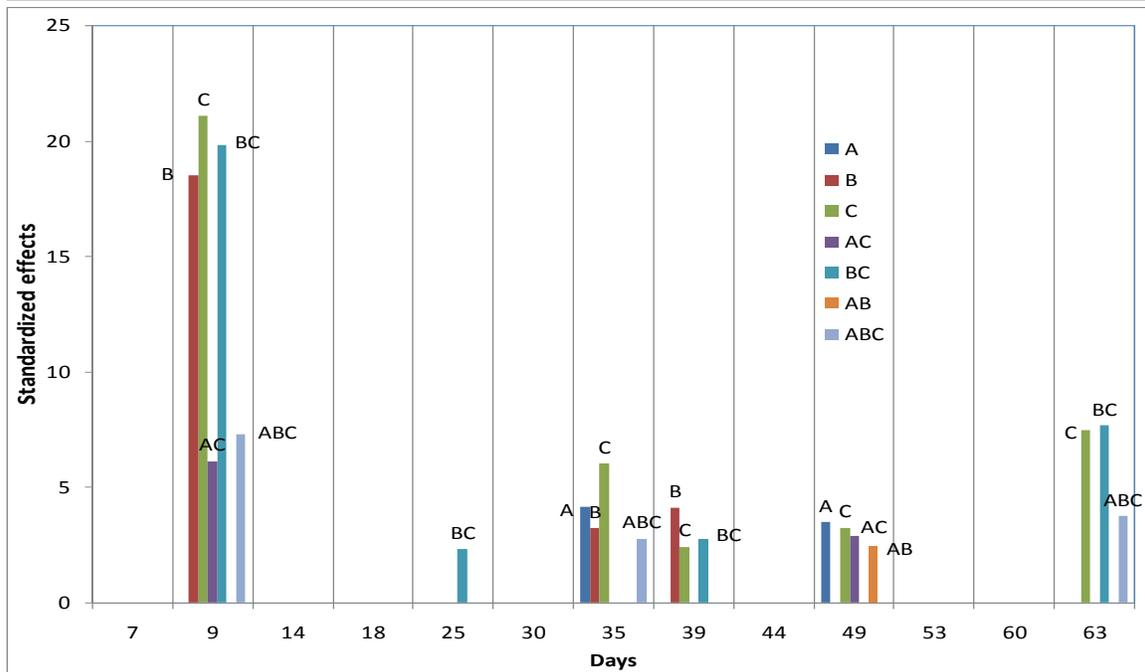
Figure 11. Factors and their extent to have produced a statistically significant difference in pH values (top) and turbidity (bottom).

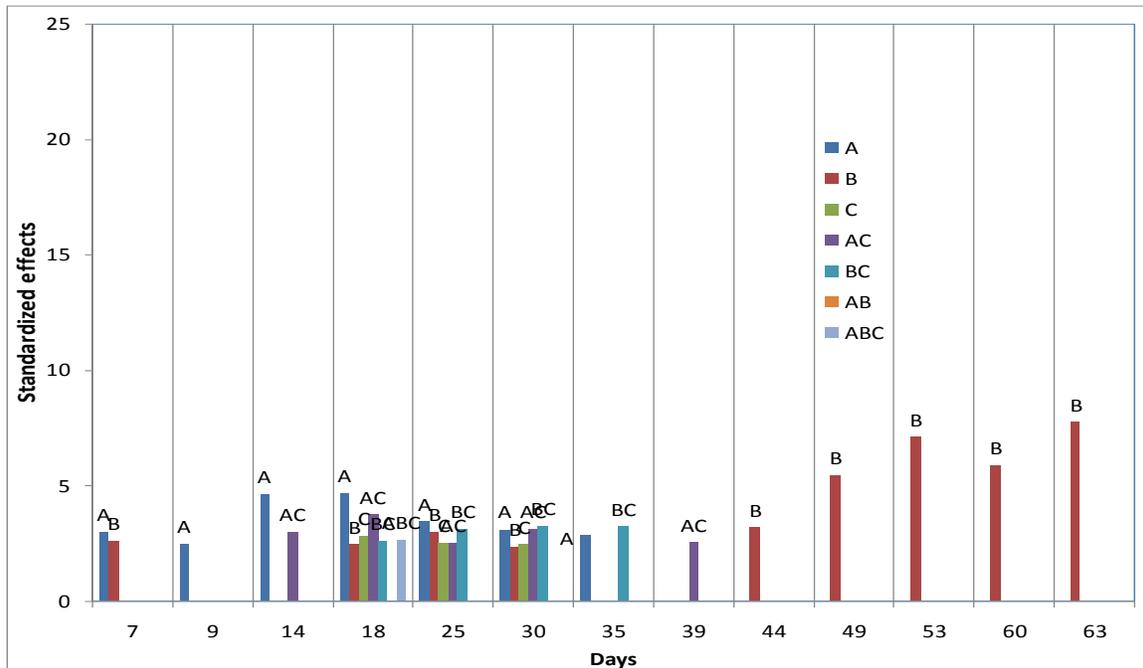
Figure 12. Factors and their extent to have produced a statistically significant difference in hardness.

For better understanding of statistically significant effects that were produced by the main factors, plots containing only the main effects and causes were constructed as shown in Figures 12 and 13. The rainfall intensity undoubtedly significantly influenced on the amount of the infiltrated water as shown in Figure 13. The difference in the amount of the infiltrated water was all statistically different, with the greater rainfall intensity being produced more amount of the infiltrated water. For the values of pH, significantly higher pH values were observed for the reactors with low-level rainfall intensities and small-sized CAAs.

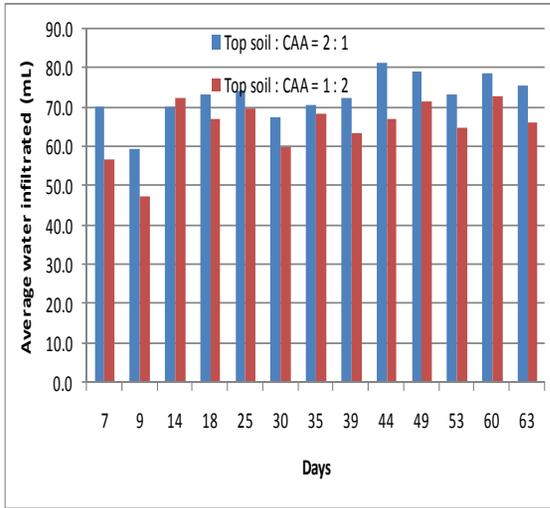
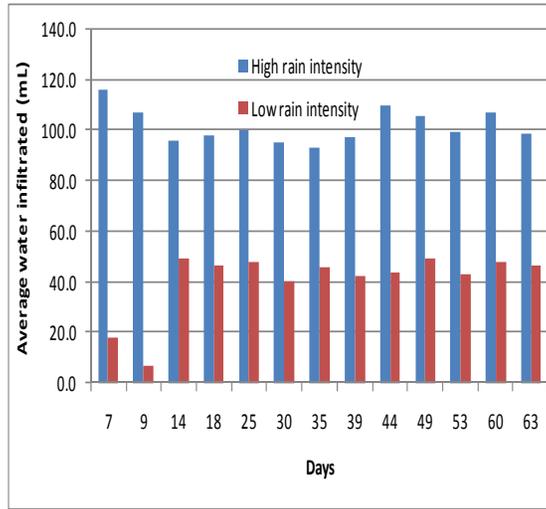
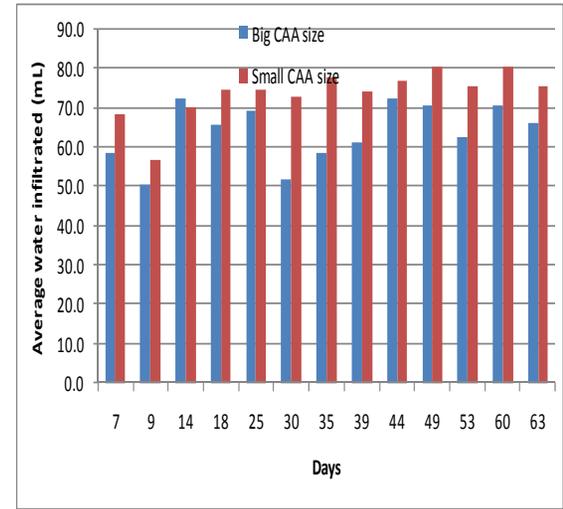
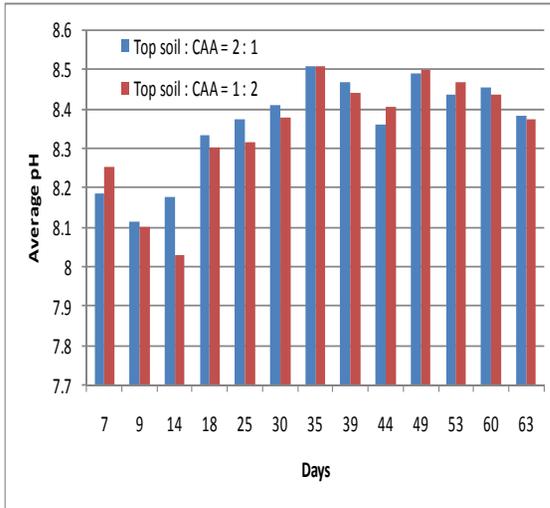
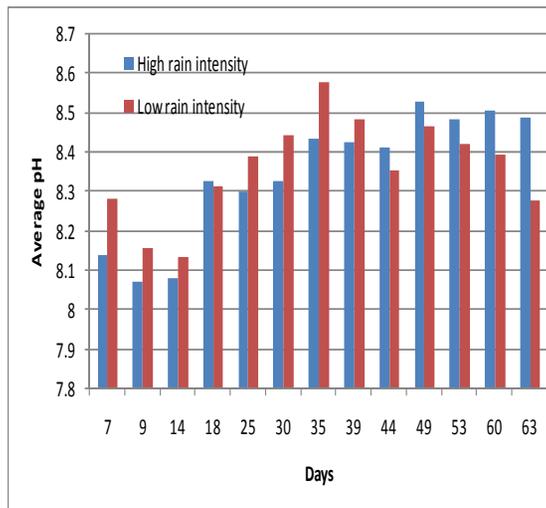
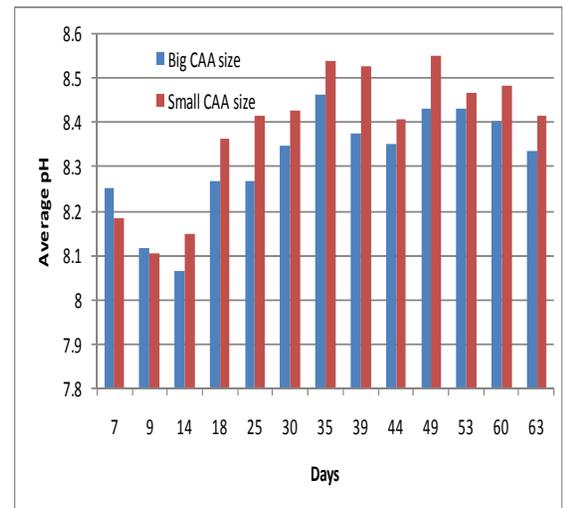
Figure 13. Plots of the main effects on the amount of infiltrated water (top row) and pH values (bottom row).

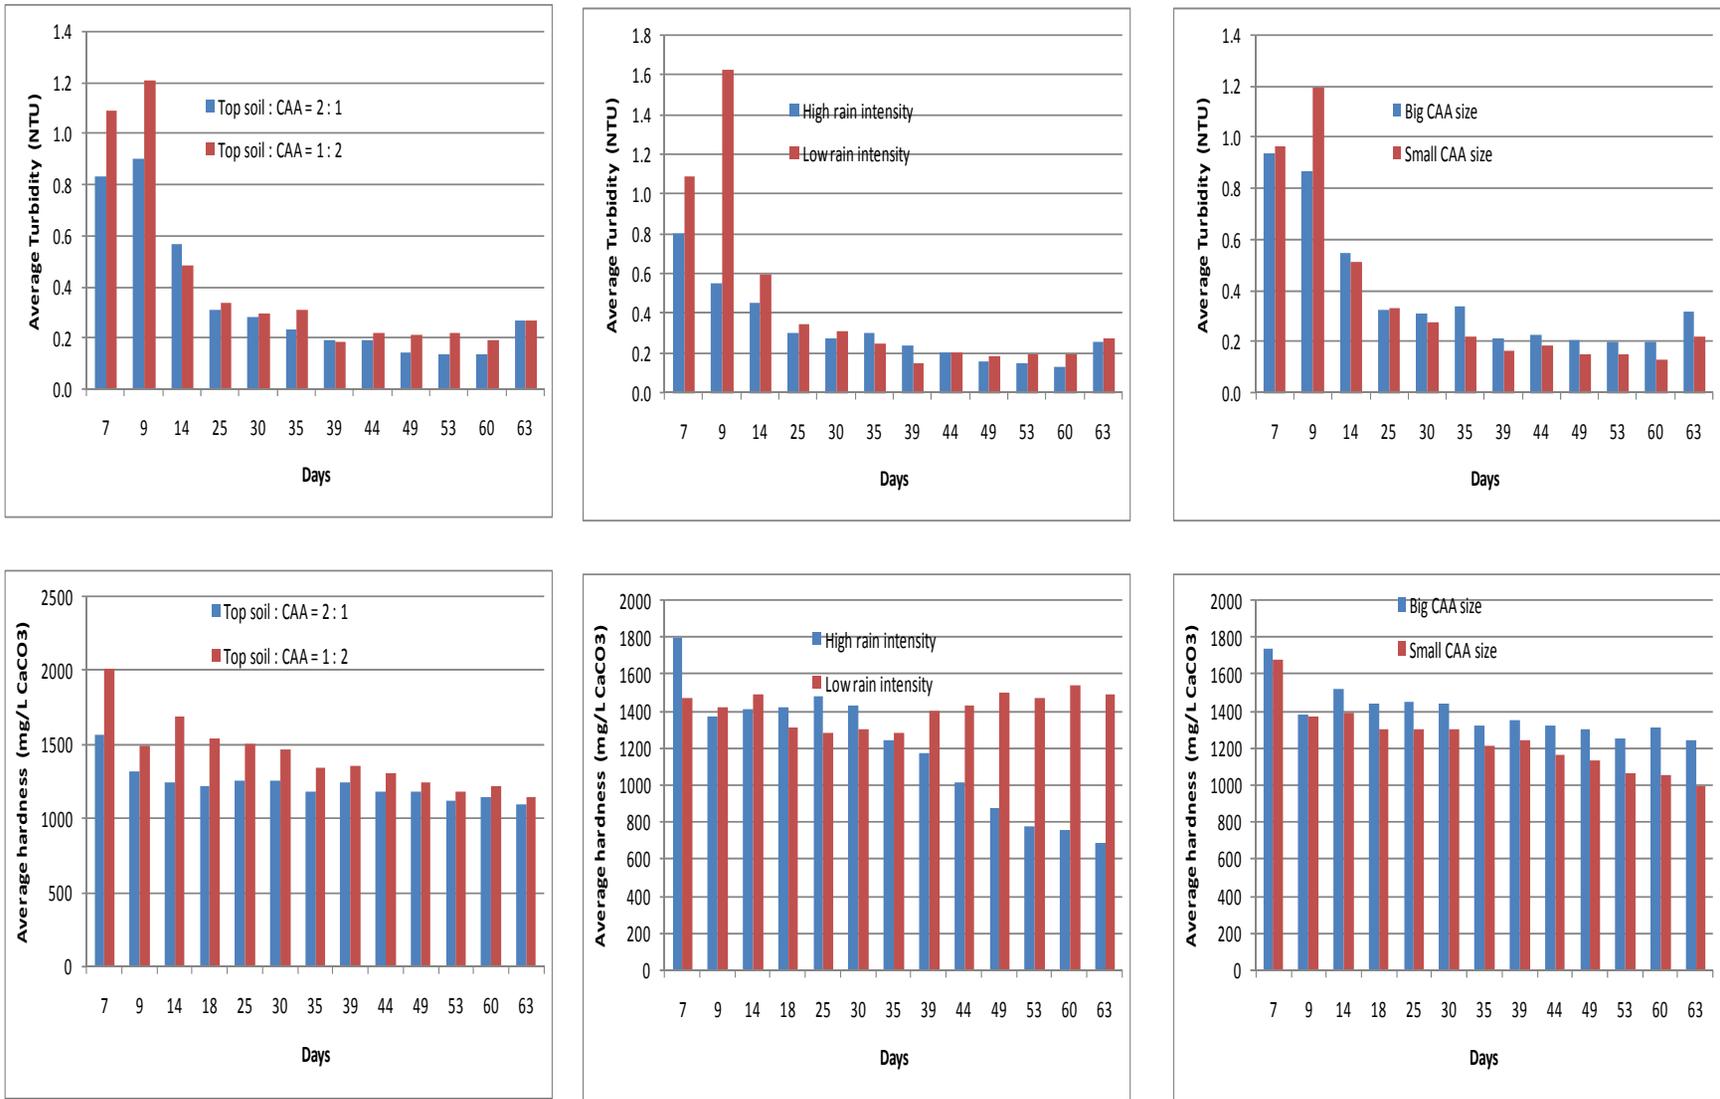
As shown in Figure 1, turbidity was statistically higher for the reactors with low-level rainfall intensities, more CAAs ratio, and smaller size CAAs. However, in the later part of the experiment, the infiltrated water from the bigger size CAAs produced significantly higher turbidity. Statistically higher hardness concentrations were monitored for the reactors with more CAAs ratio up to the middle of the experiment. However, low-level rainfall intensity dominantly produced significantly higher concentrations of hardness in the later experiment.

Figure 14. Plots of the main effects on the amount of turbidity (top row) and hardness (bottom row).

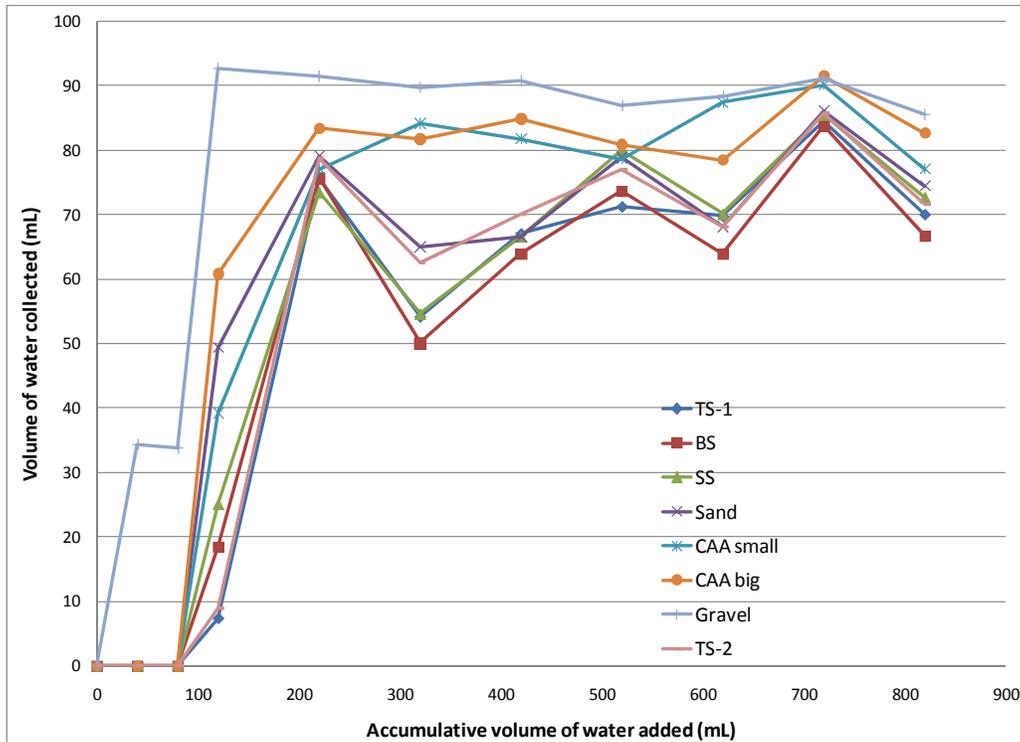
Figure 15 shows the trends of water infiltration for each column packed with the different solid materials (i.e., top soil, bottom soil, site soil, sand, small CAA, big CAA, and gravel). A steady-state water infiltration was calculated by using infiltration volume data after total 120 mL was added to each column. After that event, the infiltration trend reached a pseudo plateau producing a constant amount of water. Results are shown in Table 9. With those infiltration ratio data, water retention capacity at a steady-state was calculated per grams of solid materials tested.

Figure 15. Volume of water collected from each reactor.
