**Puerto Rico Water Resources Research Institute
Annual Technical Report
FY 2008**

Monitoring Nutrients Content in the San Juan Bay Estuary using Hyperspectral Remote Sensing

Title: Monitoring Nutrients Content in the San Juan Bay Estuary using Hyperspectral Remote Sensing

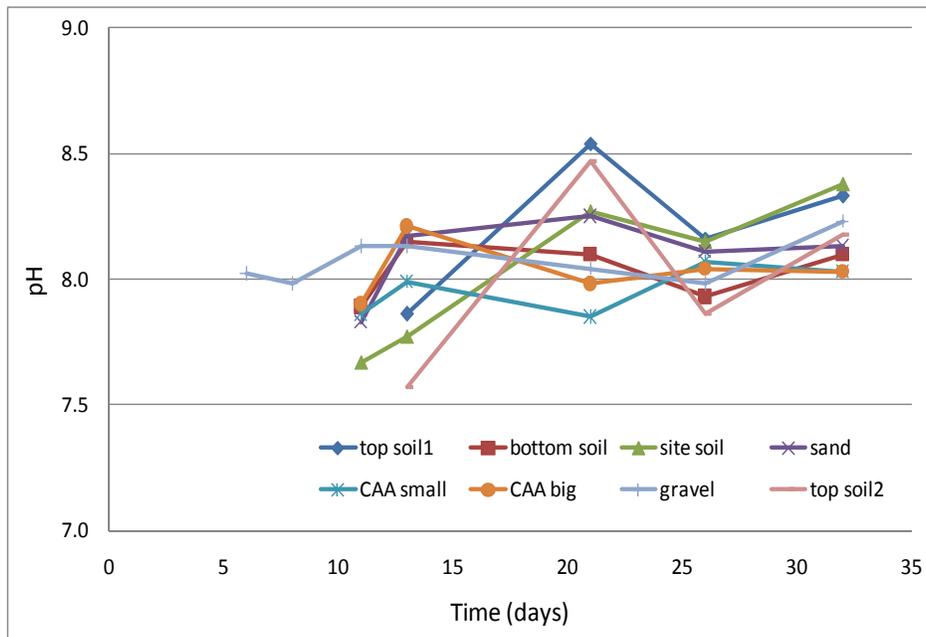
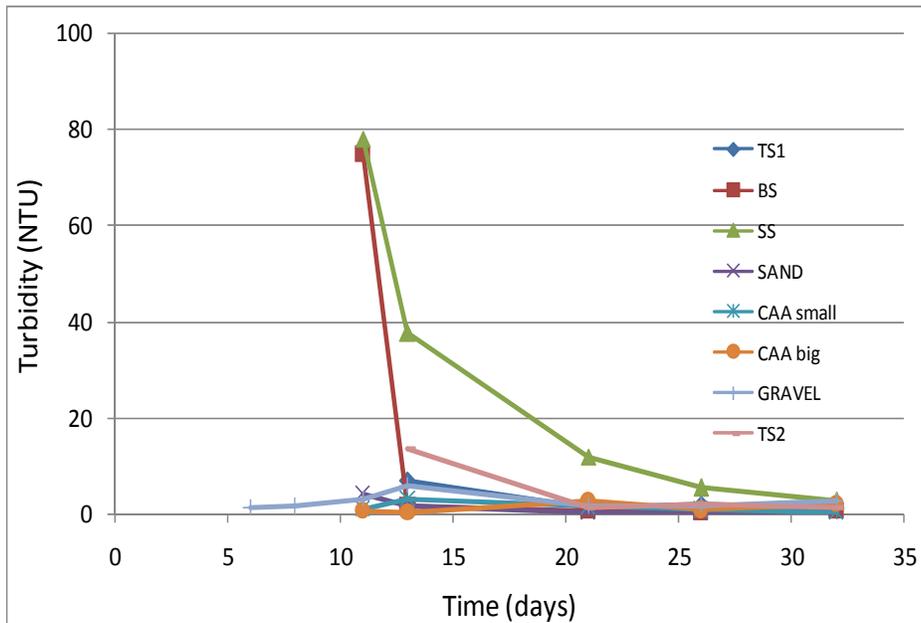
the infiltration test as shown in **Figure 16 (bottom)**. Further sophisticated experiment is warranted to assess the contribution extent of each solid material to overall water quality parameters.

Figure 16. Trends of pH (top) and turbidity (bottom) in the infiltrated water collected.

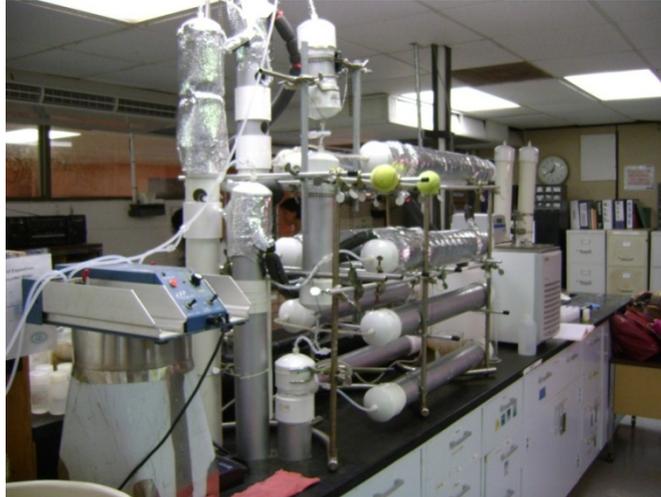
Column reactors have been constructed as shown **Photo 5**. Sampling and water quality assessment have been actively conducted. Concrete results will be delivered in the next progress report.

Photo 5. Column set up for the experiment of water quality assessment with the worst-case combinational refilling and temperature effect.

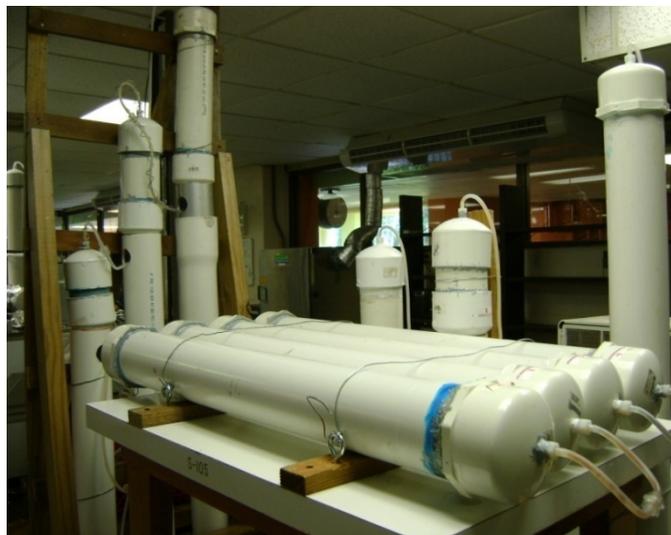
Another set of column reactors were constructed to assess water quality parameters for the case when backfilling is done with the deeper top soil layer, shallower CAA layer with smaller particle sizes and greater rainfall intensity. Together with the Water Quality Monitoring 1, this experiment is the main components of the proposed work during the second project year. Data will be presented as they come out in the progress reports.

Photo 6. Column set up for the experiment of water quality assessment with the best-case combinational refilling.

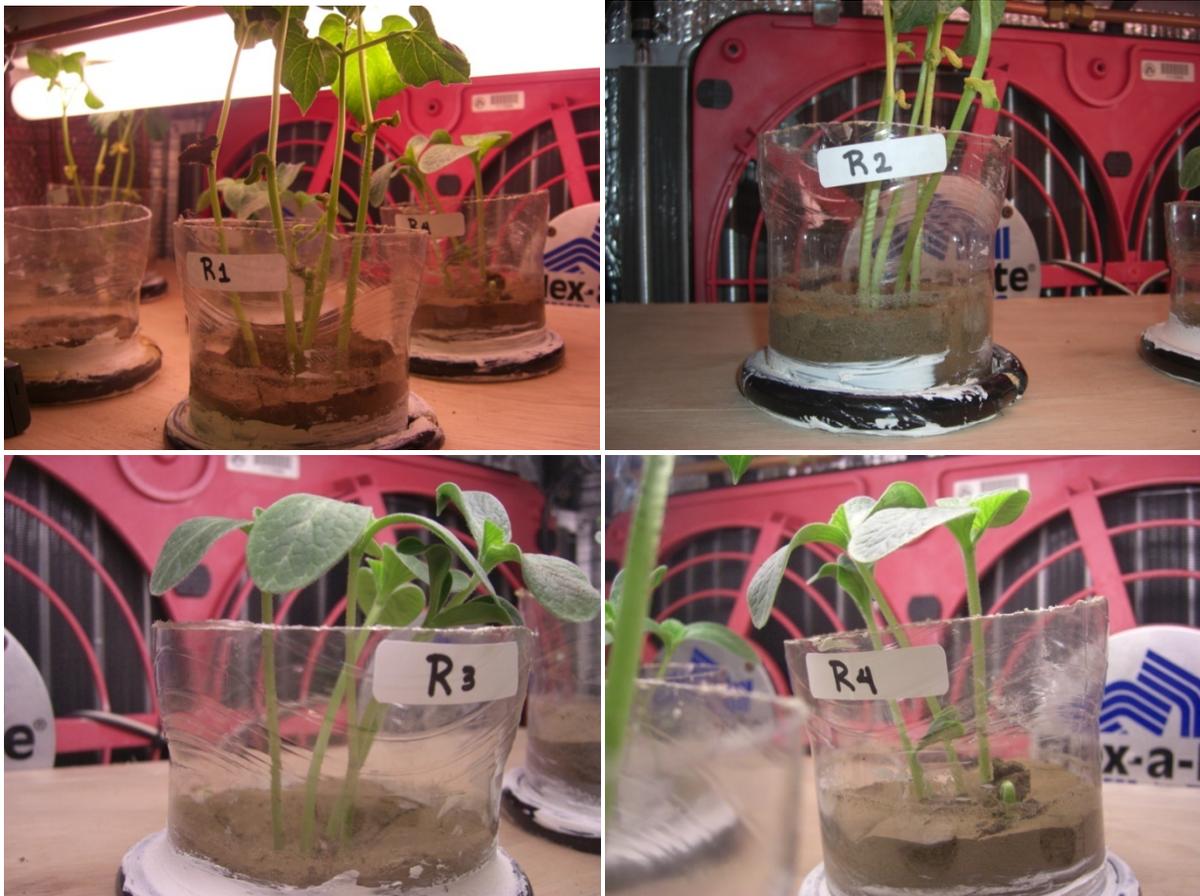
Photo 7. Germination results of bean (top row) and pumpkin (bottom row) seeds.

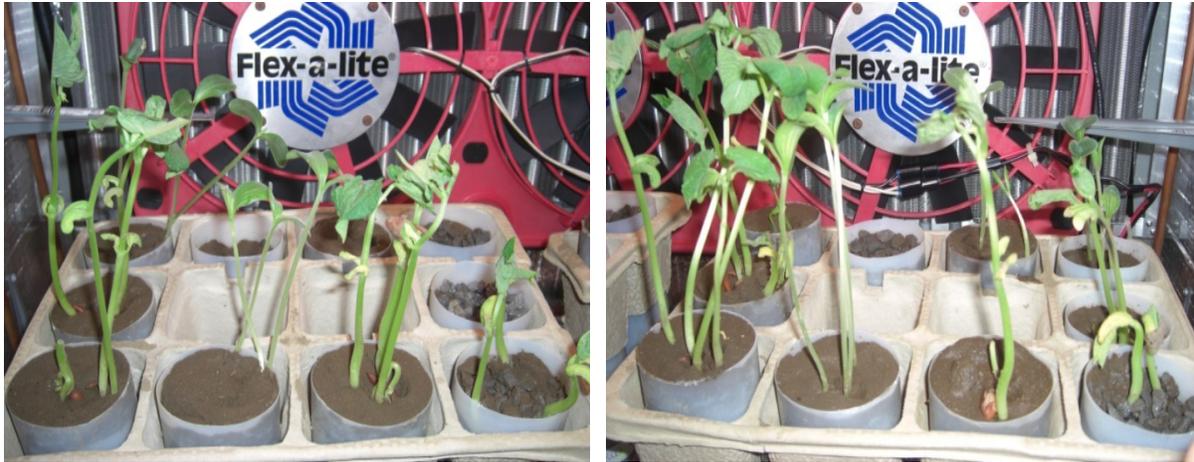
Generally, beans germinated and grew much better than pumpkins during the period of the experiment (2 weeks) as shown in **Photo 8** and **Figure 17**. Between two backfilling modes, a layered mode showed better results than a mixed mode. Regardless of the seed type, better results were observed with a greater depth of the top soil for a layered backfilling mode and a higher ratio of the top soil to the CAAs for a mixed mode. Both plants also showed better results when their seeds were planted into the system that had more top soils than the CAAs.

Photo 8. Beans and pumpkins growing in various reactors which were designed to assess the effects of multiple factors on the germination rate and shoot growth.

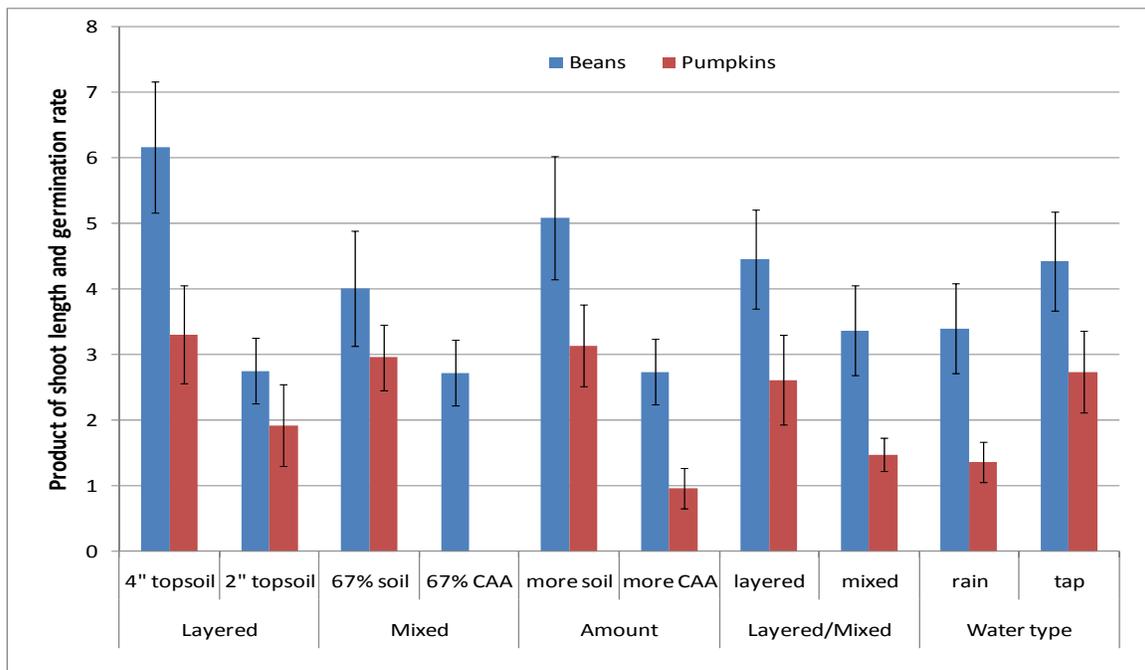
Figure 17. Results of the effects of multiple factors on the product of germination rate and shoot length.

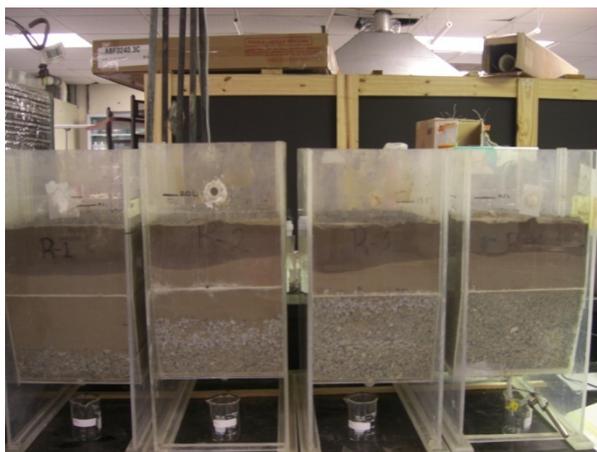
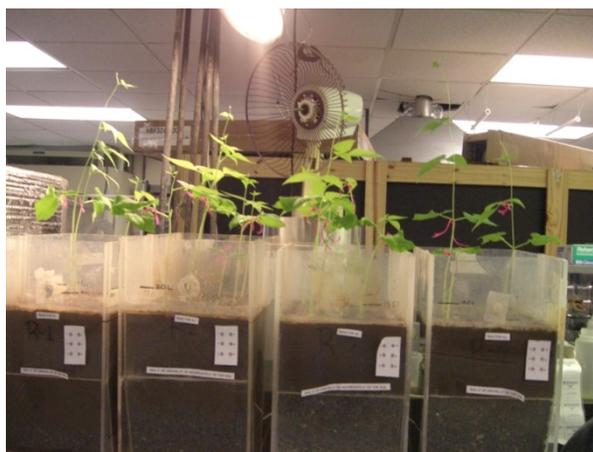
As shown in Photo 9 and Figure 18, all of 6 bean seeds germinated from each reactor. However, after about a month of growth, 3 shoots died from the Reactors 1 and 4 (i.e., 50% survivability), and 1 shoot died from the Reactor 2 (i.e., 83% survivability). No shoot death was observed from the Reactor 3, resulting in 100% survivability).

Photo 9. Scene of the 1st day (left) and the 20th day (right) of the reactors to assess physical hindrance of the CAAs.

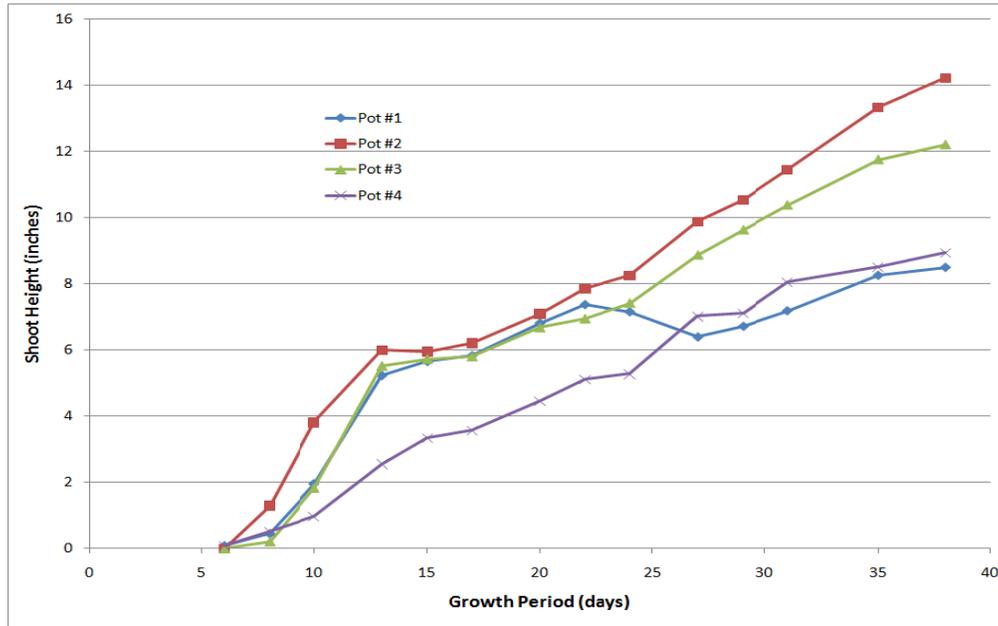
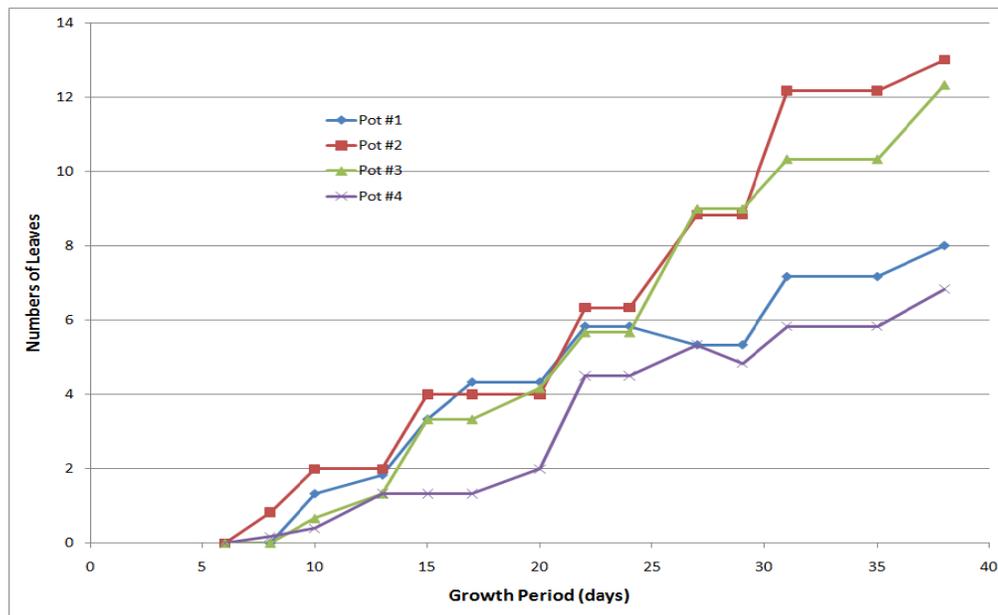
Figure 19. Results of the study which aimed to assess effect of physical hindrance on germination and growth.

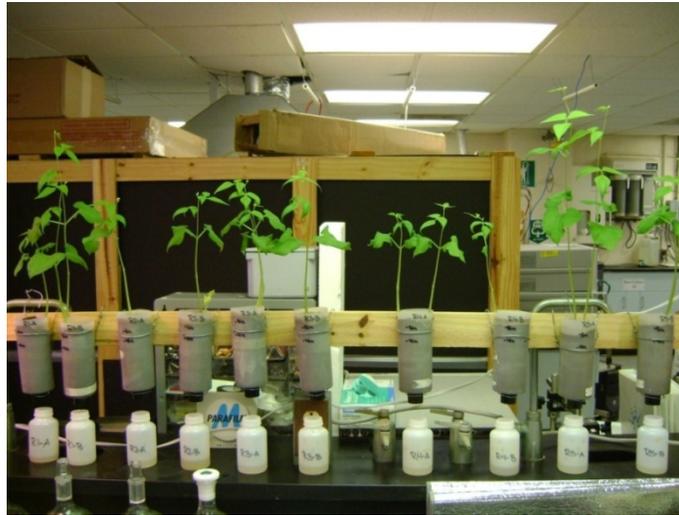
Reactors in duplicate were sprayed with water having different hardness concentrations (0 ~ 80 mg/L as CaCO_3). The Reactors having received the highest hardness water made 100% germination (i.e., 4 germinations out of 4 seeds planted). Other Reactors made 75% (i.e., 3 out of 4) germination. As shown in **Photo 10** and **Figure 20**, the highest growth of the beans was achieved in Reactor D which has been sprayed with water at a hardness concentration of 80 mg/L as CaCO_3 . In general, the numbers of leaves were not significantly different among the reactors (**Figure 21**).

Photo 10. Resulting view of the experiment to assess the effect of hardness on germination and growth.

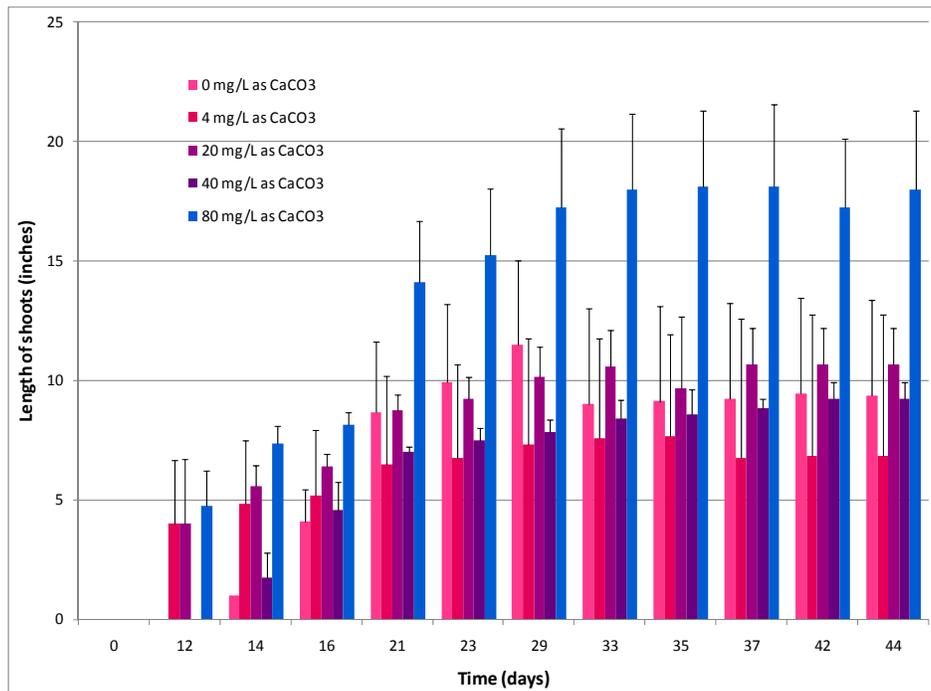
Figure 20. Length of bean shoots when receiving water at different hardness concentrations. Bars indicate standard deviations: $n=3$ for the reactors receiving 0, 4, 20, and 40 mg/L hardness as CaCO_3 , whereas $n=4$ for 80 mg/L case.

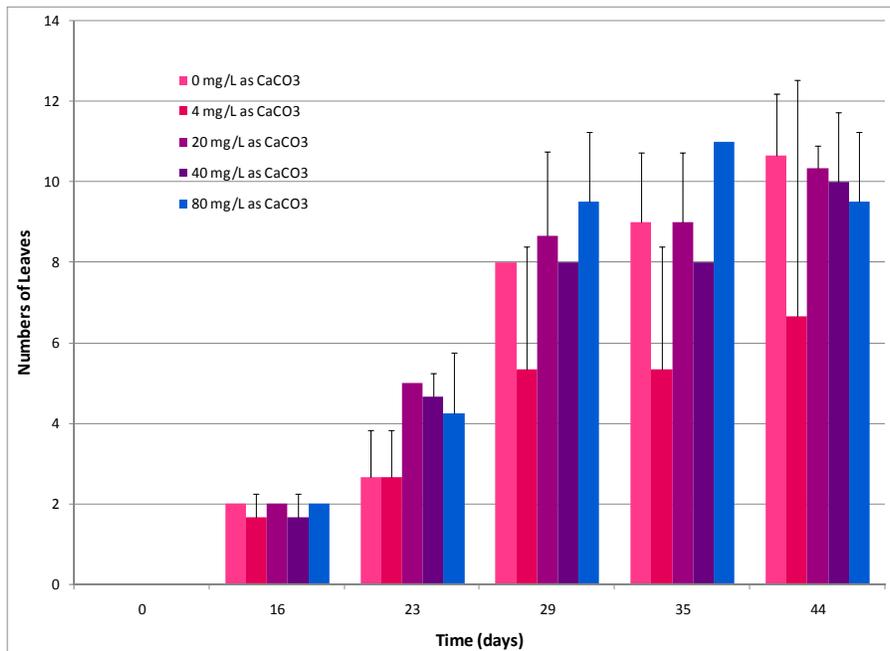
Figure 21. The numbers of bean leaves when receiving water at different hardness concentrations. Bars indicate standard deviations: n=3 for the reactors receiving 0, 4, 20, and 40 mg/L hardness as CaCO₃, whereas n=4 for 80 mg/L case.

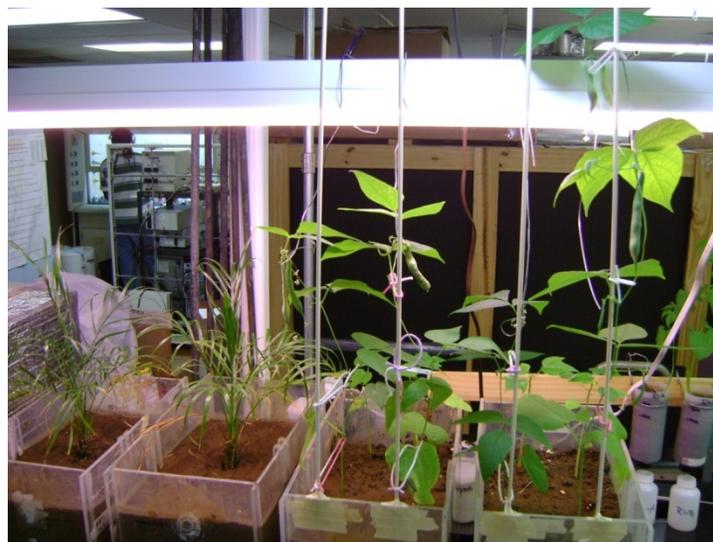
As shown in Photo 11, botellas, papayas, beans and later pumpkins were tested with respect to physical hindrance that the CAA layer might exert for their roots and consequently their growth. Baby botellas (~8 inches) and papayas (~5 inches) were planted directly to the Reactors, whereas beans and pumpkins were seeded to the Reactors.

Photo 11. Various plants (botellas, beans, papayas, and pumpkins) tested for potential physical hindrance.

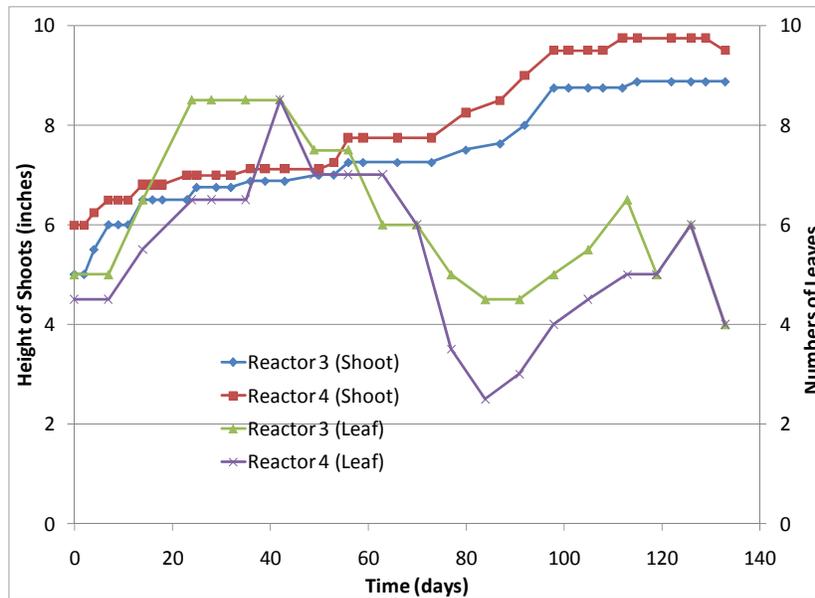
Figure 22. Height of shoots and the numbers of leaves of papayas.

As shown, shorter shoots but more leaves were found from the papayas planted in Reactor 3 which had the CAAs layer five inches below the top soil. However, it is not sure at the moment whether or not the initial physical conditions have influenced the results. That is, four identical baby papayas were obtained and planted to the Reactors but the Reactor 3 started with shorter shoot and more leaves in the beginning.

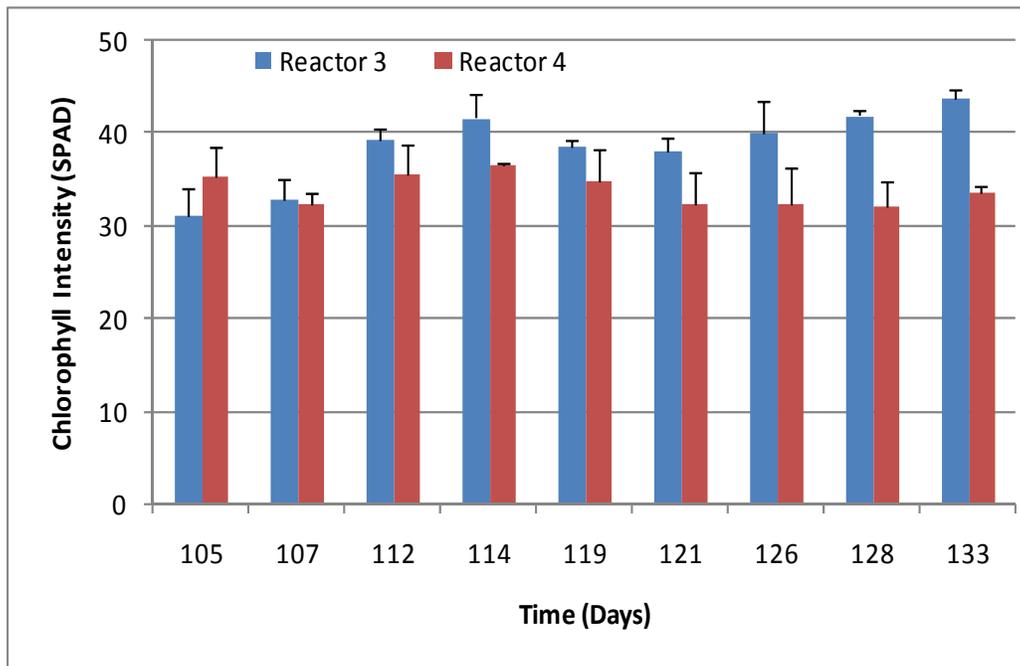
Figure 23. Chlorophyll intensity in the papaya leaves.

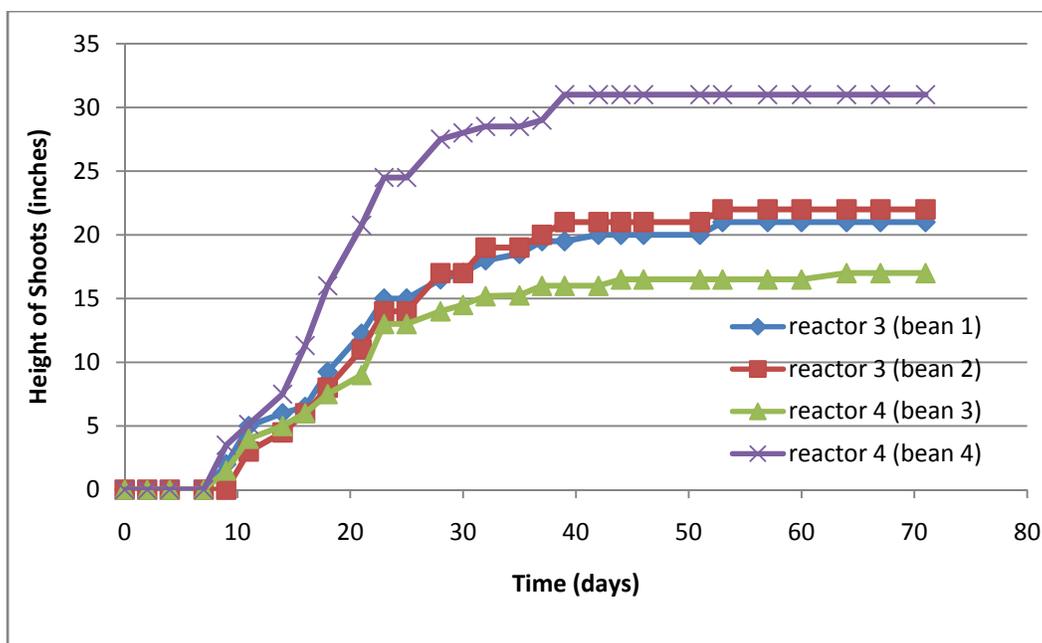
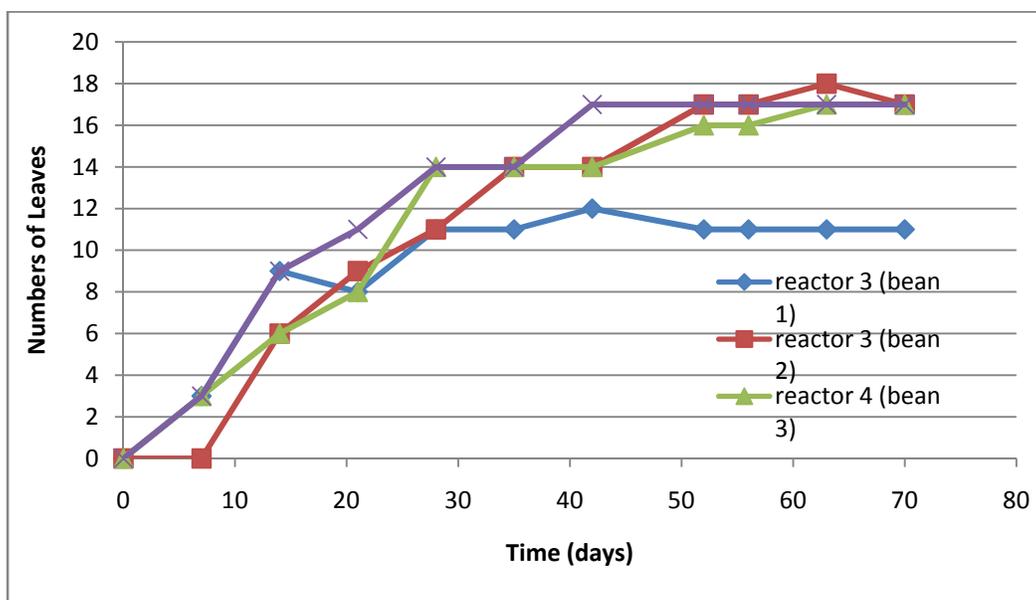
Beans: Beans were germinated almost the same time. First cotyledon was observed after 8 ~ 10 days. Likely, they started blossoming 29 ~ 31 days after seeding. The heights of shoots of the beans grown in the Reactor 4 were very dissimilar between two bean plants. The numbers of bean leaves were found very similar except for a bean grown in the Reactor 4 (Figure 24).

Figure 24. Height of shoots (top) and the numbers of leaves (bottom) of the beans.

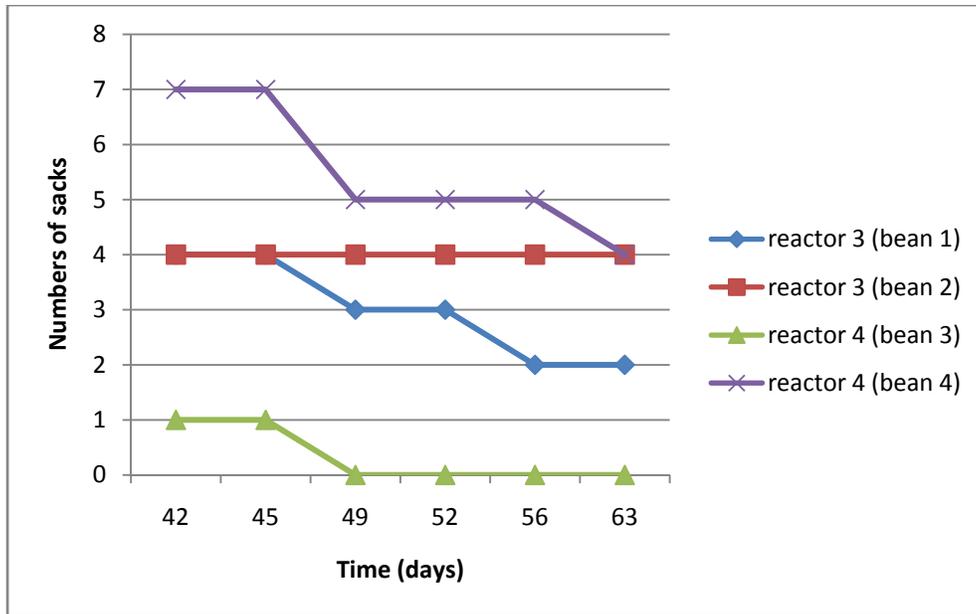
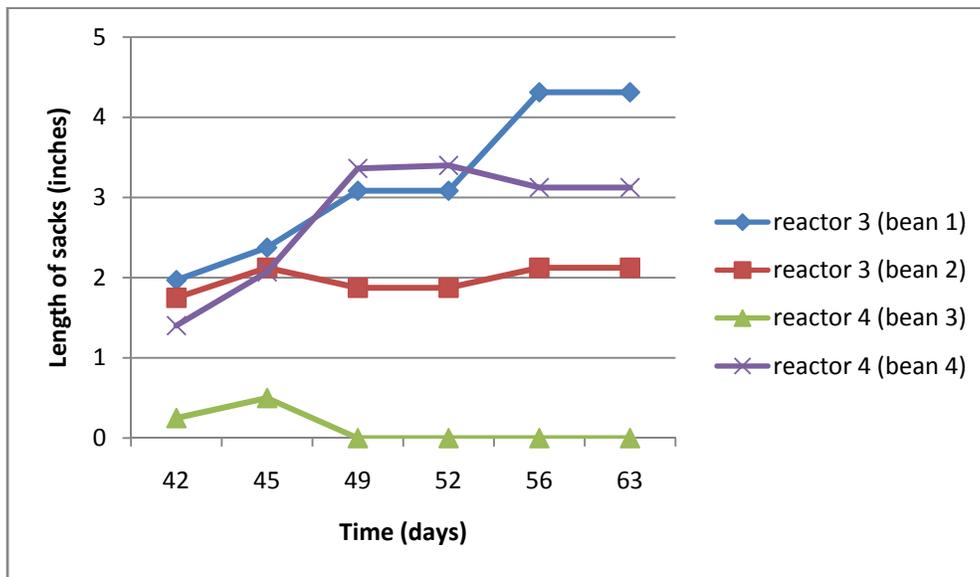
Figure 25. The numbers (top) and length (bottom) of bean sacks.

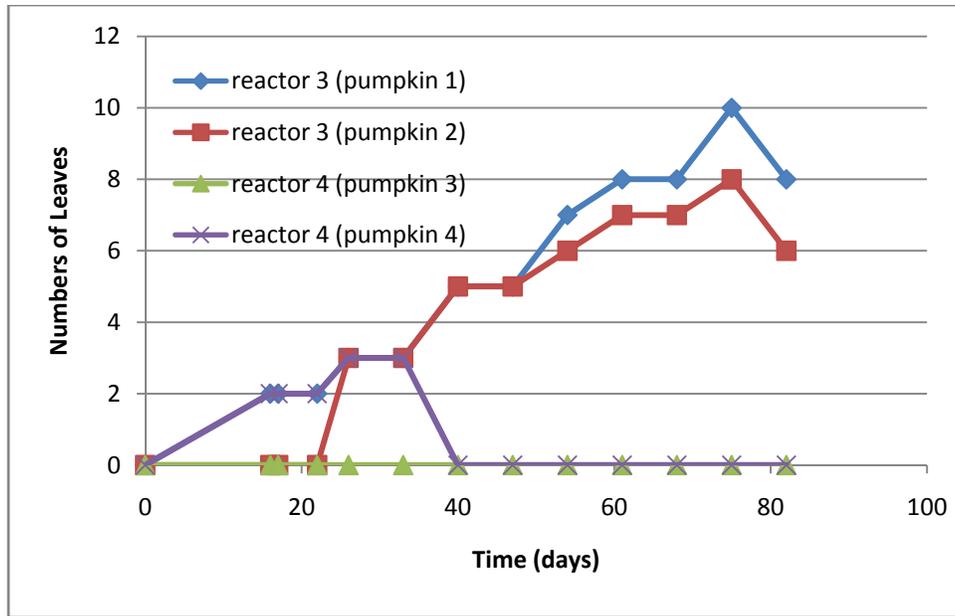
Figure 26. The numbers of pumpkin leaves.
