**Puerto Rico Water Resources Research Institute
Annual Technical Report
FY 2009**

OPEN PIT QUARRY RESTORATION TO BIO-VIABLE LAND

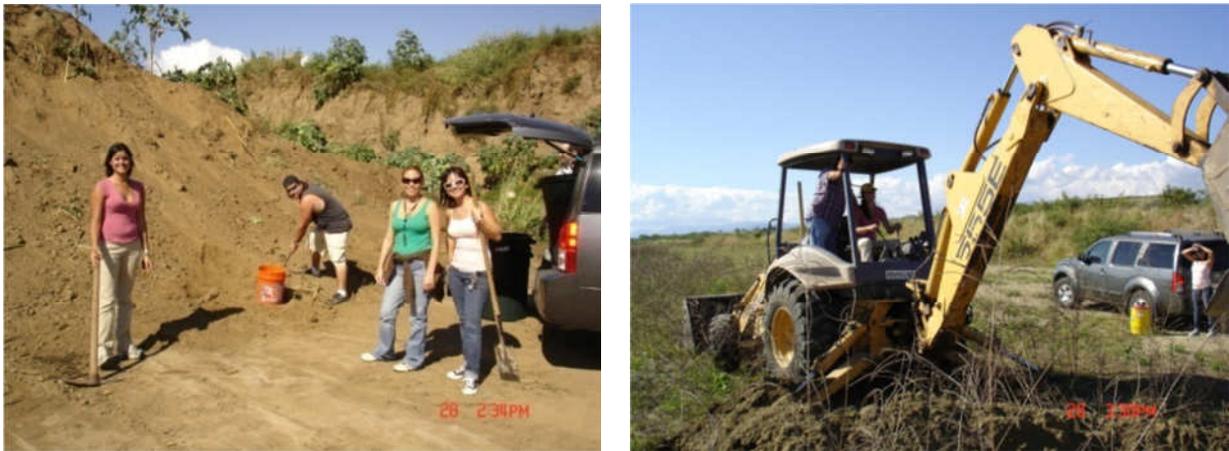
Photo 2. Soil Sampling on site.

The open pit site was filled with the dredged sandy sediments from the Guayama bay on the bottom at a depth of 0.3 m. As the site will be eventually used as an agricultural area, an organic-rich soil from the Coamo Lake will be used as a top soil at a depth of 1 m. In these regards, two soils were sampled on site as shown in Photo 2. After being transported, the soil samples passed a sieve size 3/8" were collected for the experiment.

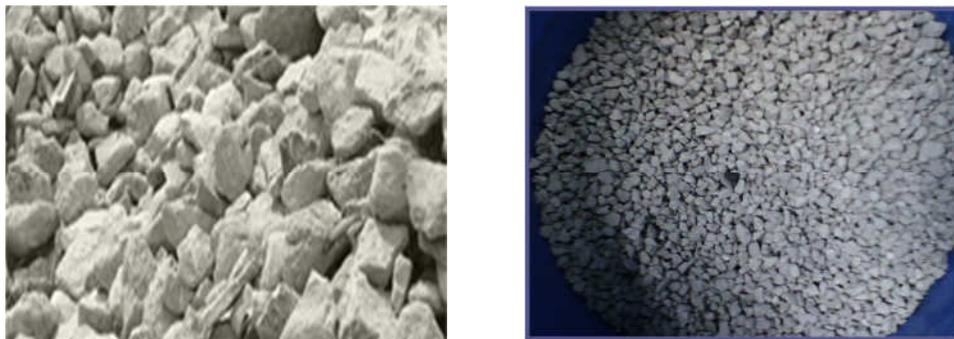
Coal ash aggregates were obtained from a local coal burning power plant in Guayama, PR. It is a solidified mixture of fly and bottom ashes with water. Main chemical components, by weight, are: 51% of ($\text{SiO}_2 + \text{Al}_2\text{O}_3 + \text{Fe}_2\text{O}_3$), 30% Lime (CaO), and 15% SO_3 (Pando and Hwang, 2006). The CAAs were first oven dried at 105°C overnight, crushed with a mechanical mixer, and sieved to collect the CAA sizes of 2.36 ~ 9.53 mm (Photo 3).

Photo 3. Coal ash aggregates before (left) and after (right) preparation for the experiment,

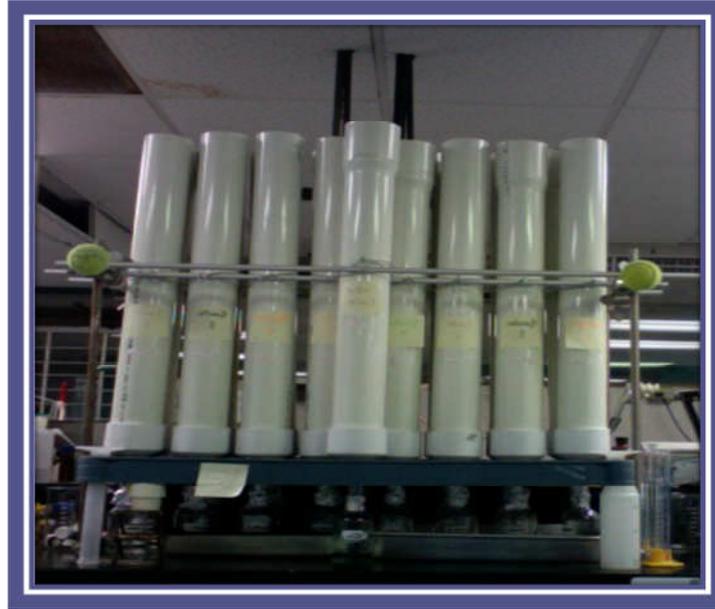
Photo 4. Column Reactors setup for water quality assessment in a statistical design and analysis.

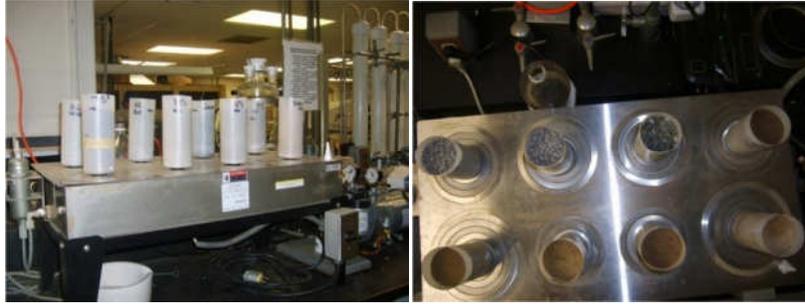
Total 8 plastic reactors (2.5-in D x 6-in L) were constructed to test leaching characteristics of each solid material being used in the project as shown in Photo 5. Each component was packed at a depth of 5 inches. Table 2 shows the design matrix of leaching test. Tap water was sprayed on the top of the reactors on every Mondays, Wednesdays, and Fridays. During the first 2 watering events, 40 mL was sprayed, but the amount of water added was increased to 100 mL to collect enough amount of infiltrated water with which water quality parameters were analyzed. This experiment was done over 4 weeks.

Photo 5. Views of leaching tests of each solid material used in the project.

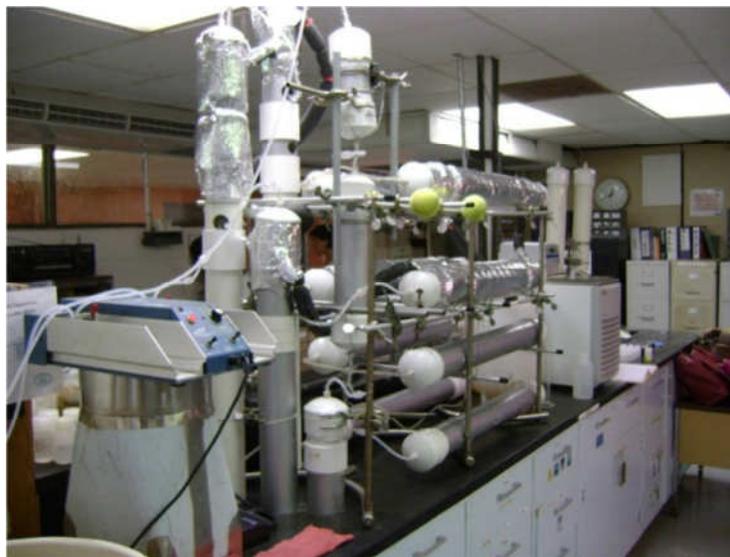
Photo 6. Column set up for the experiment of water quality assessment with the worst-case combinational refilling and temperature effect.

The System 1 was constructed in the same way as the System 2, except for the operating temperature. It was coiled with a vinyl tube and cold water (10°C) was recirculated through it by a temperature controlled bath. The columns and coiled tubes were wrapped with an insulation sheet. Tap water was pumped to the Systems 1 and 2 at a rate of 10 mL/min from a reservoir by a peristaltic pump. Pumping was scheduled for 3 hours per week day at the consistent time frame using a timer. Samples were collected from the sampling ports once every two weeks and analyzed for water quality parameters.

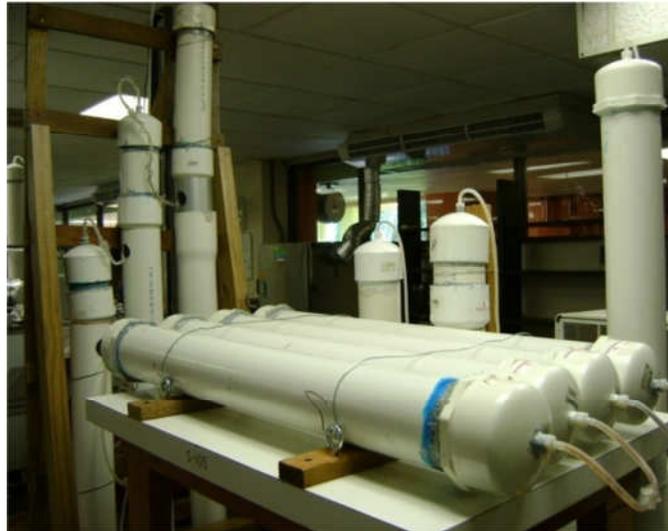
Top Soil	CAA	Bottom Soil	Site Soil
Numbers of columns	1	1	1	4
Lengths of columns (inches)	13	6.5	2.5	30 each
Bulk density (g/cm ³)	1.32	0.53	1.08	1.32

Photo 7. Column set up for the experiment of water quality assessment with the best-case combinational refilling.

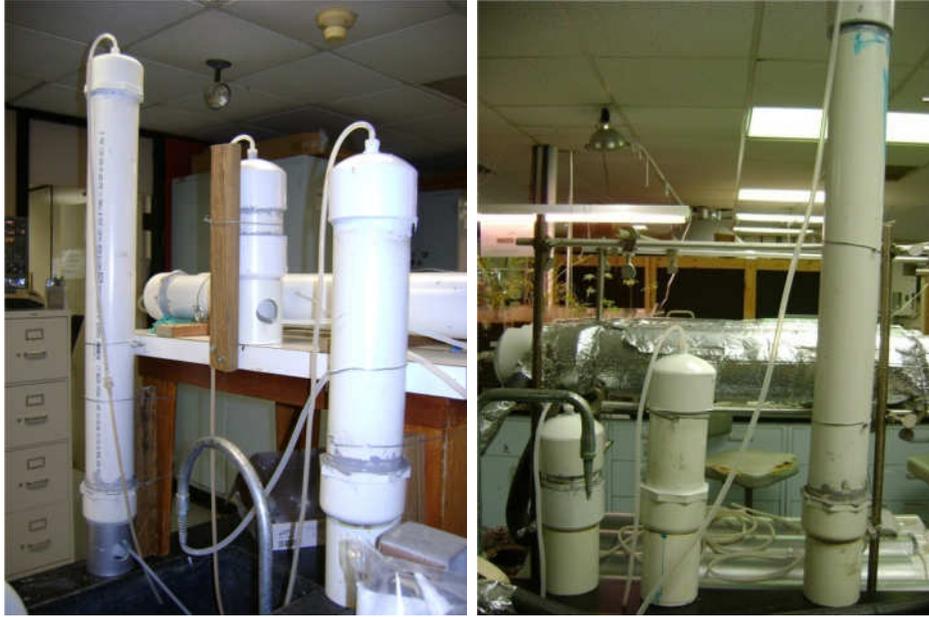
Three soils were tested: CAA, bottom soil, and site soil. Two sets of experiments were conducted as shown in Photo 8 and Table 1. Each column was stand alone and was not connected each other. System 4 was with soil and CAA distribution which had showed the worst water qualities. Each column received tap water pumped at a rate of 10 mL/min for 4 hours on each weekday. System 5 was with the cases which had produced the best water qualities and the columns were pumped at 10 mL/min for 4 hours on each week days. All columns were operated at 25°C.

Photo 8. Water quality monitoring for individual soil components (left: System 4; right: System54).

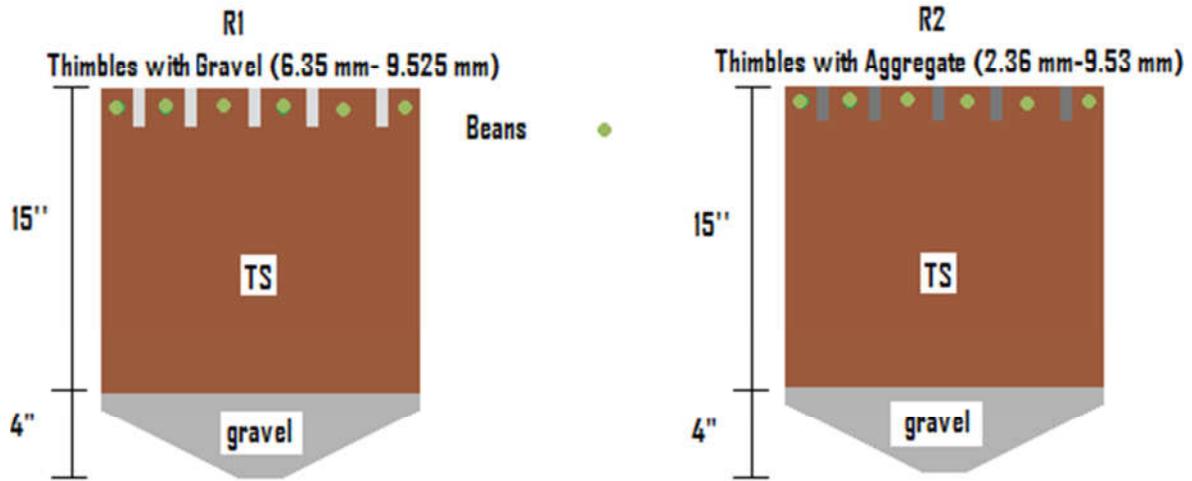
To test phyto-viability and evaluate consequent rhizospheric biochemical changes, an experiment was designed as shown in Figure 6. Two pots with a width of 2 inches, a length of 15 inches and a depth of 15 inches were constructed. Narrow width allowed observing the shape and conditions of roots. On the side wall, there were 9 evenly distributed sampling ports for soil microbial analysis: 3 in the top layer, 3 in the middle layer, and 3 in the bottom layer (Photo 10). CAAs were applied in 5 thimbles on the top of the top soils. A bean seed was planted between CAA thimbles. A control pot was also constructed in the same manner but with gravels in the thimbles. Microbial activity in rhizosphere in

Figure 6. Design of 2 reactors for assessment of soil microbiology and plant growth with addition of CAAs (left: control pot; right: CAA pot).

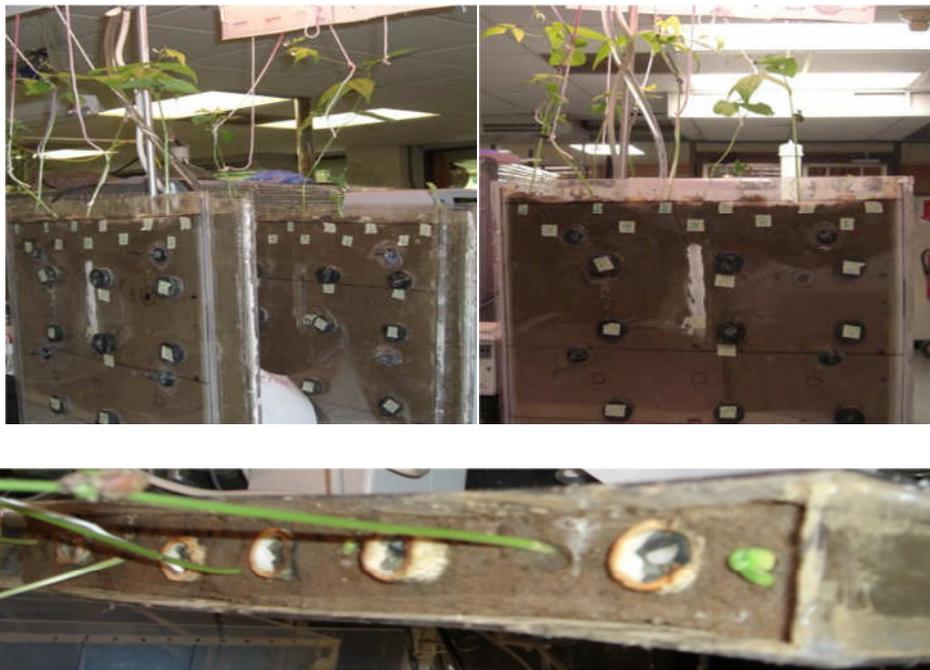
Photo 10. Side views of two pots with 9 sampling ports on the side wall (top 2 photos) and top view of the arrangement of CAAs in the thimble (bottom).

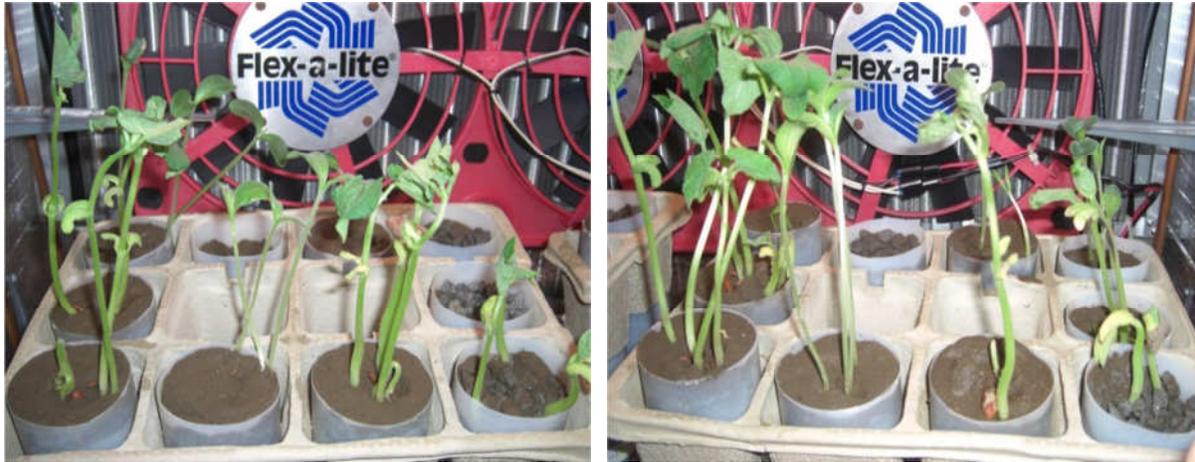
Generally, beans germinated and grew much better than pumpkins during the period of the experiment (2 weeks) as shown in Photo 12 and Figure 31. Between two backfilling modes, a layered mode showed better results than a mixed mode. Regardless of the seed type, better results were observed with a greater depth of the top soil for a layered backfilling mode and a higher ratio of the top soil to the CAAs for a mixed mode. Both plants also showed better results when their seeds were planted into the system that had more top soils than the CAAs.

Photo 12. Beans and pumpkins growing in various reactors which were designed to assess the effects of multiple factors on the germination rate and shoot growth.

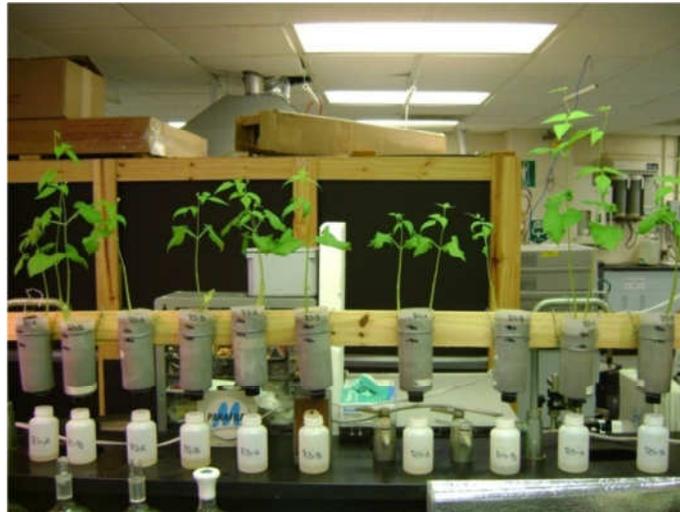
Reactors in duplicate were sprayed with water having different hardness concentrations (0 ~ 80 mg/L as CaCO_3). The Reactors having received the highest hardness water made 100% germination (i.e., 4 germinations out of 4 seeds planted). Other Reactors made 75% (i.e., 3 out of 4) germination. As shown in Photo 14 and Figure 34, the highest growth of the beans was achieved in Reactor D which has been sprayed with water at a hardness concentration of 80 mg/L as CaCO_3 . In general, the numbers of leaves were not significantly different among the reactors (Figure 35).

Photo 14. Resulting view of the experiment to assess the effect of hardness on germination and growth.

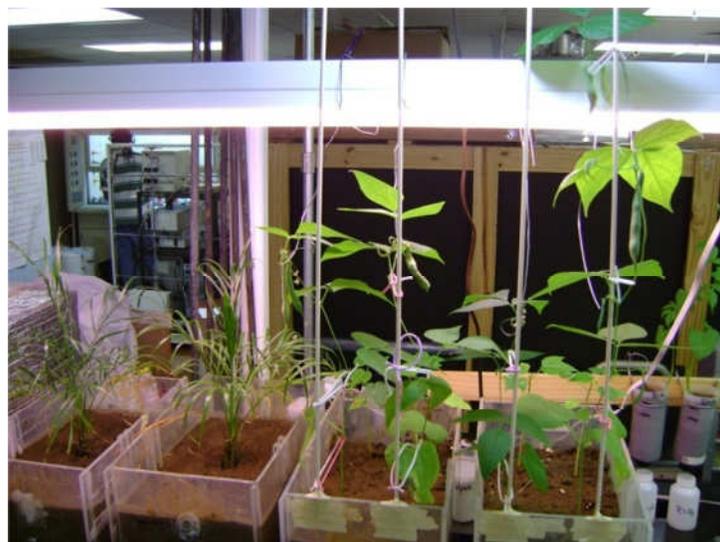
As shown in Photo 15, botellas, papayas, beans and later pumpkins were tested with respect to physical hindrance that the CAA layer might exert for their roots and consequently their growth. Baby botellas (~8 inches) and papayas (~5 inches) were planted directly to the Reactors, whereas beans and pumpkins were seeded to the Reactors.

Photo 15. Various plants (botellas, beans, papayas, and pumpkins) tested for potential physical hindrance.

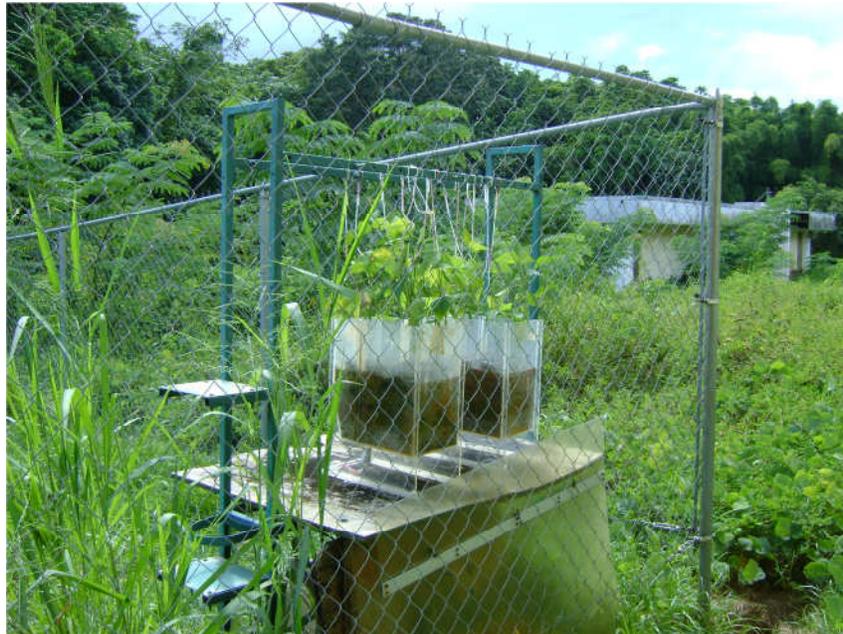
Photo 17. A view of outdoor plant growth experiment.
