# United States Department of the Interior

U. S. GEOLOGICAL SURVEY  
Reston, VA 20192

## **WATER MISSION AREA MEMORANDUM NO. 13.03**

Subject: SAFETY— Policy and Recommended Actions to Further Minimize the Potential for Aircraft Accidents at Cableways

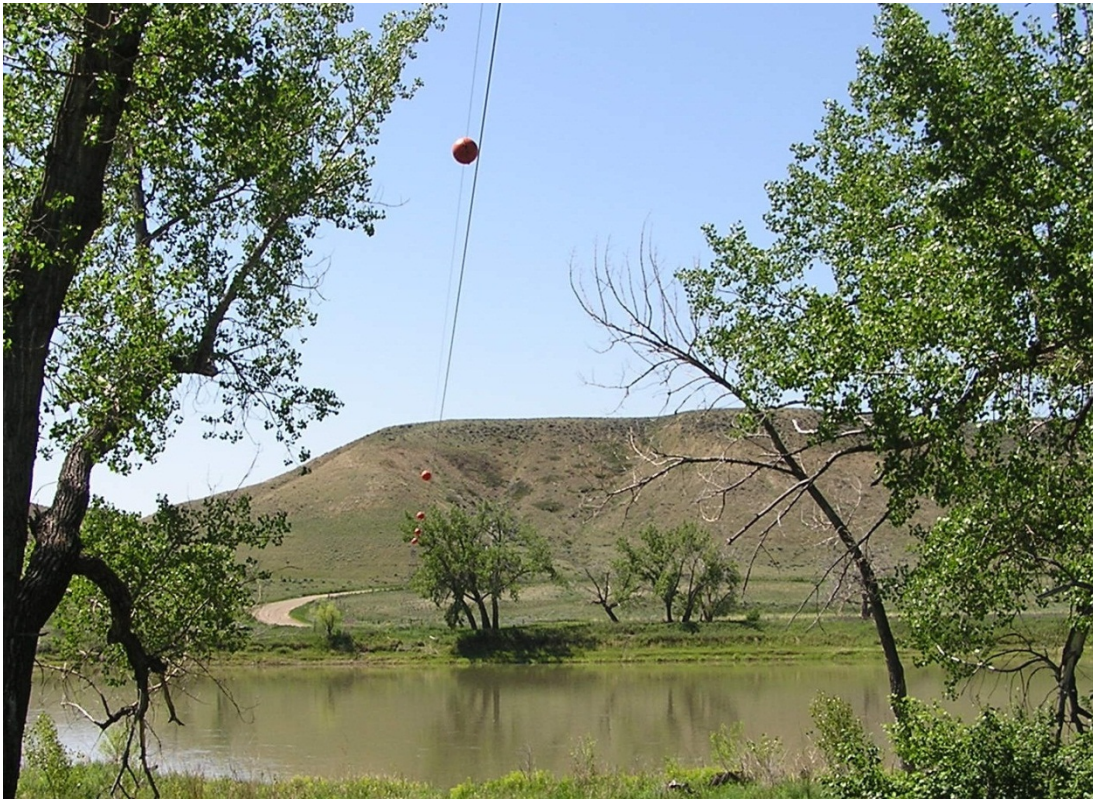
**Figure 1.** Cableway at Missouri River at Virgelle, Montana (station 06109500).

It is USGS WMA policy to comply with FAA recommendations regarding notification of cableway locations and use of aircraft warning markers at cableways. Figures 1 and 2 show examples of cableways with aircraft warning markers. Congress has charged the FAA with the responsibility to promote the safety of aircraft and the efficient use of navigable airspace. The regulatory framework that governs the conduct of the FAA's obstruction evaluation program is Title 14, Code of Federal Regulations, part 77.

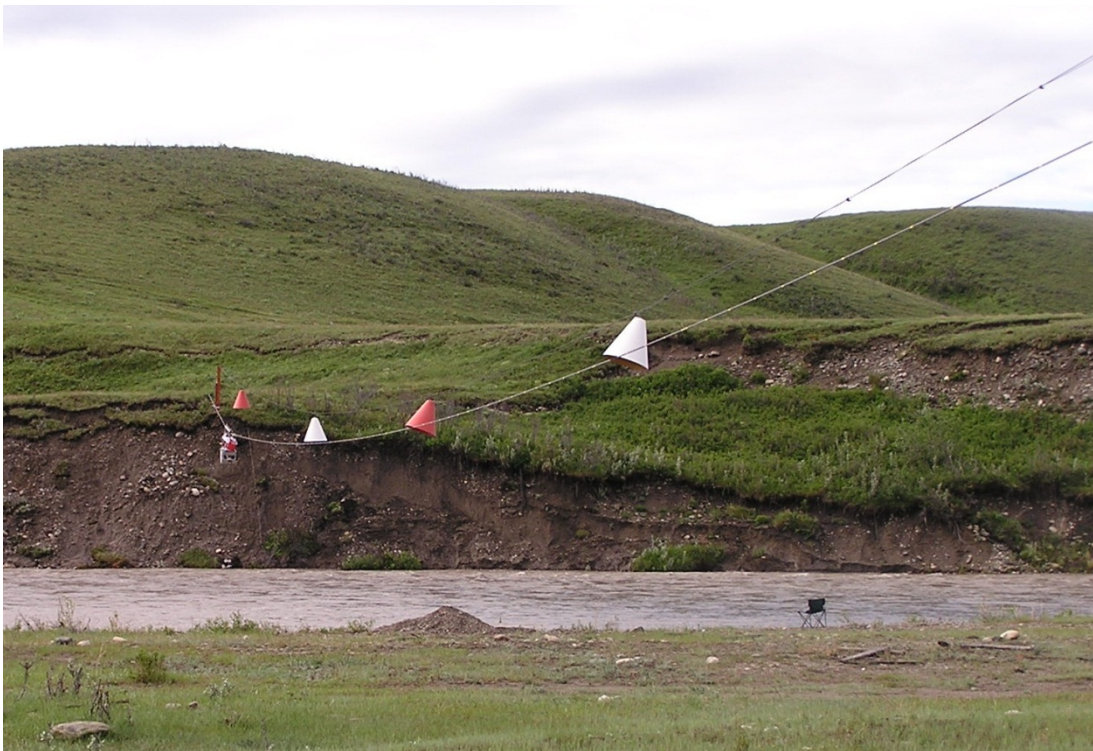
**Figure 2.** Cableway at St. Mary River at International Boundary (station 05020500).
