**U.S. Geological Survey Karst Interest Group  
Proceedings, Shepherdstown, West Virginia,  
August 20-22, 2002**

**U.S. Geological Survey  
Water-Resources Investigations Report 02-4174**

## Karstification Along an Active Fault Zone in Cyprus

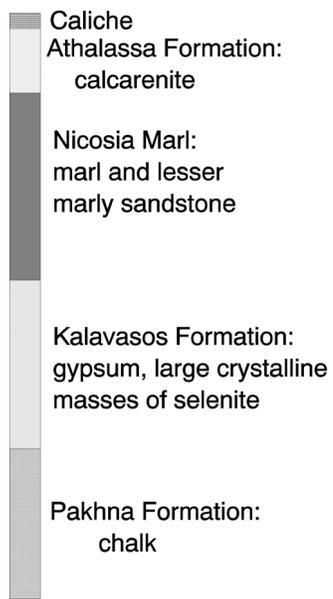
Figure 2. Generalized stratigraphic column for the Pergamos, Cyprus area, based on logs of drilled wells and a hand dug well that penetrated gypsum. Not to scale; see text for approximate thicknesses.

Pergamos lies within the circum-Troodos geologic terrane of Cyprus (Fig. 1), comprised of a Cenozoic sedimentary sequence dominated by carbonates (chalks, marls, and calcarenites) and lesser evaporites (Geological Survey Department of Cyprus, 1995). At Pergamos, the near surface stratigraphy (Fig. 2) is flat lying and consists of approximately 4 m of well-indurated calcarenite (Quaternary Athalassa Formation), which overlies approximately 30 m of poorly indurated marl (Pliocene Nicosia Marl), which overlies more than 60 m of massive gypsum (Messinian Kalavasos Formation). Chalks of the Miocene Pakhna Formation underlie the Kalavasos Formation at an unknown depth.
