Report for 2001WV2941B: Water Quality Measurement in Polishing Ponds of AMD Treatment Plants for Selection of Commercial Aquaculture Sites and Waste Management Studies

**Water Quality Measurement in Polishing Ponds of AMD Treatment
Plants for Selection of Commercial Aquaculture Sites
and Waste Management Studies**

FINAL REPORT

**Dr. Kenneth Semmens
WVU Extension Specialist - Aquaculture**

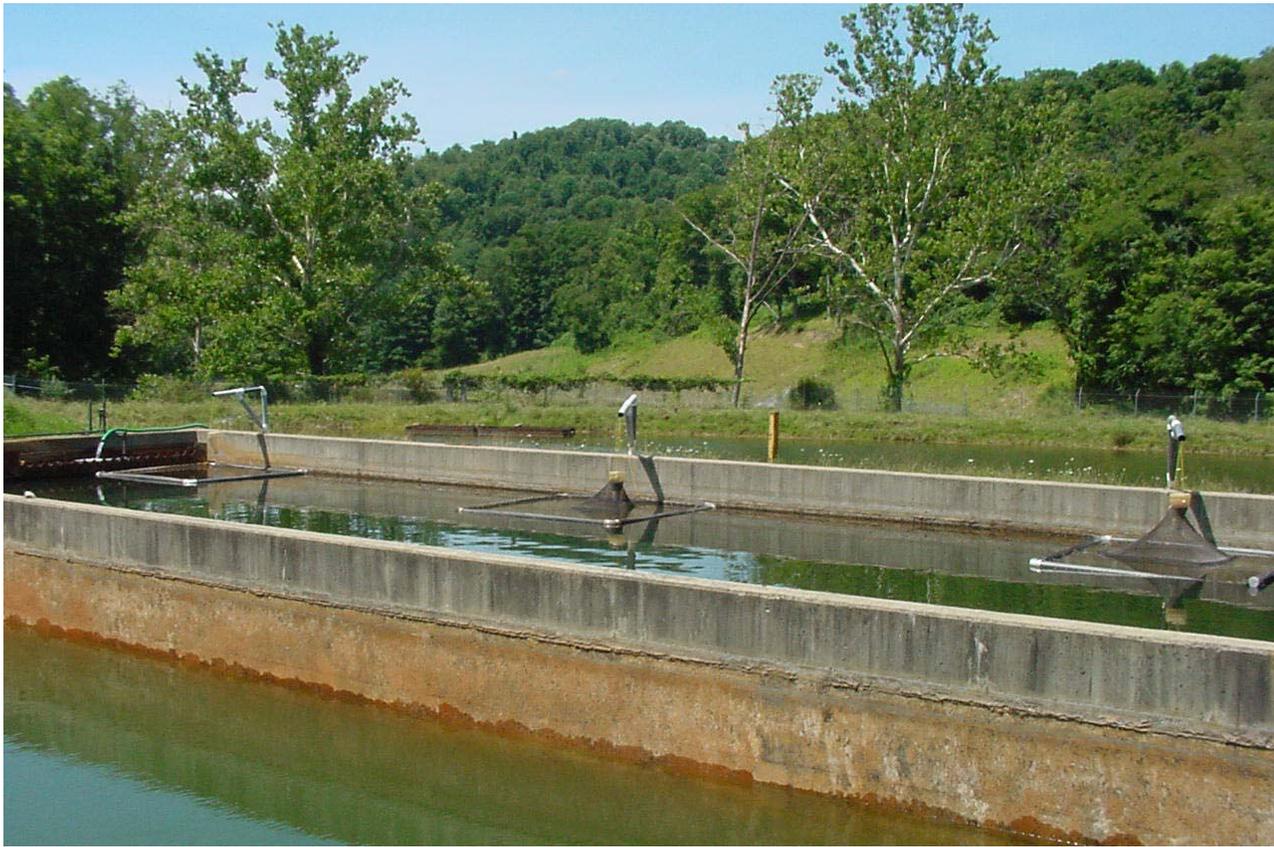
**Old AMD plan for Tygart River Mine:
Stocked with 3 warm water species
Infrastructure: elec./road/fenced/3 ponds/ 2x100,000 gal. basins**
