# **Report as of FY2008 for 2008VI118B: "Virgin Islands Water Resources Map Study"**

## **PROBLEM AND RESEARCH OBJECTIVES**

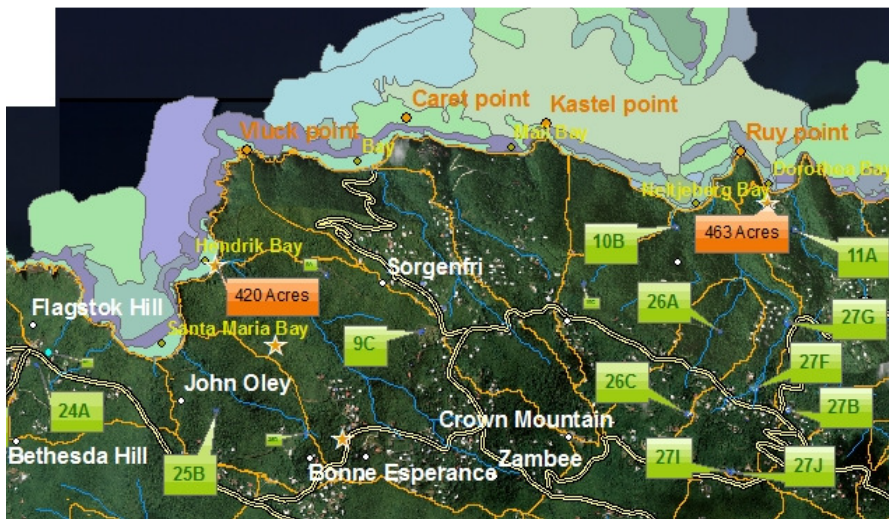
**Figure 2** View of the St. Thomas Water Resources GIS project map view

The study area inventory of impoundments GIS layer based on an on-screen aerial photo survey was completed. The St. Thomas point layer has a total of 24 features and St. Croix 33 features. A total of 80 pictures have been catalogued: 24 for St. Thomas and 56 for St. Croix;

A GIS project and draft maps are being prepared for a focus group presentation to resource managers and development plan reviewers to provide feedback on a proposed workflow for updating the water resources map and utilizing GIS to support the permitting review process relating to sediment control.
